## IATSB004503

| Title | Software Update for Fuel Plausibility – US MY26 only | |
| Affected Vehicle(s) | Grenadier | TF028817 – TF035401 |

**Issue:** An issue has been identified on a small percentage of the affected vehicles where the Engine Management Light turns on after the vehicle has been re-fuelled. The DTC shown for this is **P193208**

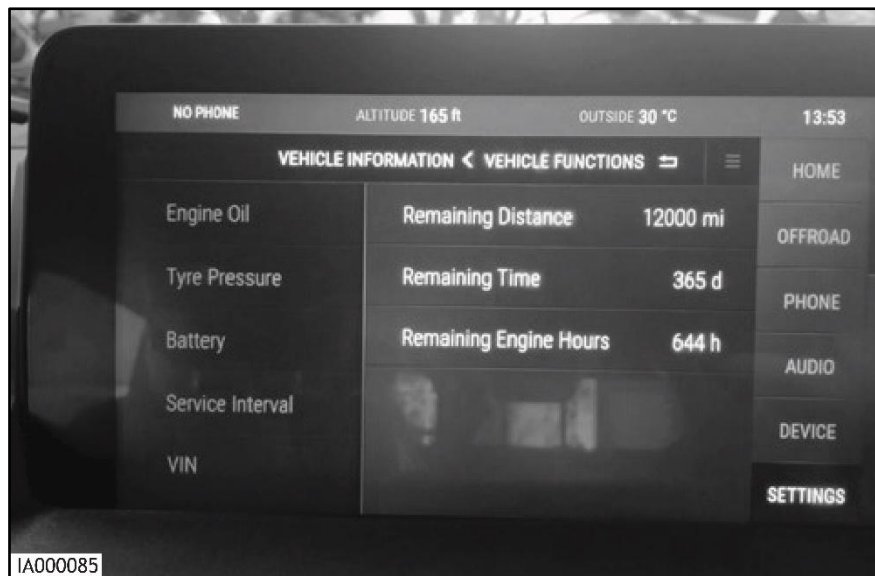
2.

Before the head unit is flashed. Write down the service interval information.

- Distance (Miles/Kilometres).
- Date.
- Engine running time.

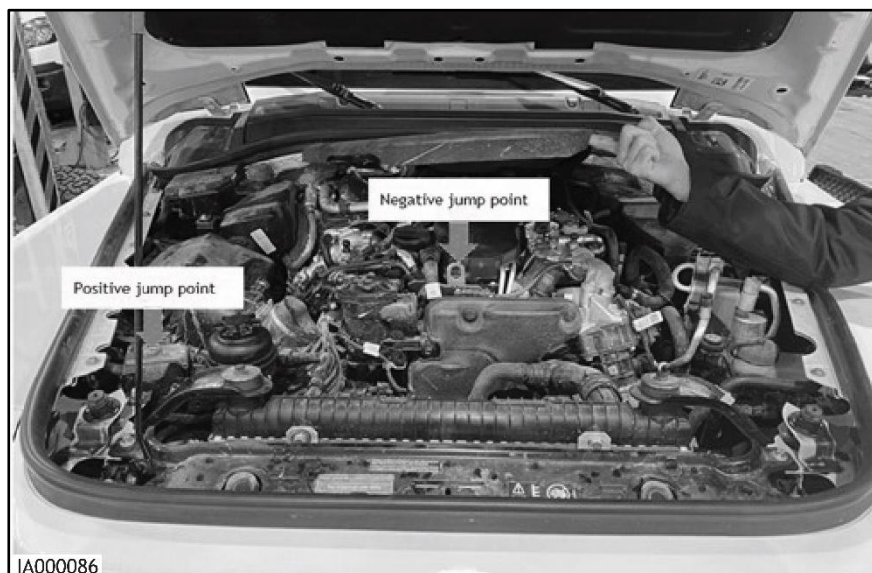
3.

- Place the vehicle on charge.
- Ensuring the battery charger can output up to 40 amps to support the vehicle power supply during the process.

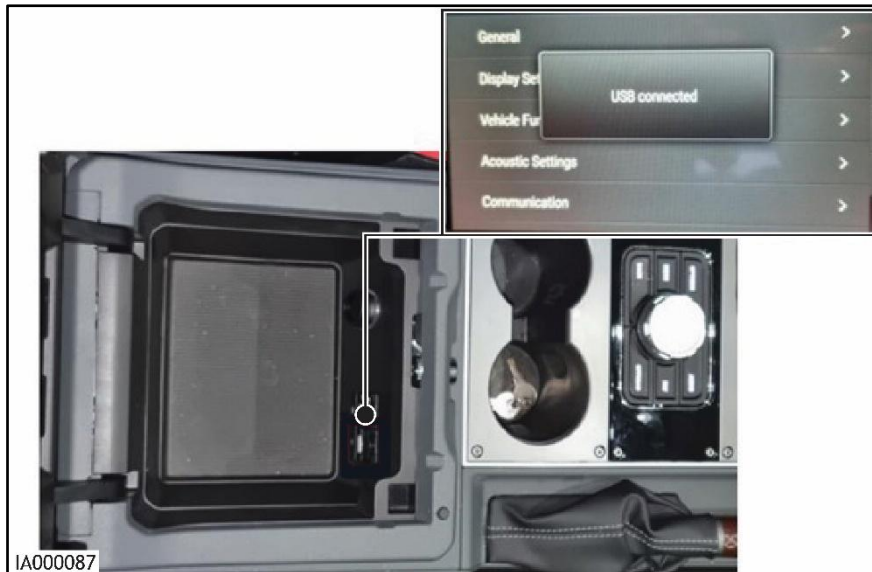
4.

Insert the USB stick into USB-A connection in the center console storage area with Head Unit (HU) 'update' software data from software pack SW-0000001024 (HU). A notification will display stating 'USB connected'

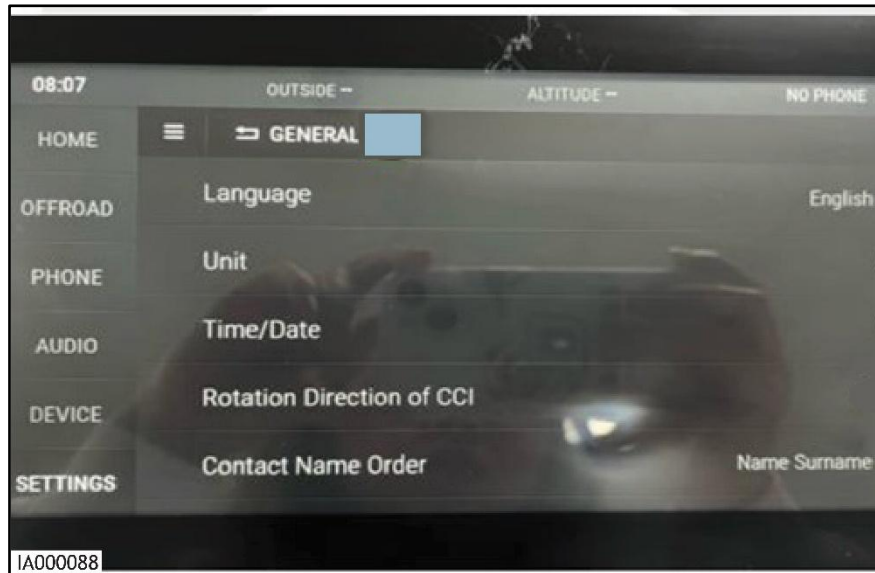
5.

- On the central display select '**SETTINGS – GENERAL**'.
- On the touchscreen, press and hold the area to the right of the '**GENERAL**' title for approximately 8 seconds. A screen will appear for PIN input.

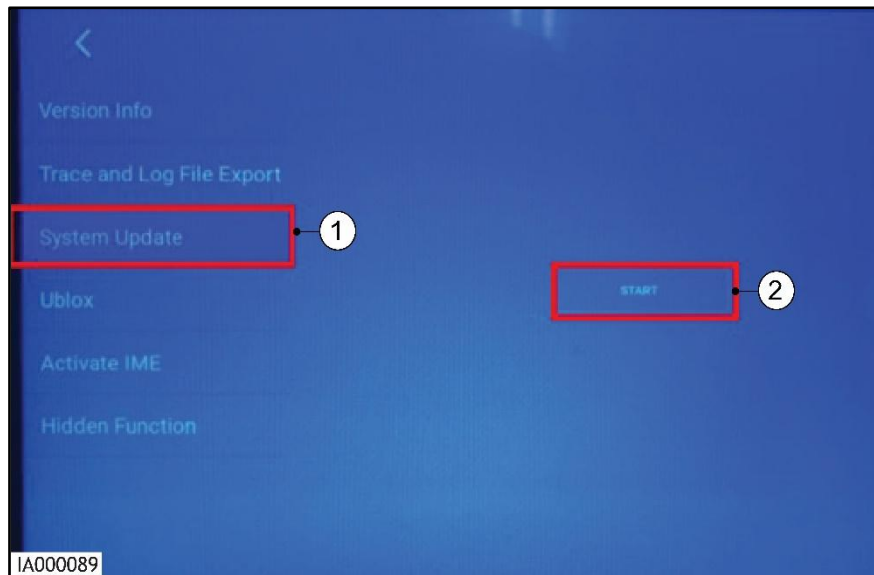
7.

- 1) Select '**System Update**'.
- 2) Select '**Start**'.

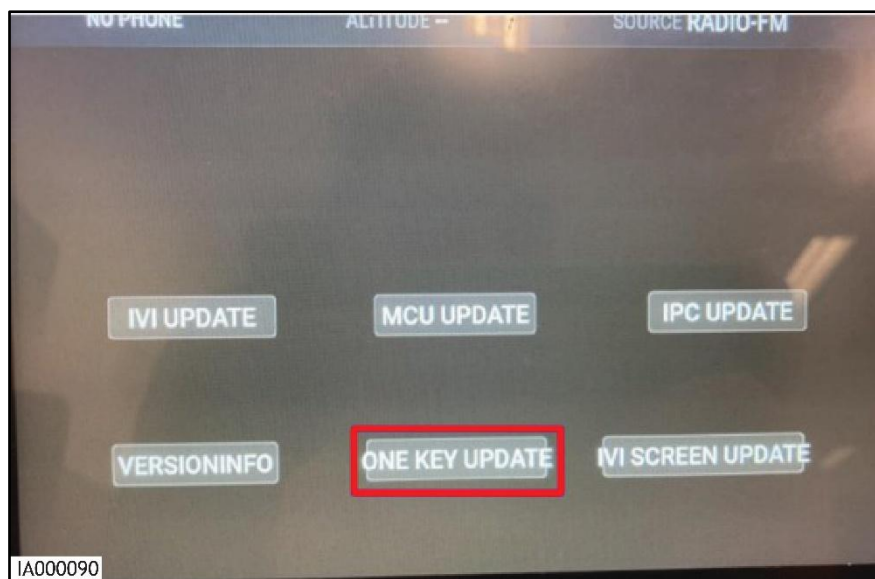
8.

- The software update takes approximately 40 minutes to complete.
- Place the vehicle on charge ensuring the vehicle battery charger can output up to 40 Amps.
- The technician is NOT required to be with the vehicle during this time.
- The software update no longer requires each application to be selected individually.
- Do not switch off the ignition or stop the process unless there is a notification is displayed in the central display.
- The ONE KEY UPDATE will flash all applications of the Head unit (i.e., IVI UPDATE / MCU UPDATE / IPC UPDATE / IVI SCREEN UPDATE)

Select '**ONE KEY UPDATE**'

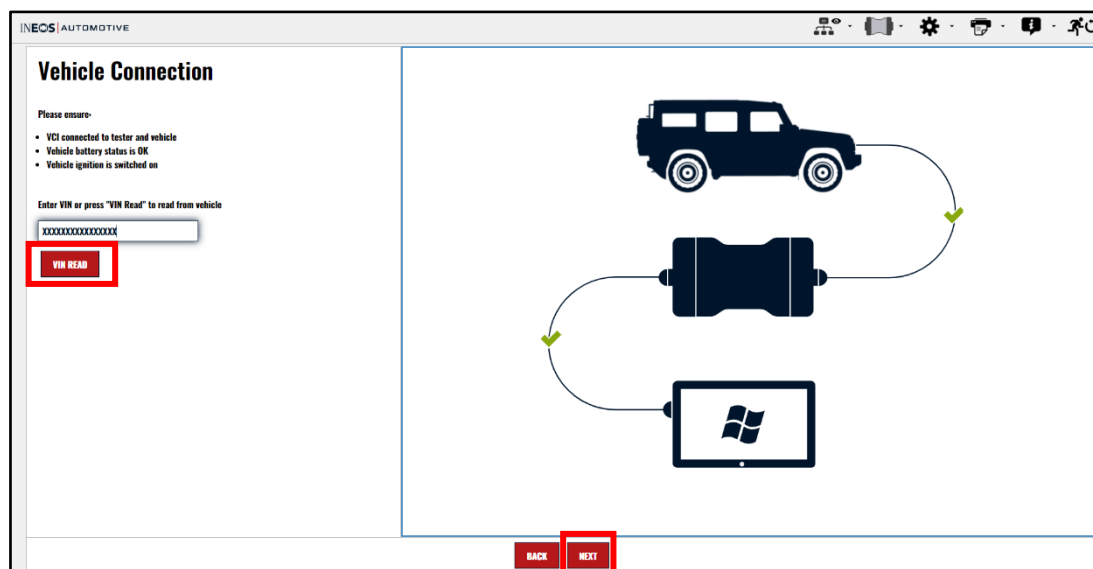
9.

- See VCI connection documentation for VCI self-help.
- Ensure the connection is **NOT** in simulation.

Connect the vehicle to Grade-X using the VCI connected to the OBD port in the driver's footwell.

- 1) Select '**VIN READ**'.
- 2) Select '**NEXT**'.

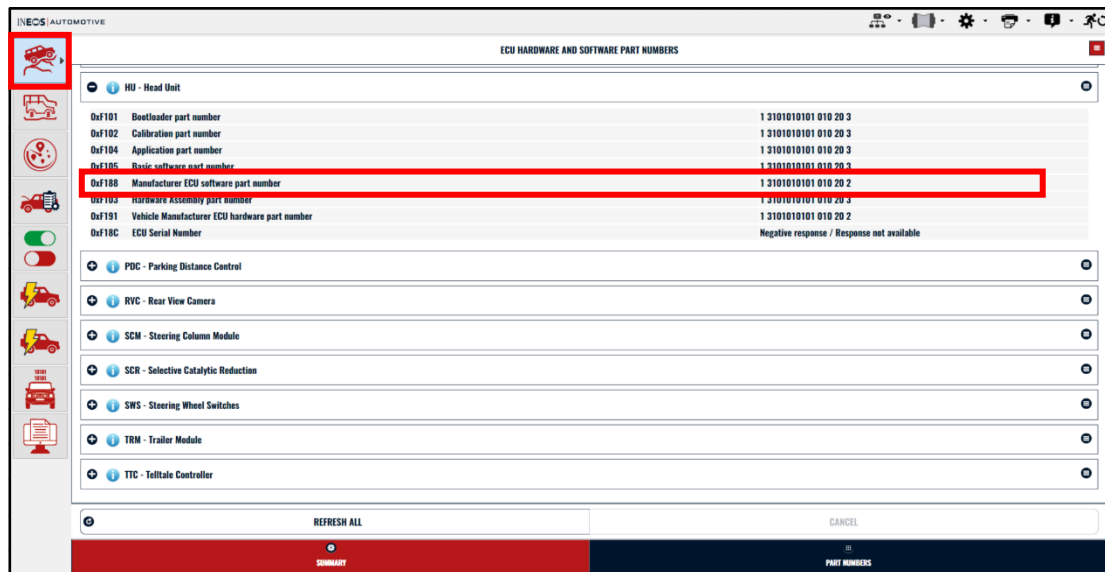
10.

- Open the vehicle summary page.
- Select '**PART NUMBERS**'.
- Select '**HU - Head Unit**'.
- Review the '**F188 - Manufacturers ECU software part number**' check and ensure SW-0000001024 (HU) is displayed as the part number.

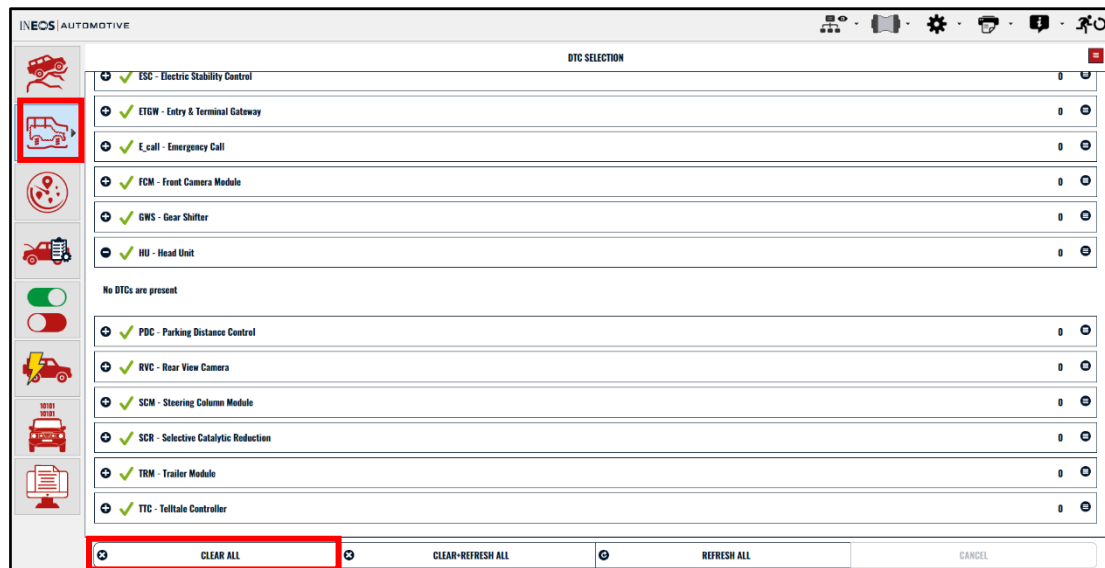
11.

- Select '**DTC Memory**' tab.
- Grade -X will start to read the ECU DTCs.
- Select '**CLEAR ALL**'.
- Grade - X will clear and read the vehicles DTCs.

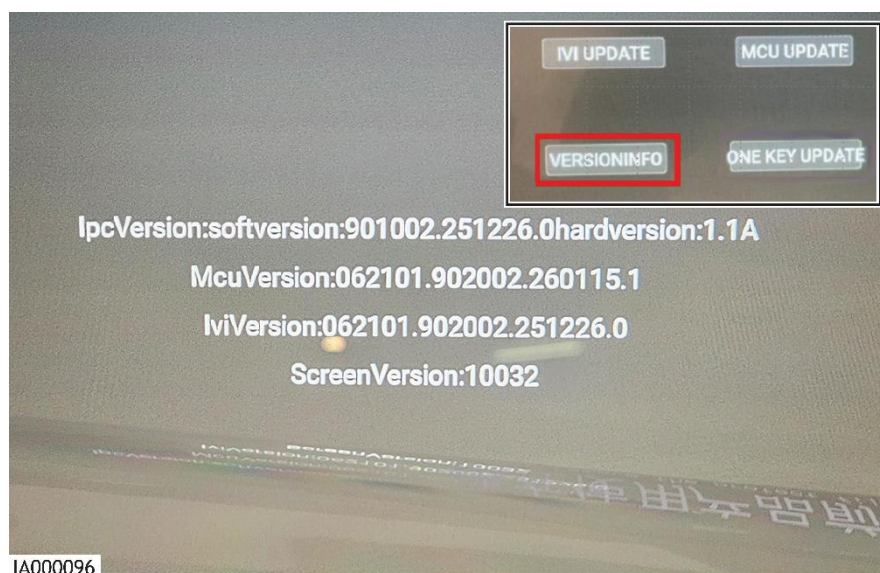
Select '**VERSIONINFO**' and check that all 3 dates are exactly the same.

To identify the dates, the information is written in the below format (Image shown for illustration purposes)

lpcVersion:Softversion: XXXXXX.**YYMMDD**.0hardversion:1.1A

McuVersion: XXXXXX.XXXXXX.**YYMMDD**.X

IviVersion: XXXXXX.XXXXXX.**YYMMDD**.X
