### Customer states:

There may be problems with various MMI functions or “Emergency call fault” may be displayed in the instrument cluster.

## Repair procedure

## **2. SVM code for AED control unit, software update for emergency call module (0075), and if necessary, for gateway (0019) and information electronics (005F)**

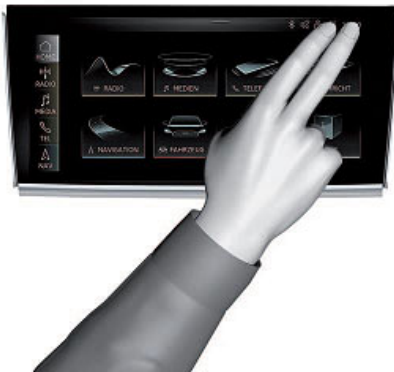
Select the red menu by pressing the following buttons:

Select "Update" and the source in which you have inserted the update medium (USB connection). Use the volume control to do this. All control units to be updated (AED) are shown; scroll all the way down and start the update.

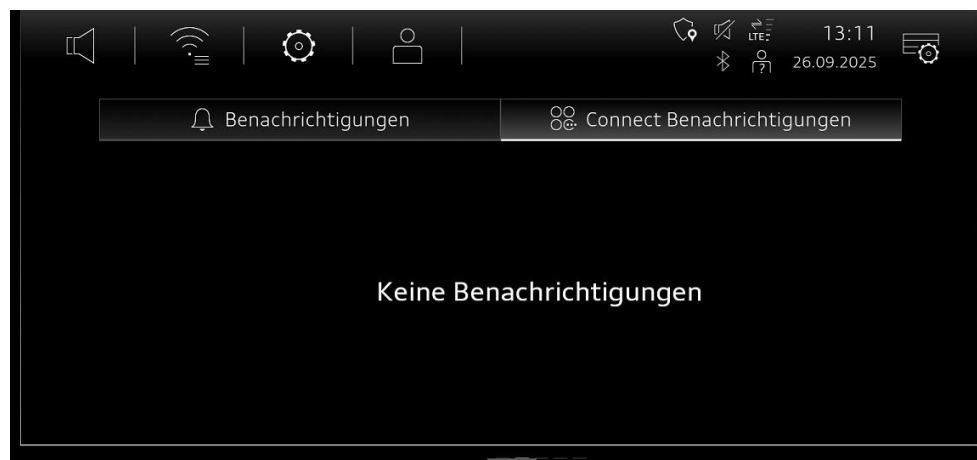
- The MMI will now restart.
- Wait until the MMI has fully initialized. The home screen must be complete and display all apps.
- Please restart the system by pressing and holding the volume control for 10 seconds.
- Open the notification center and switch to the "Audi connect notifications" tab.

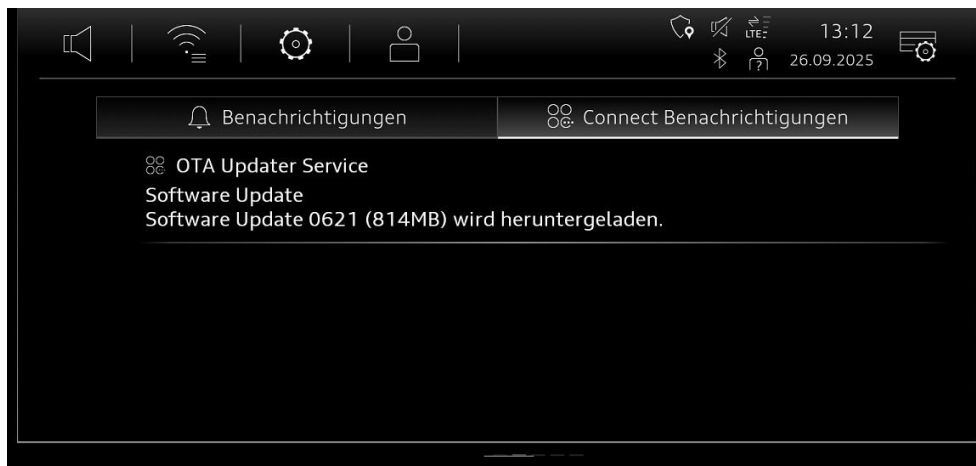
- It may take several minutes for further information to appear. **Please wait.**

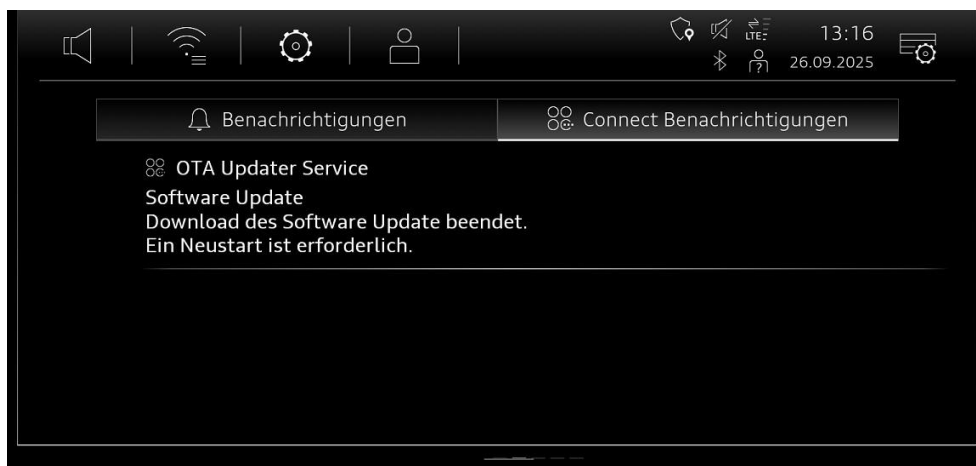
- **Please note:** This procedure will only work if the USB stick is still inserted.
- Please wait (approx. 5 min.) until the download is complete.

**Now please remove the USB stick.**

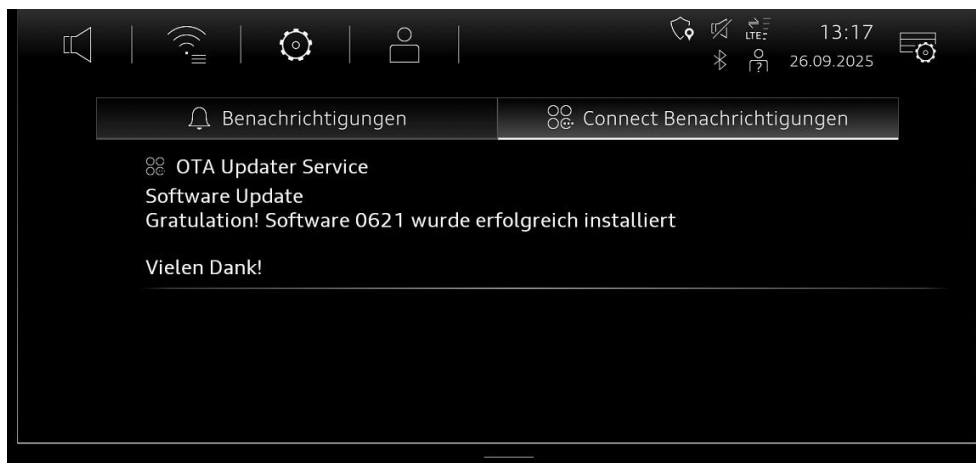
- Please restart the system by pressing and holding the volume control.
- Check whether the update was successful by calling up the notification center / Audi connect notifications.

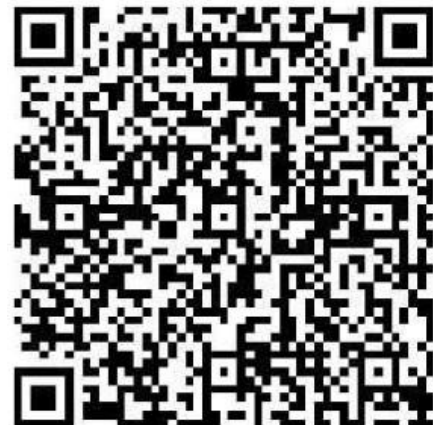
**Only H08 in 0019**

**Hardware version in diagnostic address 0019 = H08**

- **DUCDTCPR0075MLB,078EA001,FLIGHTON0075MLB,ZGDOIP,CL3BPA001US,TGU1MDMVB,CL3BPA002US,FLIGHTOFF0075MLB**

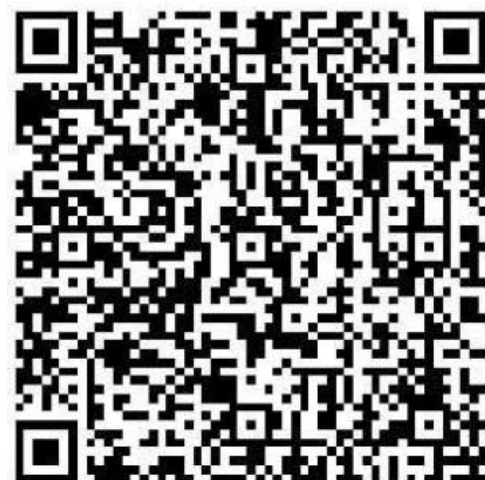
**All other hardware versions (e.g. H06) in diagnostic address 0019**

**DUCDTCPR0075MLB,078EA001,FLIGHTON0075MLB,ZGDOIP,CL3BPA001US,19A027,19B027,TGU1MDMVB,CL3BPA002US,FLIGHTOFF0075MLB**
