| Model(s) | Year(s) | VIN Range | Vehicle Specific Equipment |
| A3, S3, and RS 3 | 2024 – 2025 | All | With PR Code: IU4<br>078E – Android control module<br>Software version:<br>0555 |

## Repair procedure

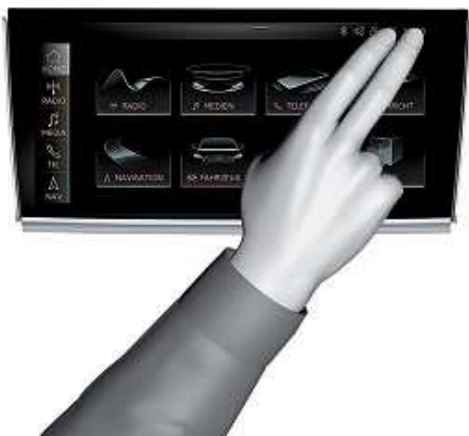
Select the red menu by pressing the following buttons:

Select “Update” and the source in which you have inserted the update medium (USB connection). Use the volume control to do this. All control units to be updated are shown; scroll all the way down and start the update.

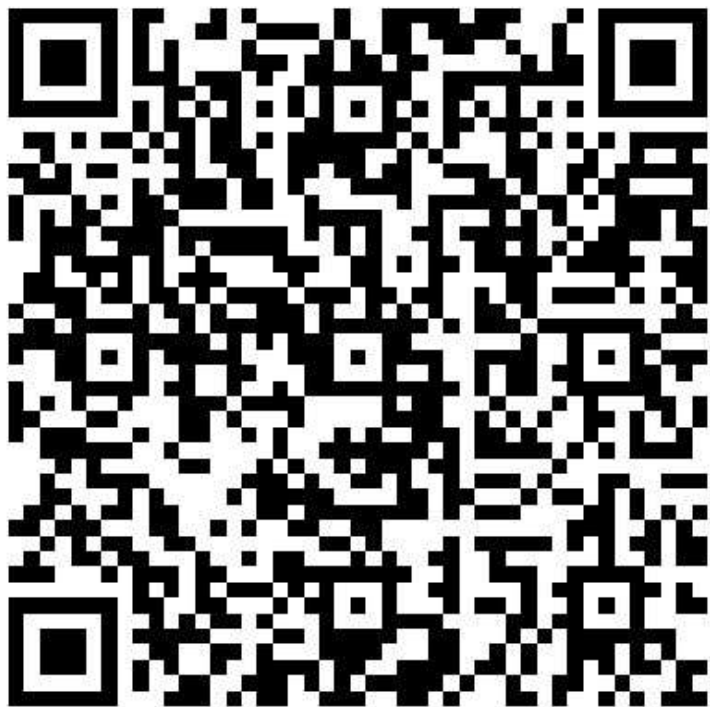
Only H08 in 0019

**IMPORTANT:** For the new software update program, the following SVM code must be entered exactly, including commas and without spaces (recommendation: scan QR code with hand-held scanner or copy and paste the SVM code chain).

Hardware version in diagnostic address 0019 = H08

078EA001,FLIGHTON0075MLB,ZGDOIP,CL3BPA001US,TGU1MDMVB,CL3BPA002US,FLIGHTOFF0075MLB

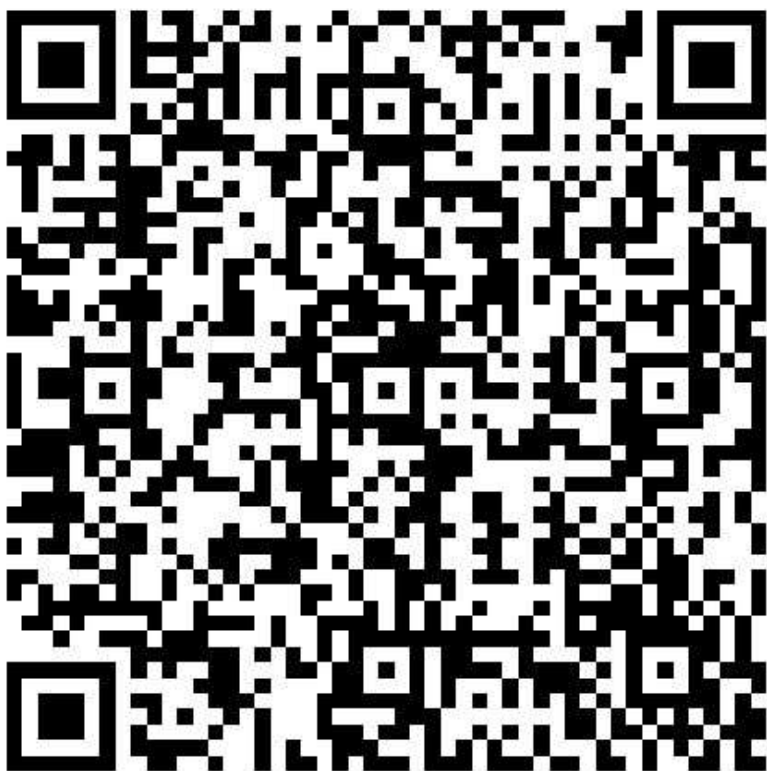
All other hardware versions (e.g. H06) in diagnostic address 0019

078EA001,FLIGHTON0075MLB,ZGDOIP,CL3BPA001US,19A027,19B027,TGU1MDMVB,CL3BPA002US,FLIGHTOFF0075MLB
