## Condition

| Model(s) | Year(s) | VIN Range | Vehicle Specific Equipment |
|---|---|---|---|
| A3, S3, and RS 3 | 2024 – 2025 | All | With PR Code: IU4<br>078E – Android control module<br>Software version:<br>0555 |

## Repair procedure

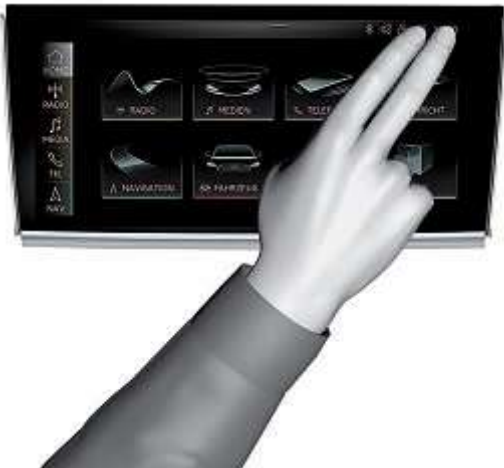
Select the red menu by pressing the following buttons:

Select "Update" and the source in which you have inserted the update medium (USB connection). Use the volume control to do this. All control units to be updated are shown; scroll all the way down and start the update.

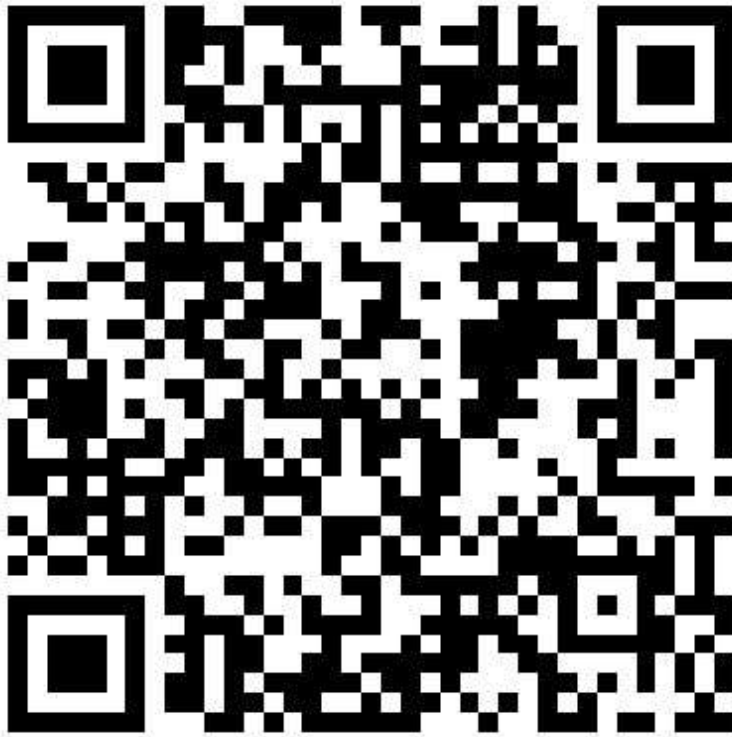
**IMPORTANT:** For the new software update program, the following SVM code must be entered exactly, including commas and without spaces (recommendation: scan QR code with hand-held scanner or copy and paste the SVM code chain).

078EA001,ZGDOIP,CL3BPA001US,TGU1MDMVB,CL3BPA002US
