## TECHNICAL SERVICE BULLETIN

### CHECK ENGINE LIGHT WITH FAULT CODE P0128-00

No: TSB-26-14-001

2026 Outlander with 4B40 Gen 2 Engine

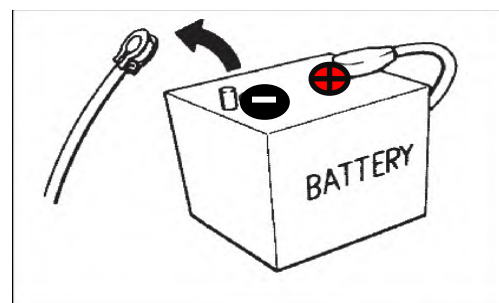
Disconnect 12V battery terminal according to instructions described below.

1. Open the hood.
2. Turn ignition switch to the ON position.
3. Turn ignition switch to the OFF position with the driver side door opened.
4. Get out of the vehicle and close the driver's side door.
5. Wait at least 3 minutes.

During the waiting period, do not operate the vehicle in any way, including locking, unlocking, or opening and closing the doors. Failure to follow this caution may trigger the ACC power supply due to the Auto ACC function.
