**TECHNICAL INSTRUCTIONS**  
**FOR**  
**SPECIAL SERVICE CAMPAIGN 26TC02**  
**REPROGRAMMING FOR PARKING ASSIST ECU**  
**CERTAIN 2023 - 2024 SEQUOIA**

## I. OPERATION FLOW CHART

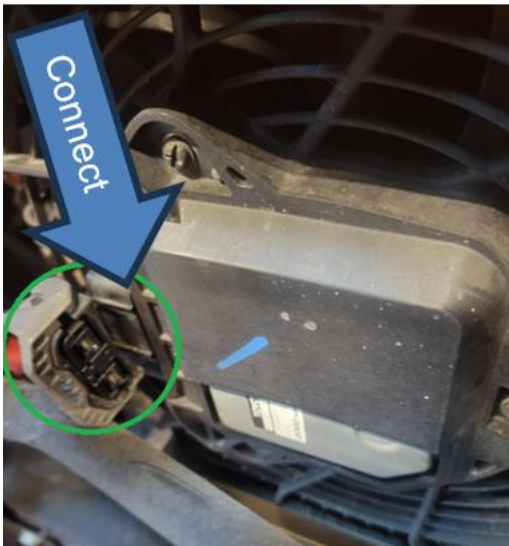
1. DISCONNECT THE DCA-8000
2. RECONNECT THE ELECTRIC RADIATOR FAN (HYBRID VEHICLES)
