# HYUNDAI

## Technical Service Bulletin

26-01-053H

DCU SOFTWARE UPDATE  
(LIMITED COVERAGE CAMPAIGN LA32)

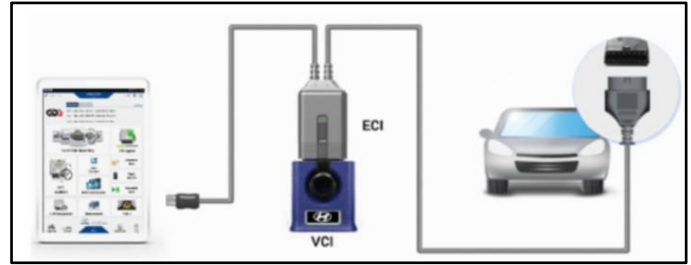
### VCI 2 Connection (must use ECI kit with USB-C cable attachment):

1. Connect the ECI DLC connector to the OBD connector of the vehicle.
2. Connect the VCI to the receiver module on the ECI cable.
3. Connect the ECI cable with the USB-C connector cable attachment to the tablet.

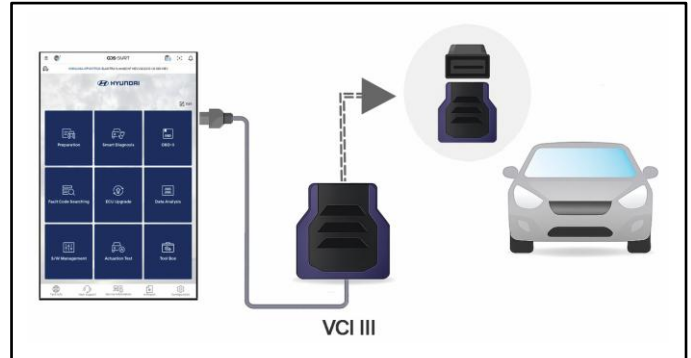
### VCI 3 Connection (use VCI 3 cable):

1. Connect the 19-pin connector to the bottom of the VCI 3.
2. Connect the VCI to the OBD connector of the vehicle.
3. Connect the cable with the USB-C connector to the tablet.

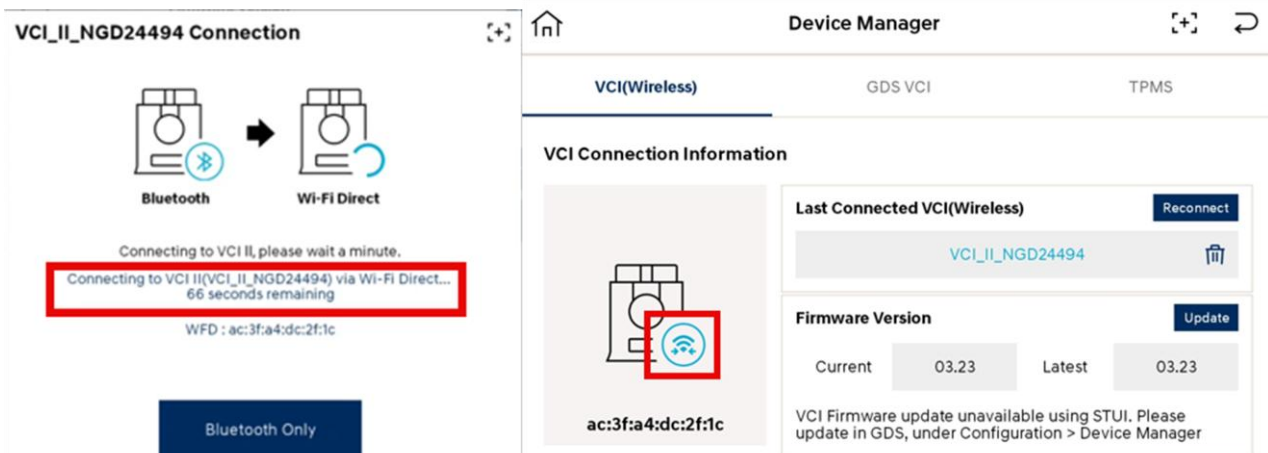
- If using VCI 2, please wait for the **Wi-Fi Direct** timer to complete to ensure the **Wi-Fi Direct** connection is established. Do **NOT** select **Bluetooth Only**.

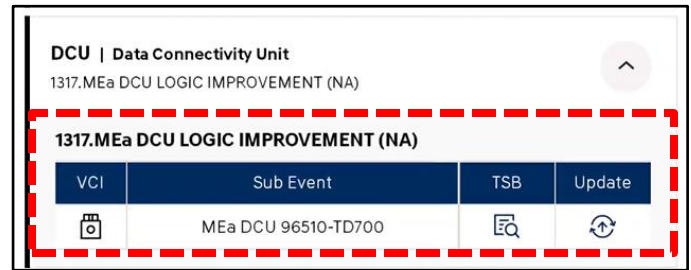
3. Verify the ROM ID by selecting the **DCU** system to scan the vehicle's current ROM ID.

Check the current ROM ID version and compare it to the ROM ID Information table before attempting to perform the software update.

If the update fails, remove the power connector from the in-cabin fuse box for at least **5 seconds**. Reassemble and retry the update.

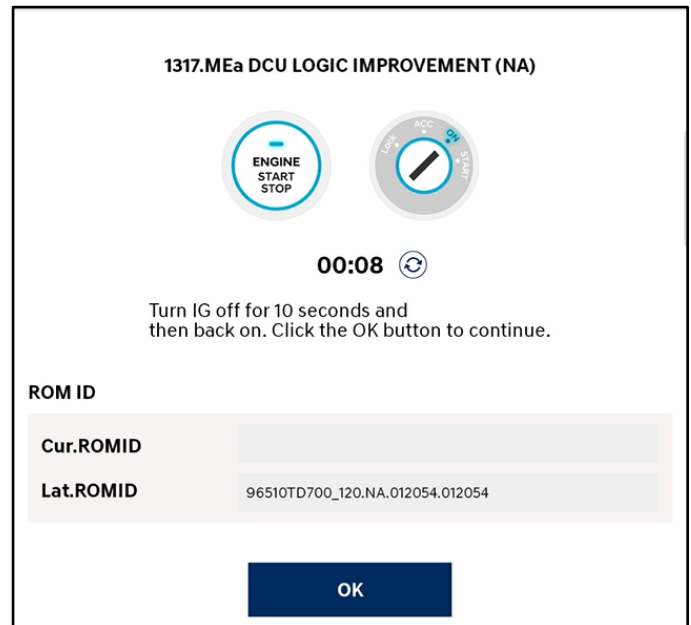
4. After the ECU update process shows 100% complete, follow the prompts on the screen to cycle the ignition **OFF** for at least **10 seconds** to reset the control unit (certain models may take up to **30 seconds**).

Use the **Refresh** button to reset the timer.

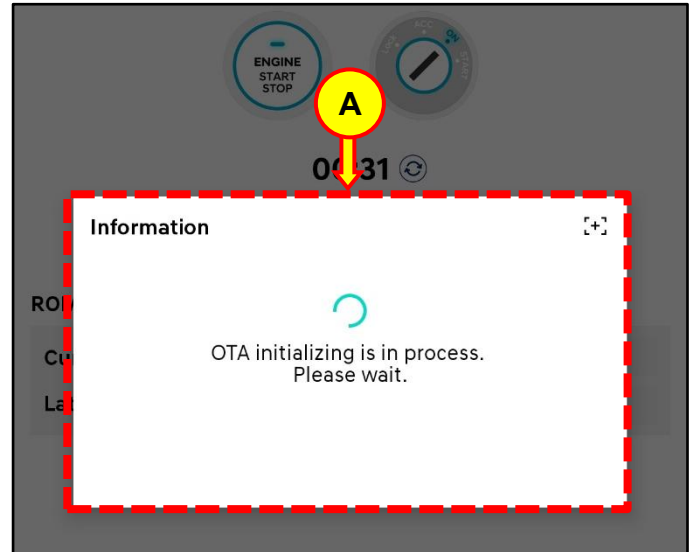
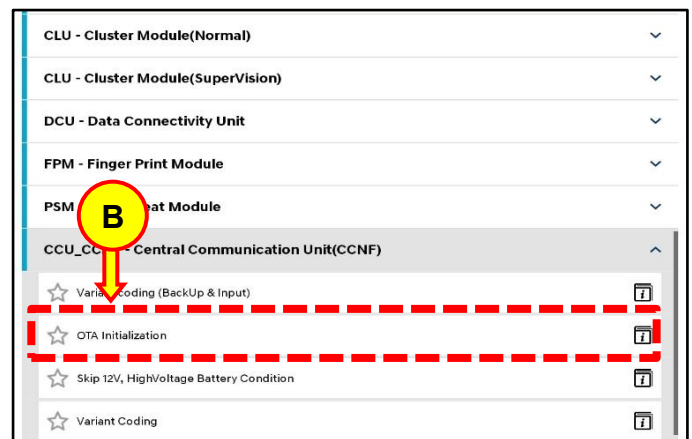
5. OTA initialization (A) should perform automatically:
  - If OTA initialization performs automatically, then proceed with the service procedure.
  - If the OTA initialization process fails, complete it manually under:  
**S/W Management > CCU\_CCNF - Central Communication Unit (CCNF) > OTA Initialization (B).**

Follow the instructions on the screen.

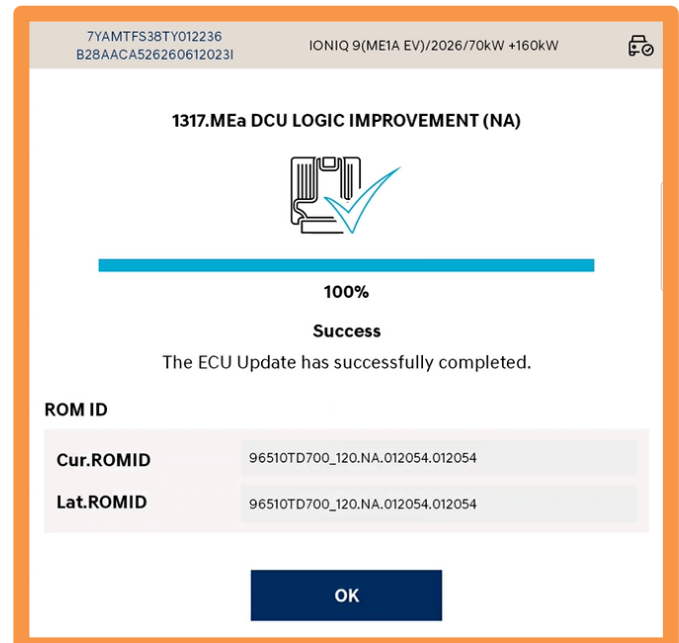
Using the tablet or GDS screen capture function, take a screenshot of the ECU Update "Success" result screen.

Upload the photo to STUI.

**NOTE:** The VIN/Date/Time/Mileage photo imprint is **NOT** required for GDS screenshots.

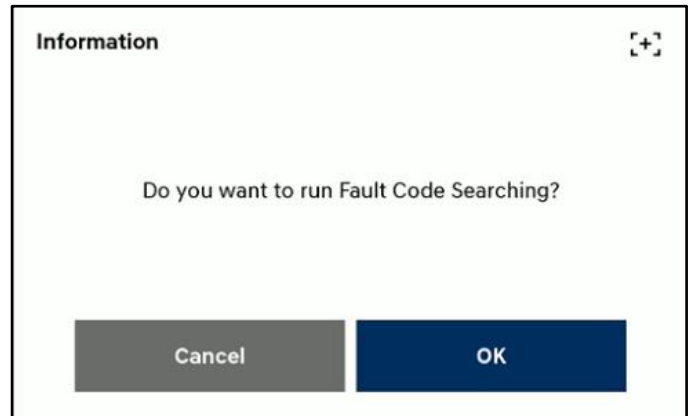
7. Perform an **All Systems Fault Code** search and erase DTC history that had incidentally occurred from the ECU update.
