**Product Update: 2023–25 Accord Hybrid PGM-FI Software Update****APPLIES TO**

To better manage engine temperatures, a PGM-FI update has been developed to optimize electric water pump operation.

Update the PGM-FI software.

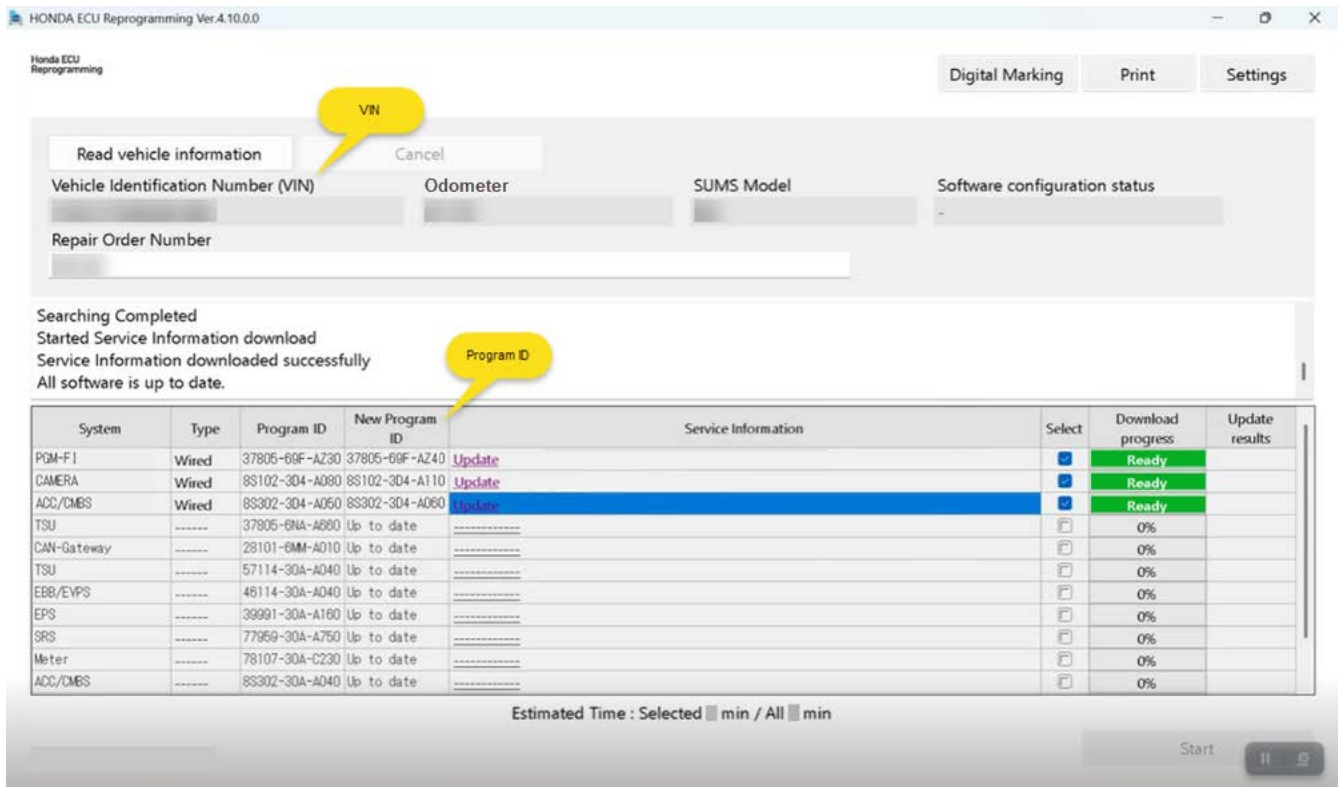
- Take a screenshot of the Honda ECU Reprogramming tool showing the VIN, odometer, and all available wired software updates.

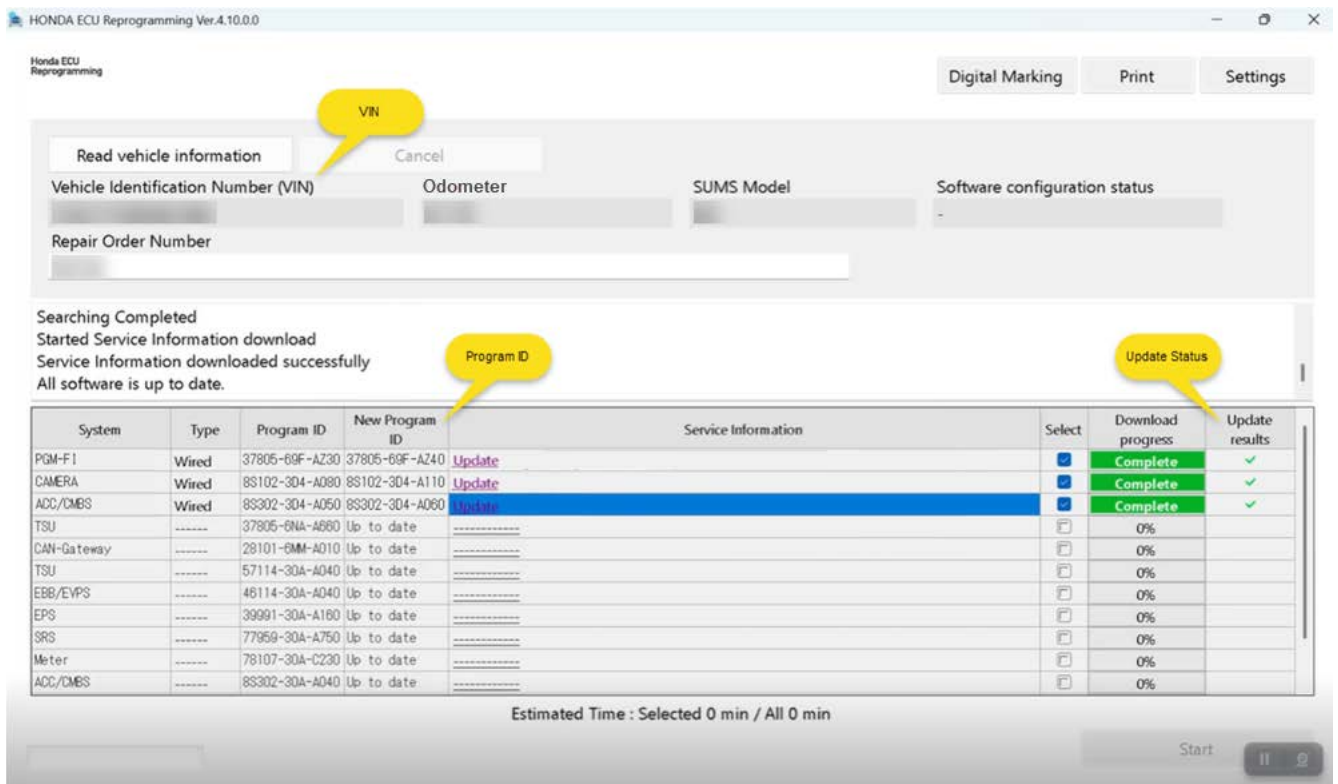
- Update the **PGM-FI** software, then update the available wired software updates, see service bulletin 22-100, [Updating Control Units/Modules with the Honda ECU Reprogramming Application](#).
- Take another screenshot of the Honda ECU Reprogramming tool showing the completed software updates, VIN, and odometer.
