| <br><b>Technical Service Bulletin</b> | <b>GROUP</b><br><b>CAMPAIGN</b> | <b>NUMBER</b><br><b>26-01-018G-1</b> |
| | <b>DATE</b><br><b>JULY 2026</b> | <b>MODEL(S)</b><br><b>GV70 ELECTRIFIED (JK1A EV)</b> |
| <b>SUBJECT:</b><br>DCU SOFTWARE UPDATE<br>(LIMITED COVERAGE CAMPAIGN L04G) | | |

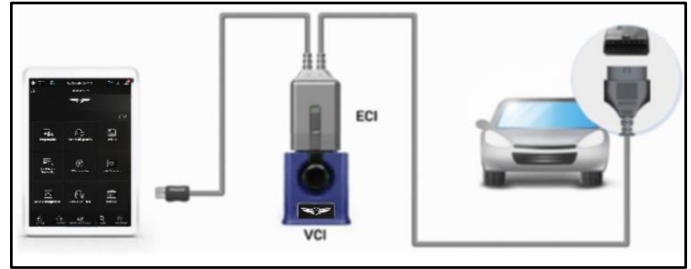
### VCI 2 Connection (must use ECI kit with USB-C cable attachment):

1. Connect the ECI DLC connector to the OBD connector of the vehicle.
2. Connect the VCI to the receiver module on the ECI cable.
3. Connect the ECI cable with the USB-C connector cable attachment to the tablet.

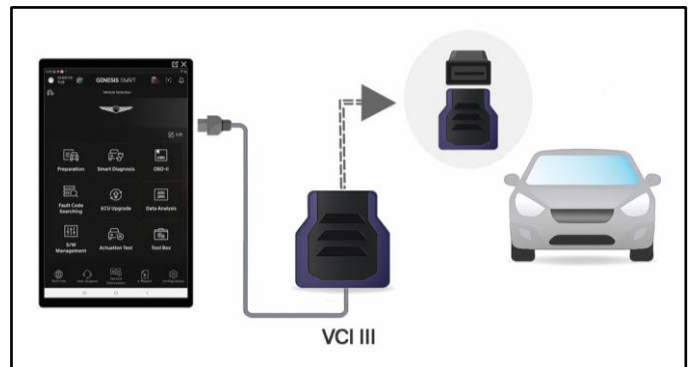
### VCI 3 Connection (use VCI 3 cable):

1. Connect the 19-pin connector to the bottom of the VCI 3.
  2. Connect the VCI to the OBD connector of the vehicle.
  3. Connect the cable with the USB-C connector to the tablet.
- Connect the cable with the USB-C connector to the tablet.

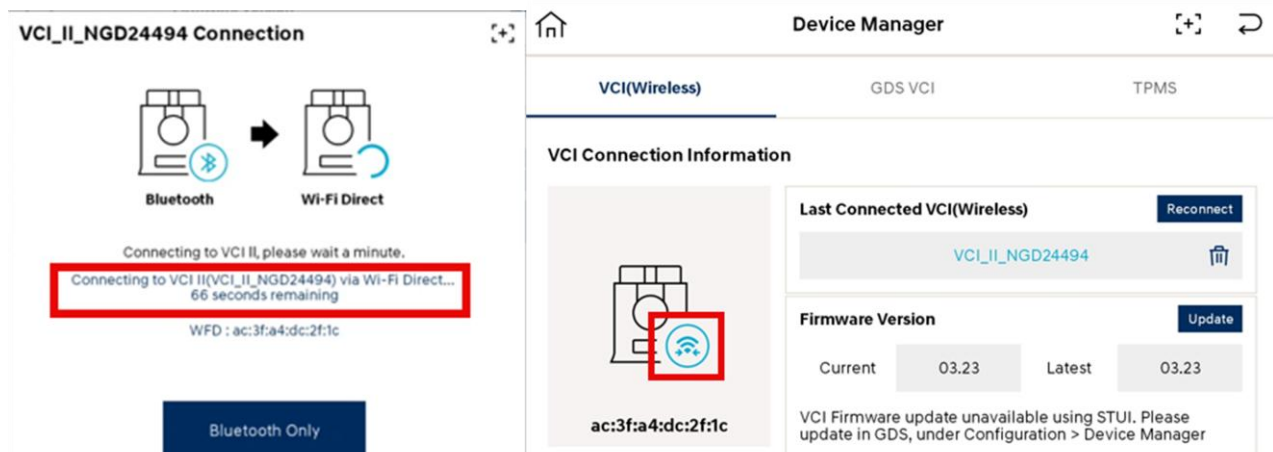
- If using VCI 2, please wait for the **Wi-Fi Direct** timer to complete to ensure the **Wi-Fi Direct** connection is established. Do **NOT** select **Bluetooth Only**.

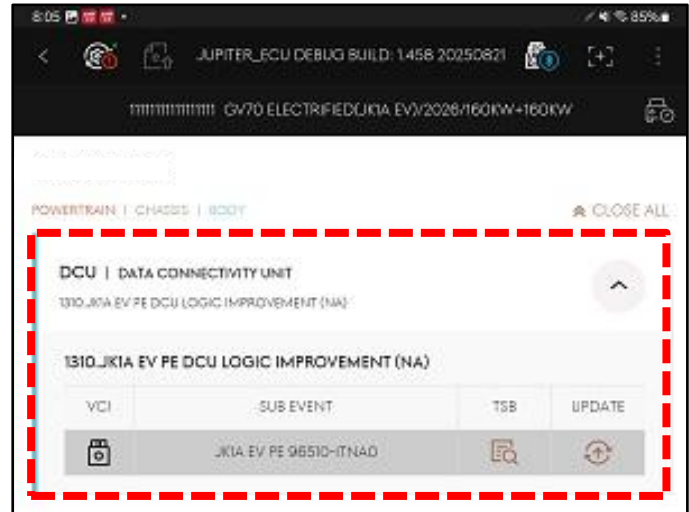
4. Verify the ROM ID by selecting the **DCU** system to scan the vehicle's current ROM ID.

Check the current ROM ID version and compare it to the ROM ID Information table before attempting to perform the software update.

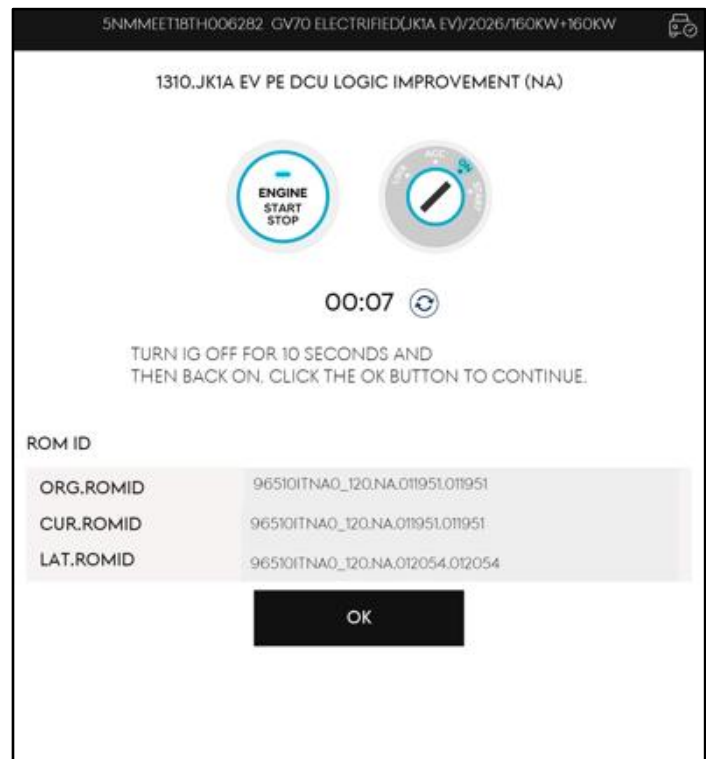
5. After the ECU update process shows 100% complete, follow the prompts on the screen to cycle the ignition **OFF** for at least **10 seconds** to reset the control unit (certain models may take up to **30 seconds**).

Use the **Refresh** button to reset the timer.

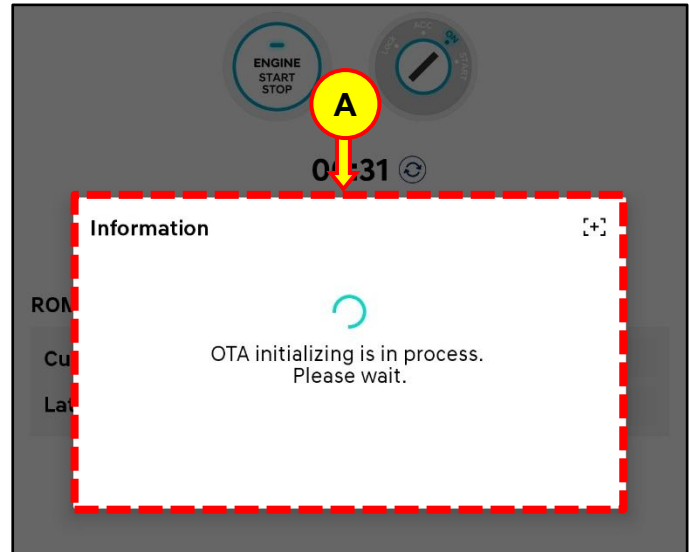
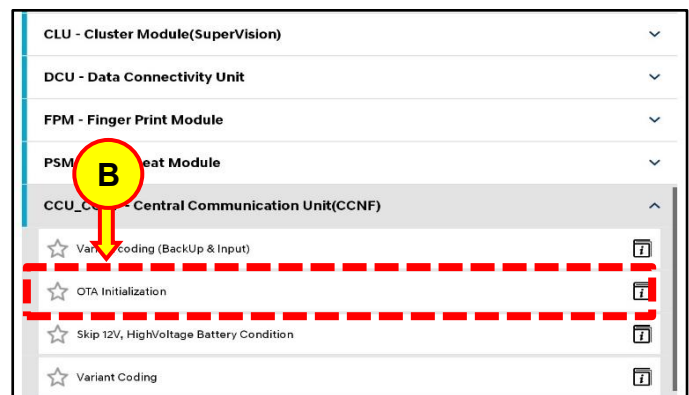
6. OTA initialization (A) should perform automatically:
- If OTA initialization performs automatically, then proceed with the service procedure.
  - If the OTA initialization process fails, complete it manually under:  
**S/W Management > CCU\_CCNF - Central Communication Unit (CCNF) > OTA Initialization (B).**

Follow the instructions on the screen.

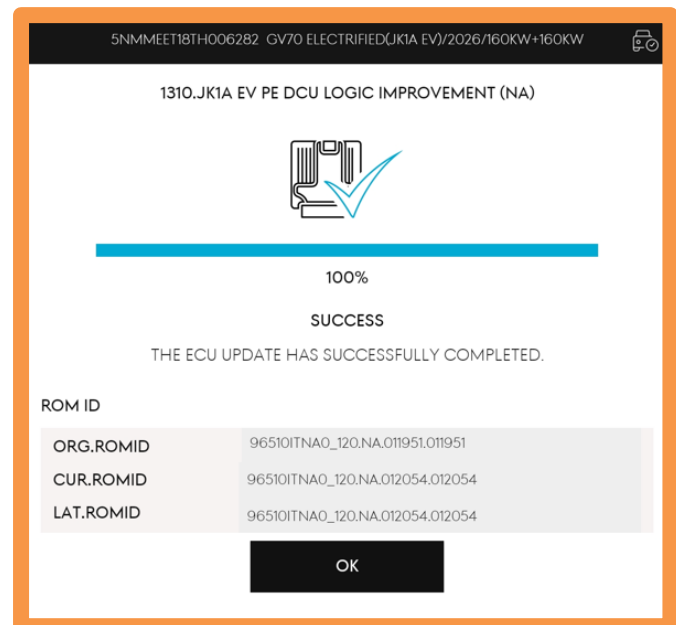
Using the tablet or GDS screen capture function, take a screenshot of the ECU Update "Success" result screen.

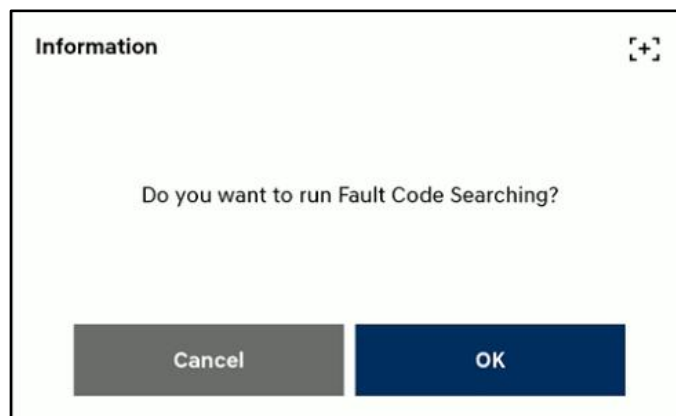
8. Perform an **All Systems Fault Code** search and erase DTC history that had incidentally occurred from the ECU update.
