## Technical Service Bulletin

| <b>CAMPAIGN</b> | <b>26-01-017G-1</b> |
| <b>JULY 2026</b> | <b>GV70 (JK1A)</b> |

**SUBJECT:** DCU SOFTWARE UPDATE  
(LIMITED COVERAGE CAMPAIGN L03G)

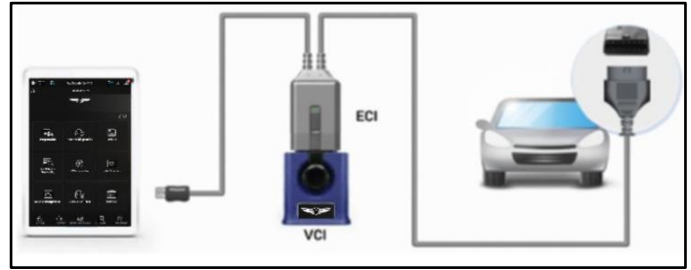
VCI 2 Connection (must use ECI kit with USB-C cable attachment):

1. Connect the ECI DLC connector to the OBD connector of the vehicle.
2. Connect the VCI to the receiver module on the ECI cable.
3. Connect the ECI cable with the USB-C connector cable attachment to the tablet.

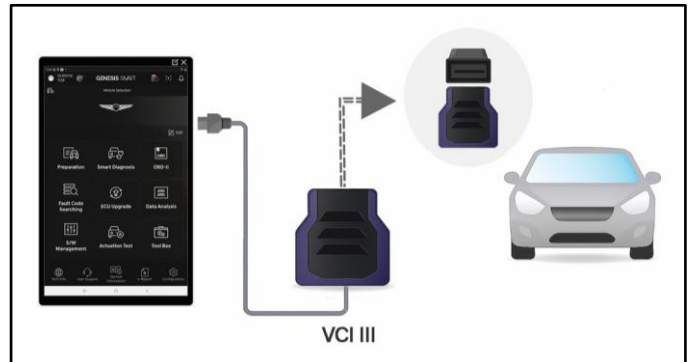
VCI 3 Connection (use VCI 3 cable):

1. Connect the 19-pin connector to the bottom of the VCI 3.
2. Connect the VCI to the OBD connector of the vehicle.
3. Connect the cable with the USB-C connector to the tablet.

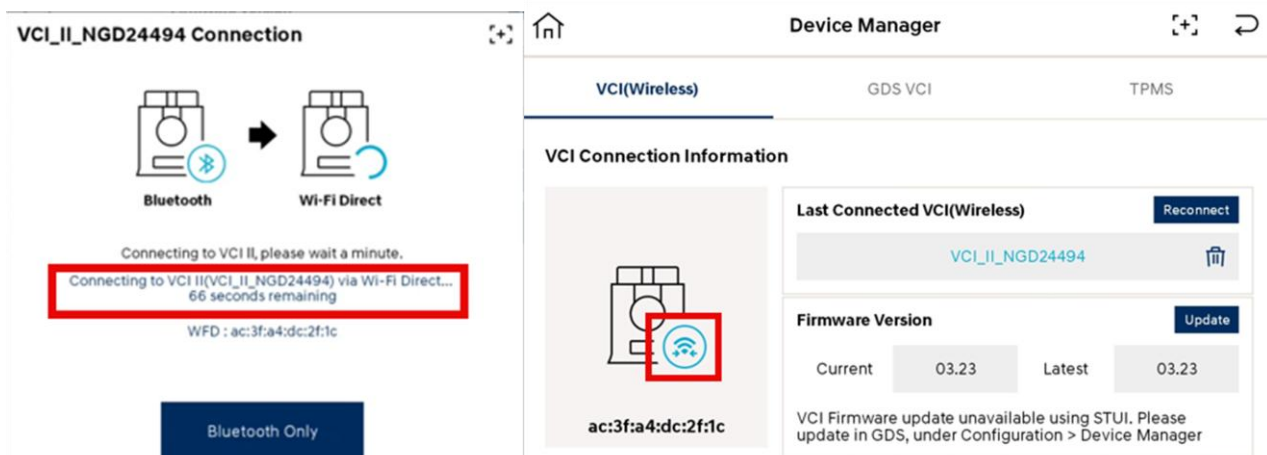
- If using VCI 2, please wait for the **Wi-Fi Direct** timer to complete to ensure the **Wi-Fi Direct** connection is established. Do **NOT** select **Bluetooth Only**.

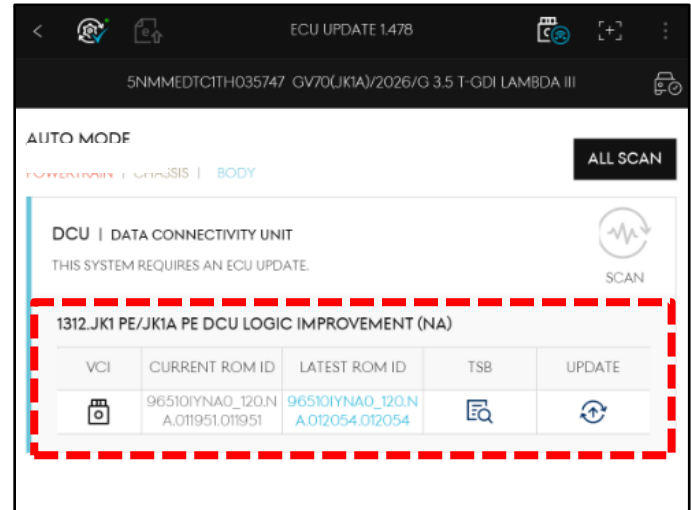
4. Verify the ROM ID by selecting the **DCU** system to scan the vehicle's current ROM ID.

Check the current ROM ID version and compare it to the ROM ID Information table before attempting to perform the software update.

If the update fails, remove the power connector from the in-cabin fuse box for at least **5 seconds**. Reassemble and retry the update.

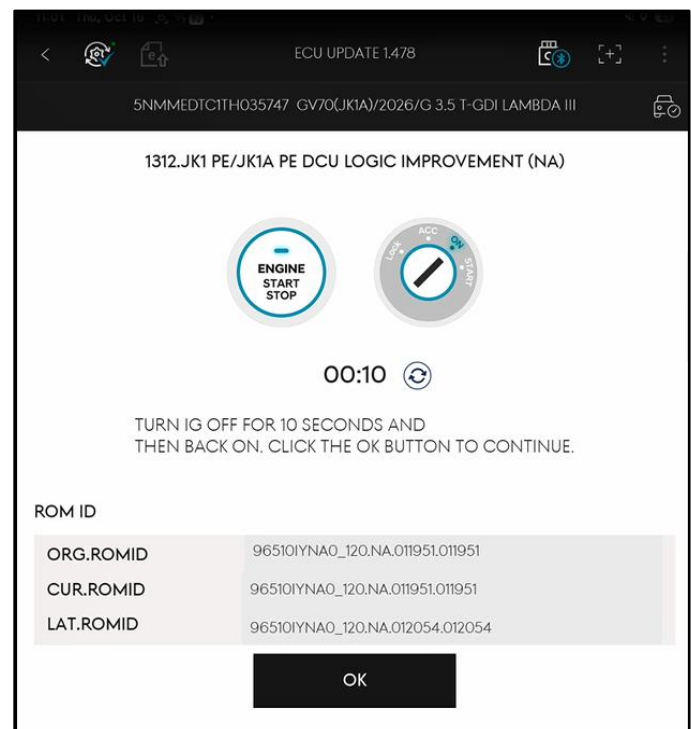
5. Once the ECU update is 100% complete, follow the prompts on the screen to cycle the ignition **OFF** for at least **10 seconds** to reset the control unit (certain models may take up to **30 seconds**).

Use the **Refresh** button to reset the timer.

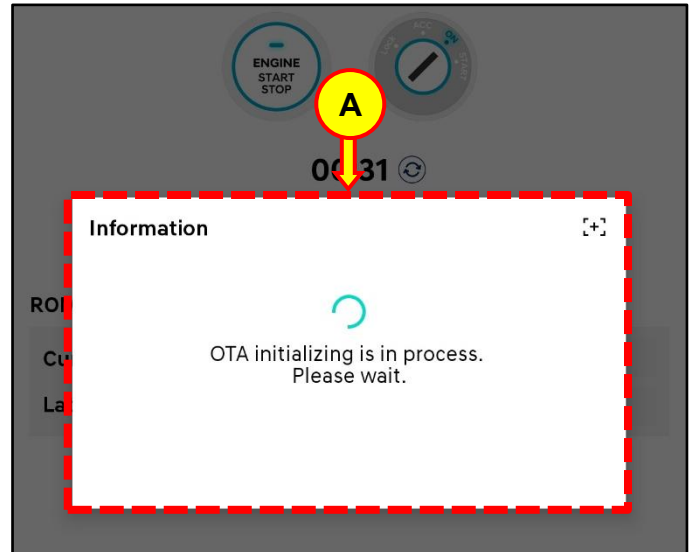
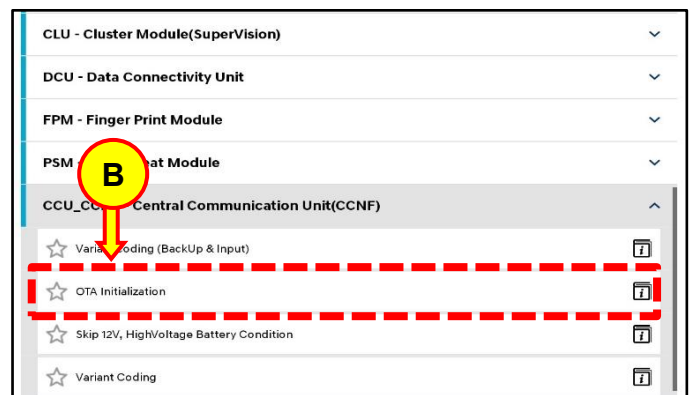
6. OTA initialization (A) should perform automatically:
- If OTA initialization performs automatically, then proceed with the service procedure.
  - If the OTA initialization process fails, complete it manually under:  
**S/W Management > CCU\_CCNF - Central Communication Unit (CCNF) > OTA Initialization (B).**

Follow the instructions on the screen.

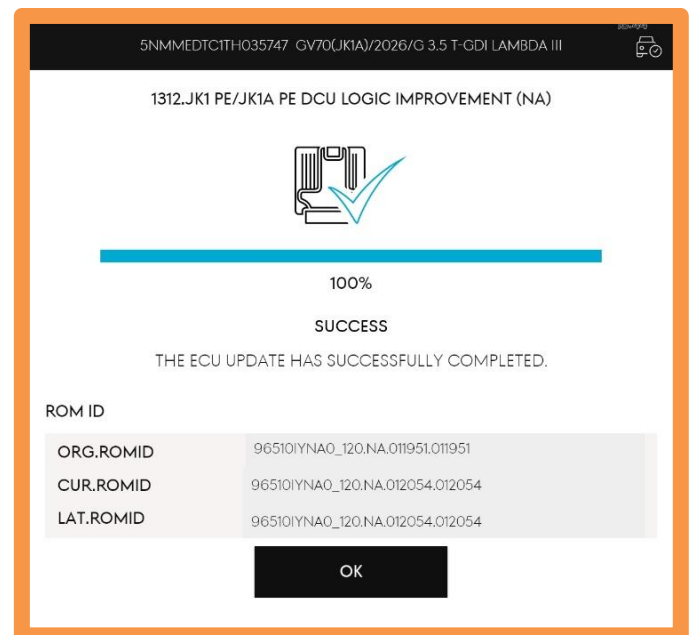
#### DIGITAL DOCUMENTATION

Using the tablet or GDS screen capture function, take a screenshot of the ECU Update "Success" result screen.

Upload the photo to STUI.

**NOTE:** The VIN/Date/Time/Mileage photo imprint is **NOT** required for GDS screenshots.

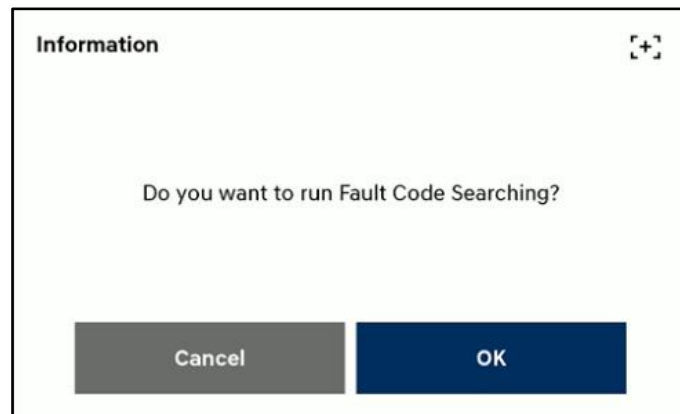
8. Perform an **All Systems Fault Code** search and erase DTC history that had incidentally occurred from the ECU update.
