| | ELE | 2025-2026MY<br>EV9 (MV1a) |
| | 427 | August 2026 |
| SUBJECT: VEHICLE-TO-EVERYTHING (V2X) SOFTWARE UPGRADE | | |

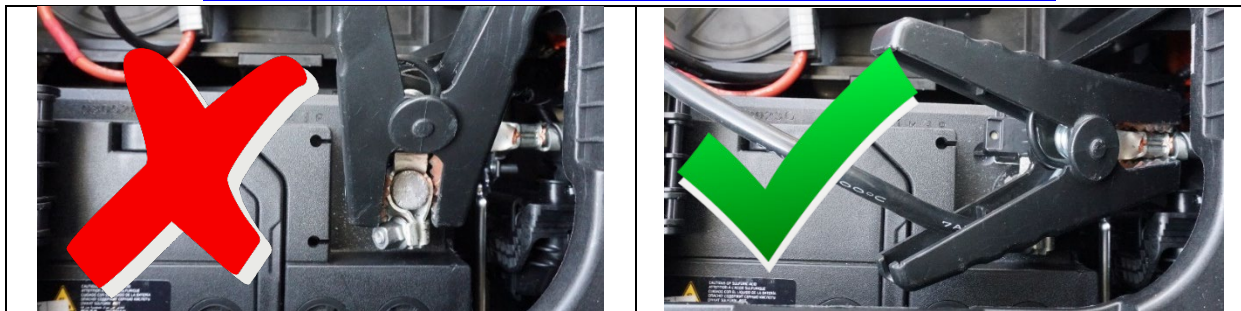
[Connect the negative \(-\) terminal to the battery as shown below.](#)

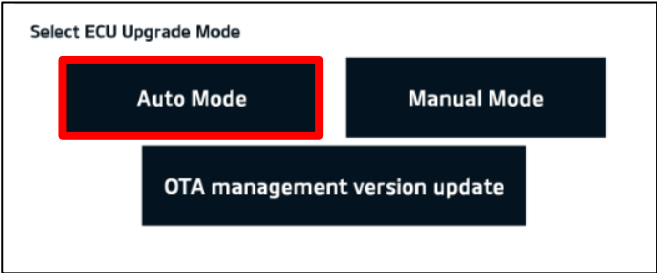
The required software must be installed by selecting the **'Auto Mode'** ECU Upgrade option.

**Note:** In some cases, the 'Manual Mode' installation option may be required **ONLY** if the 'Auto Mode' function fails or is otherwise noted above.

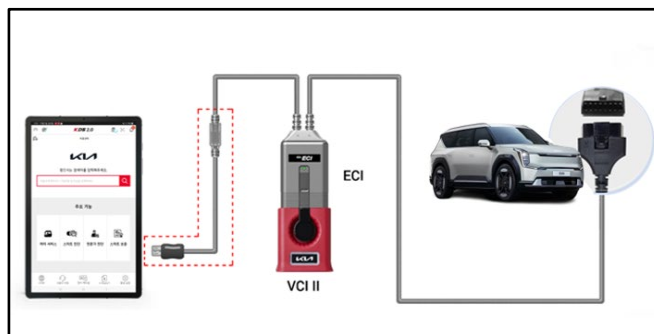
## Using KDS + VCI-II and ECI Connection

1. Connect the ECI DLC connector to the OBD-II connector, located under the driver's side of the instrument panel.
2. Connect the ECI USB -C connector to the KDS tablet.
3. Connect the VCI II to the ECI OBD-II connector.

Perform the update by connecting an additional ECI Connector to the VCI-II or by using a VCI-III Connector since the DCU upgrade uses ethernet for vehicle communication. The ECI Connector and VCI-III must be connected to the diagnostic terminal with a USB wired cable and the KDS tablet's IP must be set.

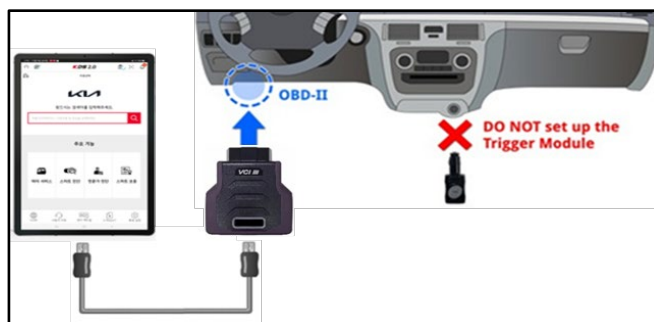
## Using KDS + VCI-III Connection

1. Connect the VCI III USB-C connector to the KDS tablet.
2. Connect the VCI III to the OBD-II connector of the vehicle.

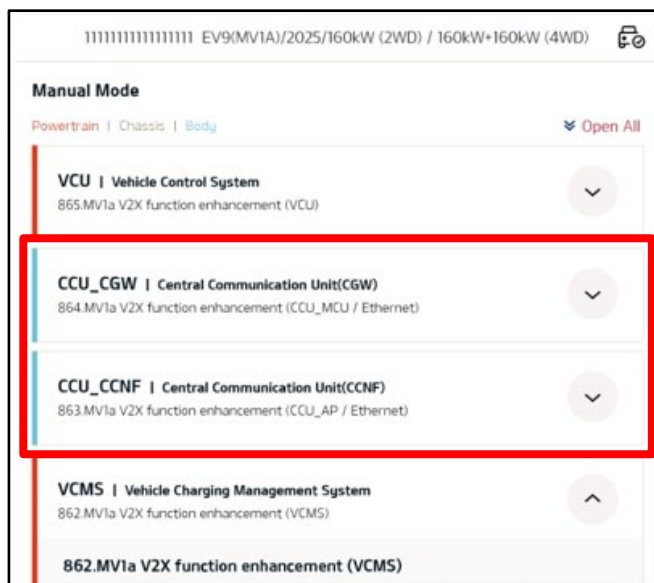
## UPGRADE EVENT(s):

Select the applicable **'CCU-CGW' (MCU)** and **'CCU\_CCNF' (AP)** system modules and the Event Group

- 863. MV1a V2X function enhancement (CCU\_AP / Ethernet)
- 864. MV1a V2X function enhancement (CCU\_MCU / Ethernet)
