| GROUP | MODEL |
|---|---|
| ELE | 2027MY<br>Telluride (LQ2a)<br>Telluride Hybrid (LQ2a HEV) |

## TECHNICAL SERVICE BULLETIN

### SERVICE ACTION: ULTRA-WIDE BAND SENSOR SOFTWARE UPDATE (SA652)

This bulletin provides information to upgrade the Ultra-Wideband Bluetooth Low Energy Master ("UWB\_BLE\_M") system software on certain Digital Key 2-equipped 2027MY Telluride (LQ2a) vehicles produced from December 03, 2025, through June 04, 2026, and certain 2027MY Telluride Hybrid (LQ2a HEV) vehicles produced from December 04, 2025, through June 04, 2026. The improved software reduces power consumption from the vehicle's auxiliary battery and enhances its performance by preventing the vehicle's auto-flush door handles from remaining extended for prolonged periods when a smartphone with Digital Key 2 remains nearby the parked vehicle. To extend the auto-flush door handles in this circumstance, the driver should press the lock/unlock indentation on either front door handle. Follow the procedure outlined in this publication to apply the improved logic to the UWB\_BLE\_M system. Refer to [SST081](#) for software upgrade instructions using Kia Diagnostic System (KDS) tablet and VCI-II or VCI-

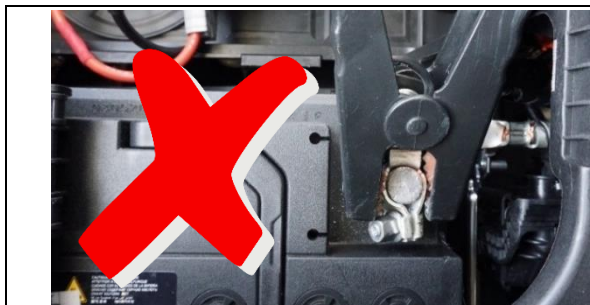
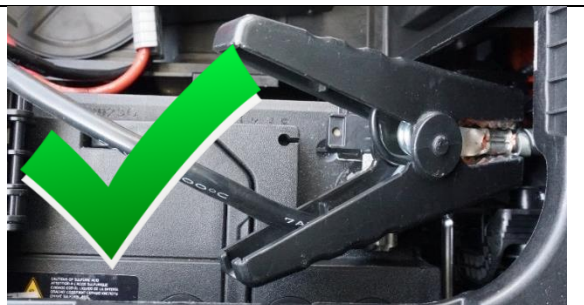
[Connect the negative \(-\) terminal to the battery as shown below.](#)

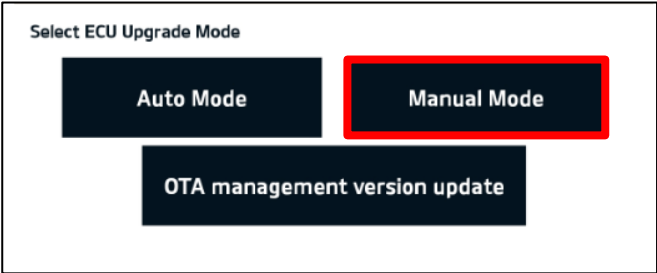
Software Information:

The required software must be installed by selecting the **Manual Mode** ECU Upgrade option.

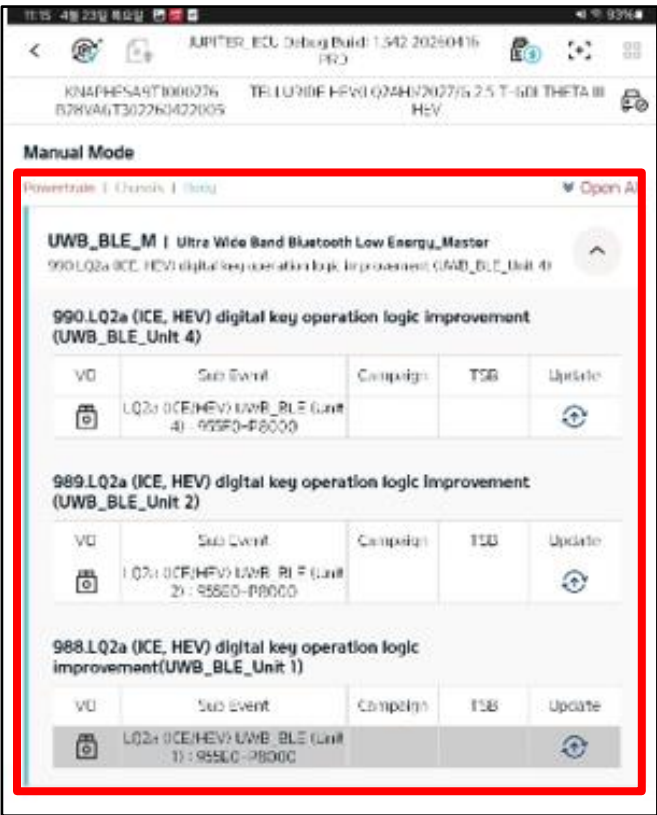
Select the applicable **'UWB\_BLE\_M'** system module and the Event Group.

- 988.LQ2a (ICE, HEV) digital key operation logic improvement (UWB\_BLE\_Unit 1)  
**AND**
- 989.LQ2a (ICE, HEV) digital key operation logic improvement (UWB\_BLE\_Unit 2)  
**AND**
- 990.LQ2a (ICE, HEV) digital key operation logic improvement (UWB\_BLE\_Unit 4)

Verify the affected vehicle Calibration Identification of the applicable ECU ROM ID and reference the Information Table on page 3 as necessary.
