| | ELE | 2027MY<br>Telluride (LQ2a)<br>Telluride Hybrid (LQ2a HEV) |
| SUBJECT: SERVICE ACTION: SUNROOF LOGIC IMPROVEMENT (SA653) | | |

This bulletin provides information to upgrade the Roof Control Module 'RCM' system software on certain 2027MY Telluride (LQ2a) vehicles produced from December 04, 2025 through May 28, 2026, and 2027MY Telluride Hybrid (LQ2a HEV) vehicles produced from December 05, 2025 through May 28, 2026. The affected vehicles may exhibit an illuminated Malfunction Indicator Lamp 'MIL' accompanied by DTC U17000 which can cause the sunroof assembly to become inoperative. Follow the procedure outlined in this publication to apply the improved logic to the 'RCM' system. Refer to [SST081](#) for software upgrade instructions using Kia Diagnostic System (KDS) tablet and VCI-II and confirm the Upgrade Event Number/Name, ROM ID Information, and Manual Mode passwords (if applicable) on the applicable vehicle.

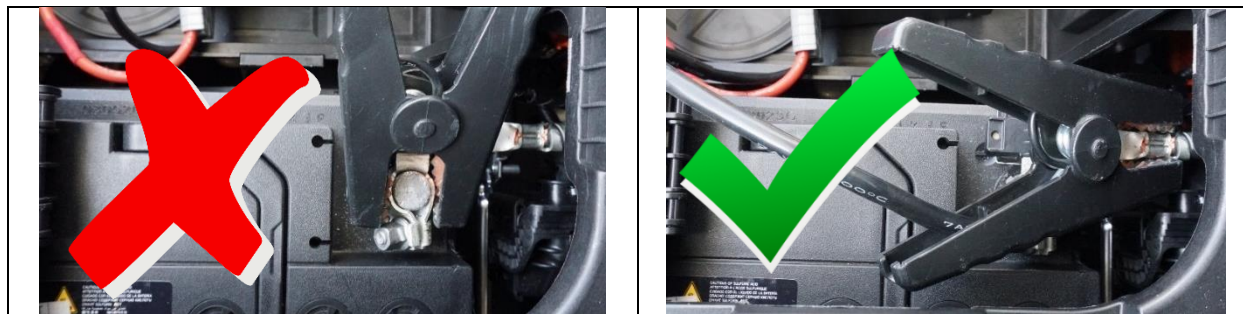
[Connect the negative \(-\) terminal to the battery as shown below.](#)

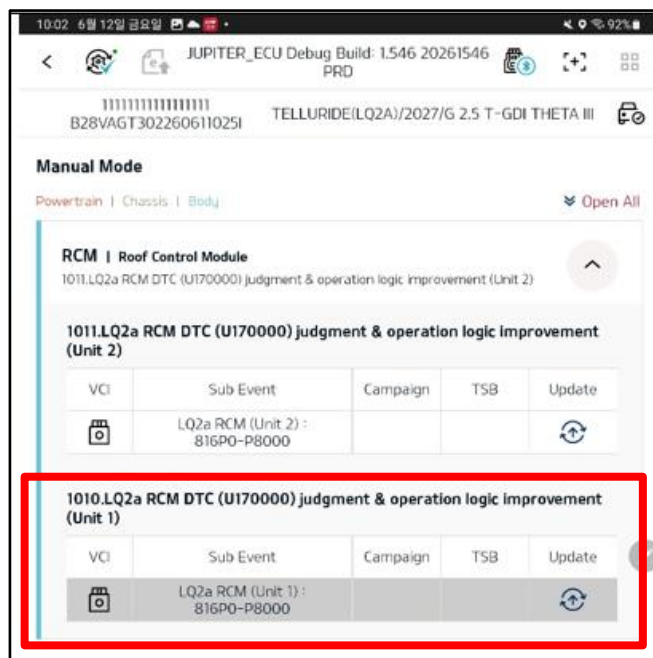
Select the applicable **'RCM'** system module and the Event Group.

- 1010.LQ2a RCM DTC (U170000) judgment & operation logic improvement (Unit 1)

Verify the affected vehicle Calibration Identification of the applicable ECU ROM ID and reference the Information Table on page 3 as necessary.
