# HYUNDAI

## Technical Service Bulletin

NUMBER  
26-BE-026H

**SUBJECT:** BDC & UWB SOFTWARE UPDATE FOR  
DIGITAL KEY LOGIC IMPROVEMENT

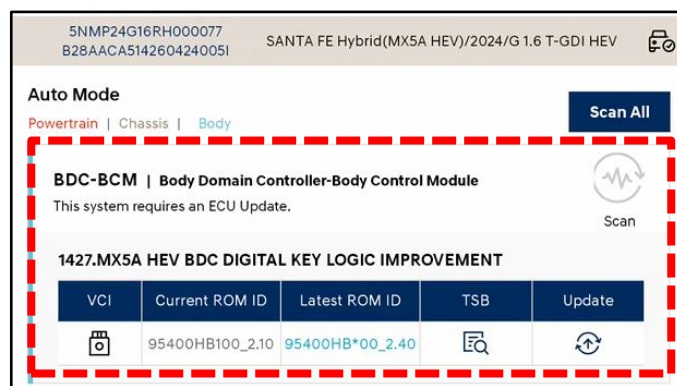
3. After the ECU update process shows 100% complete, follow the prompts on the screen to cycle the ignition **OFF** for at least **10 seconds** to reset the control unit (certain models may take up to **30 seconds**).
