| GROUP | MODEL |
|---|---|
| ELE | 2027MY<br>Telluride (LQ2a)<br>Telluride Hybrid (LQ2a HEV) |
| 434 | August 2026 |

## TECHNICAL SERVICE BULLETIN

### SERVICE ACTION: SBCM SOFTWARE LOGIC IMPROVEMENT (SA658)

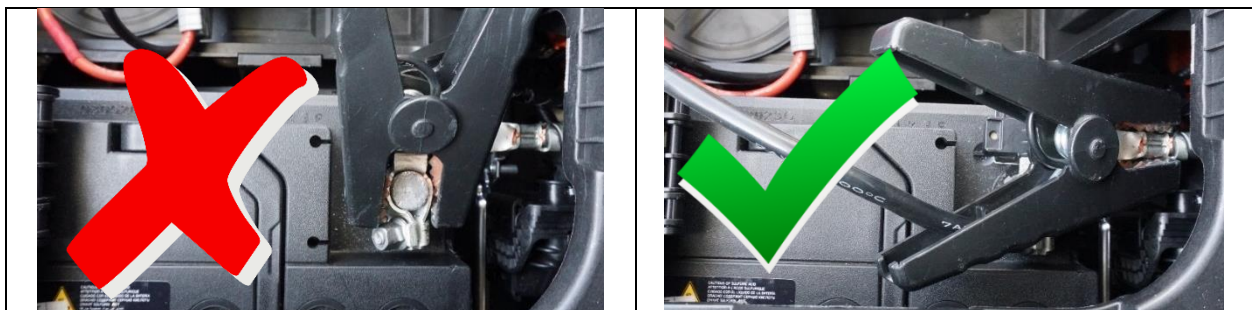
[Connect the negative \(-\) terminal to the battery as shown below.](#)

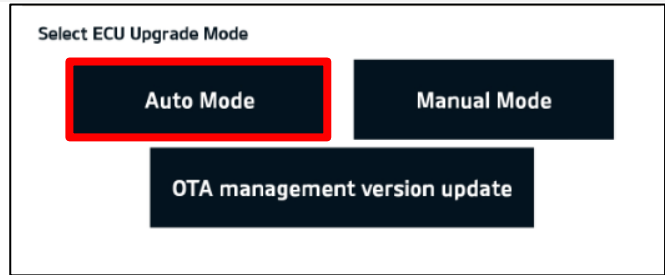
**Note:** In some cases, the 'Manual Mode' installation option may be required **ONLY if** the 'Auto Mode' function fails or is otherwise noted above.

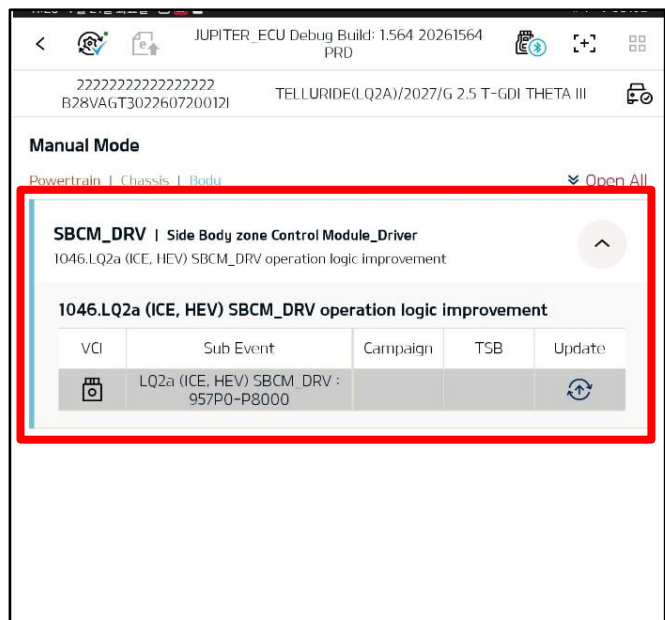
Verify the affected vehicle Calibration Identification of the applicable ECU ROM ID and reference the Information Table on page 3 as necessary.
