| Product Improvement | 25-26MY<br>EV6 (CV1 eGT, CVa) |
| PI2605 | September 2026 |

## TECHNICAL SERVICE BULLETIN

### BMU LOGIC IMPROVEMENT (PI2605)

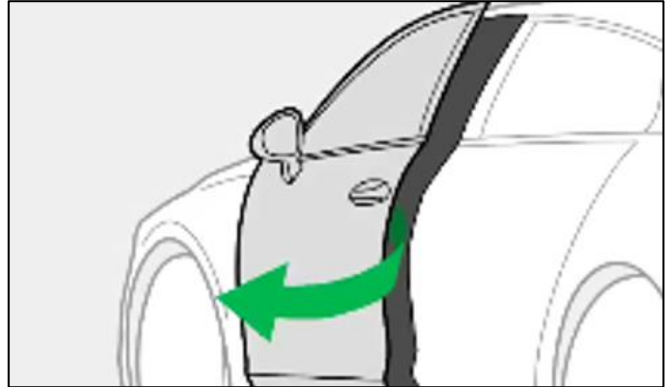
1. Open the driver's door.

Keep the left driver door open  
throughout the following steps.

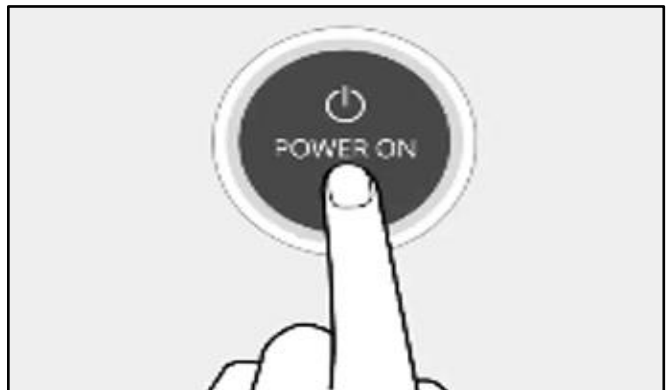
2. Press the ignition 'Power ON' button once (without depressing the brake pedal).

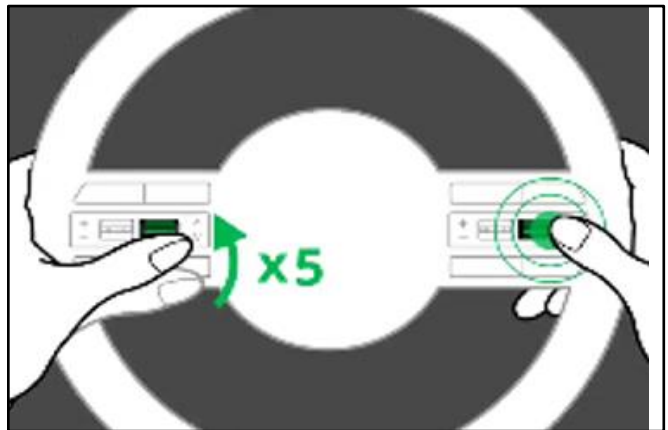
3. Press and hold the right side 'MUTE' button down on the steering wheel while pressing the left side 'UP/DOWN' button UPWARDS five (5x) times.

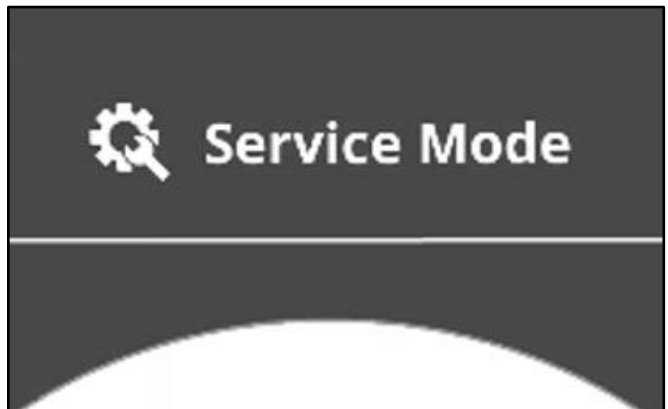
4. Confirm the vehicle is set to 'Service Mode' in the instrument cluster display.
5. Install the BMS software by proceeding to page 3.

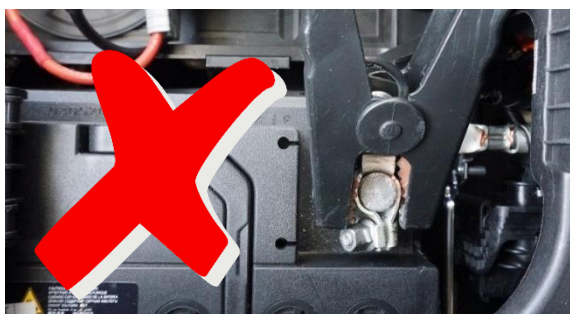
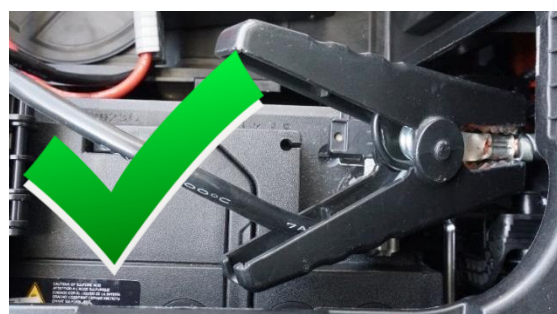
[Connect the negative \(-\) terminal to the battery as shown below.](#)

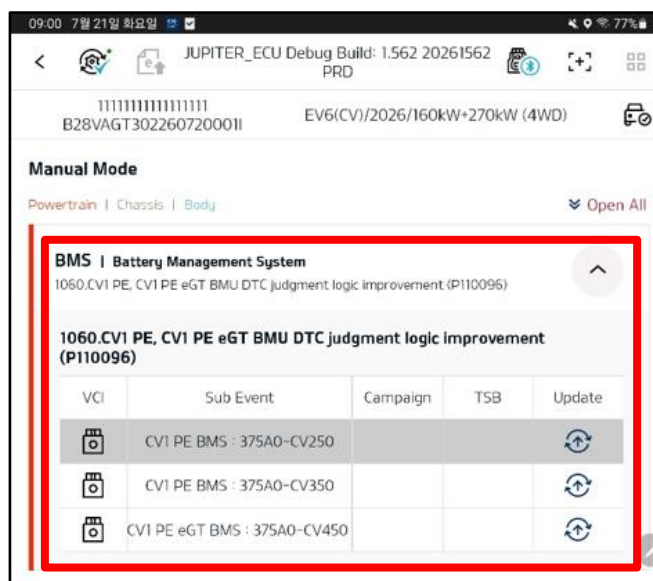
Select the applicable **'BMS'** system module and the Event Group.

- 1060.CV1 PE, CV1 PE eGT BMU DTC Judgment Logic Improvement (P110096)
- Or
- 1027.CV1A BMU DTC Judgment Logic Improvement (P110096)

Verify the affected vehicle Calibration Identification of the applicable ECU ROM ID and reference the Information Table on page 3 as necessary.
