## SERVICE INFORMATION BULLETIN

**APPLICABILITY:** 2026MY Outback

**NUMBER:** 15-331-25R

**SUBJECT:** Infotainment Concern Data Collection and  
 Sharing Guidelines for Denso Gen5 CP25 System

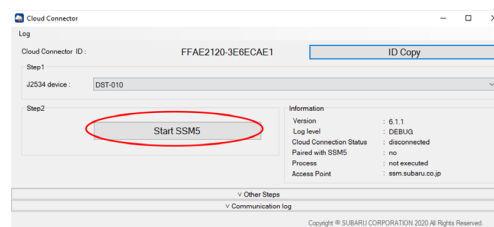
3. Connect the DST-010 to both the OBD connector and the PC.
4. Launch “Cloud Connector”, then open SSM5.
5. Click “Start SSM5” from the Cloud Connector screen.
