Mitsubishi Motors North America, Inc.  
***SERVICE CAMPAIGN BULLETIN***

**ENGINE CONTROL UNIT (ECU) REFLASH  
- SERVICE CAMPAIGN**

No: SC-26-003

2026 Outlander with 4B40 Gen 2 Engine

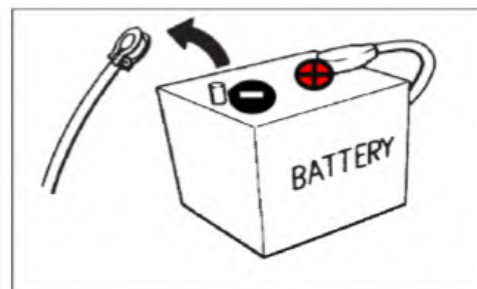
Disconnect 12V battery terminal according to instructions described below.

1. Open the hood.
2. Turn ignition switch to the ON position.
3. Turn ignition switch to the OFF position with the driver side door opened.
4. Get out of the vehicle and close the driver's side door.
5. Wait at least 3 minutes.
