# HYUNDAI

## Technical Service Bulletin

| ENGINE<br>MECHANICAL | 26-EM-014H |

**SUBJECT:** CONTINUED DTC P132600 AFTER KSDS ENGINE MONITORING ECM LOGIC UPDATE

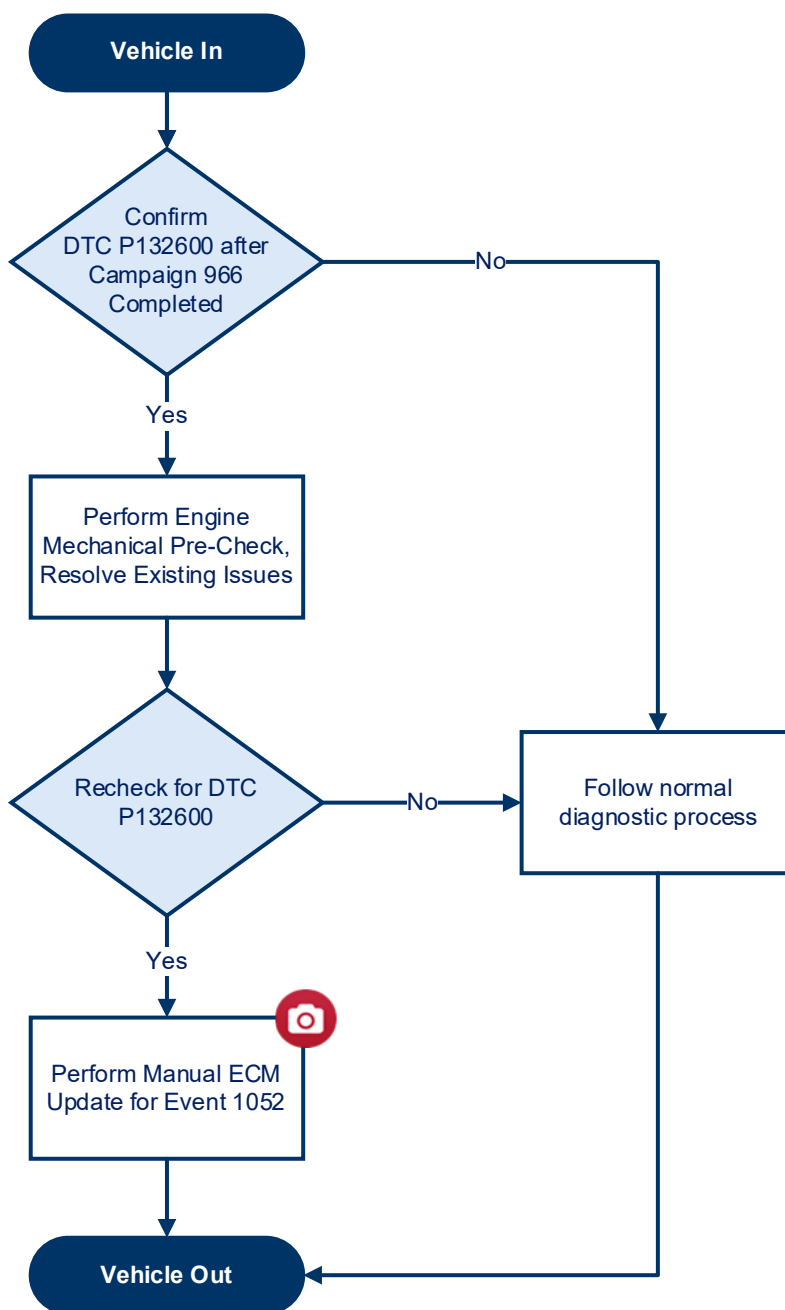
**Flowchart**

**NOTE:** Contacting Techline is **NOT** required.

- This TSB **ONLY** applies if the continued DTC P132600 condition exists.
- Perform the inspections below to resolve any contributing factors that may be causing DTC P132600.

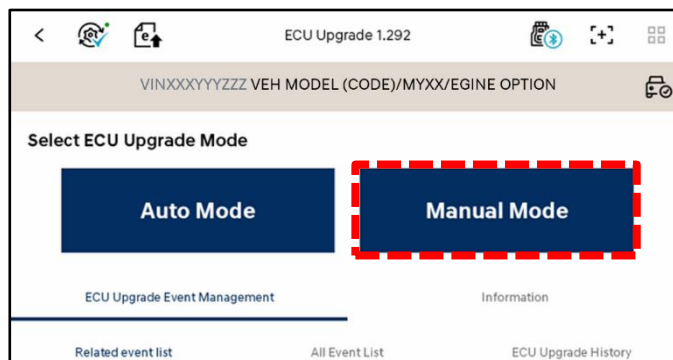
2. Verify the ROM ID by selecting the **Engine** system to scan the vehicle's current ROM ID.

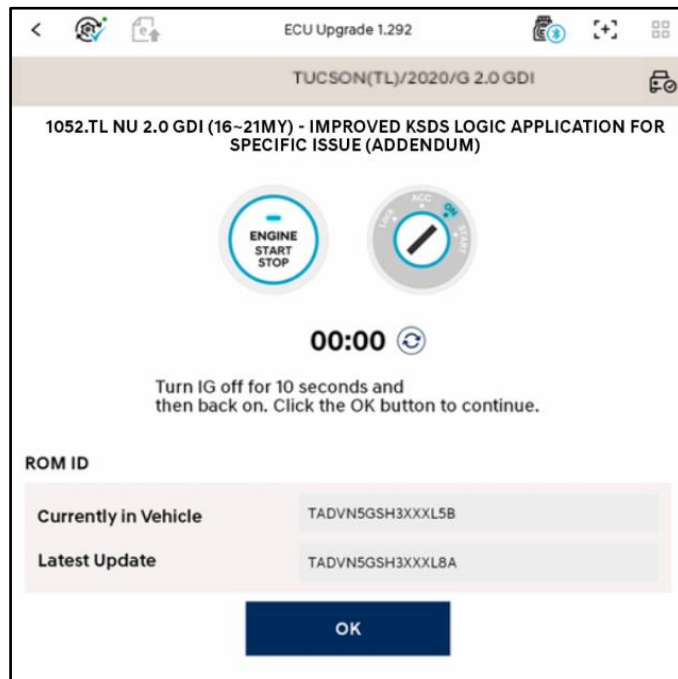
Use the **Refresh** button to reset the timer.

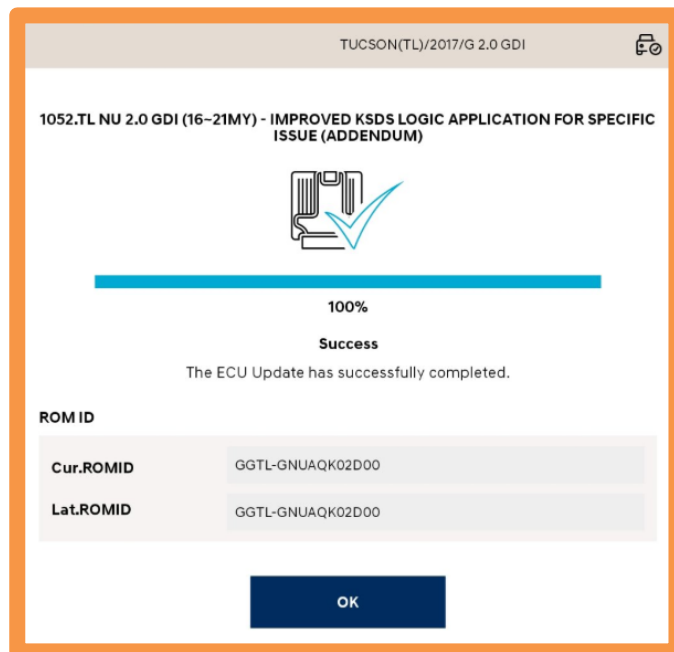
Upload the photo to STUI.

**NOTE:** The VIN/Date/Time/Mileage photo imprint is **NOT** required for GDS screenshots.

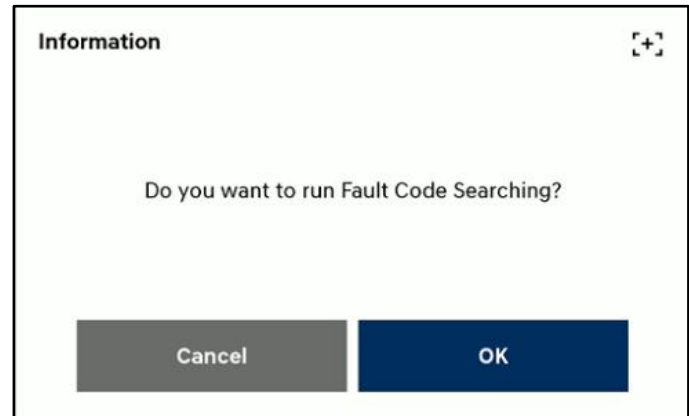
5. Perform an **All Systems Fault Code** search and erase DTC history that had incidentally occurred from the ECU update.
