PRODUCT SAFETY RECALL

SUBJECT: Front Passenger Air Bag Inflator Module

MODELS: 2003-2007 Pontiac Vibe

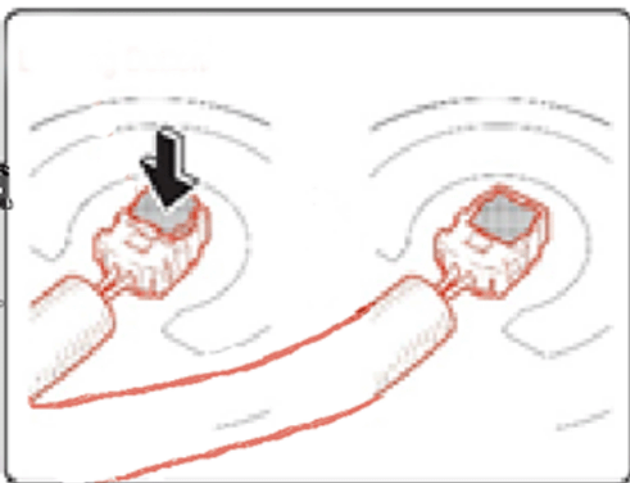
4486647

4.3. Connect the new harness to the new module.

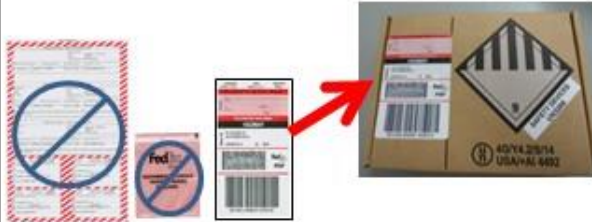
1. Place the Barcode label on the box as pictured below
2. The Address info on the Label DOES NOT need to be completed
3. Throw away the OP900 (Red Stripe Form) and the Plastic Pouch

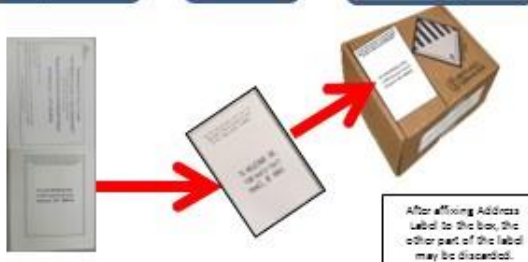
1. GM Inflator Kit will contain this two-part label:
2. Peel off 'Ship To' Label.
3. Affix Label to Box. Do not cover up Class 9 Marking.

After affixing Address Label to the box, the other part of the label may be discarded.

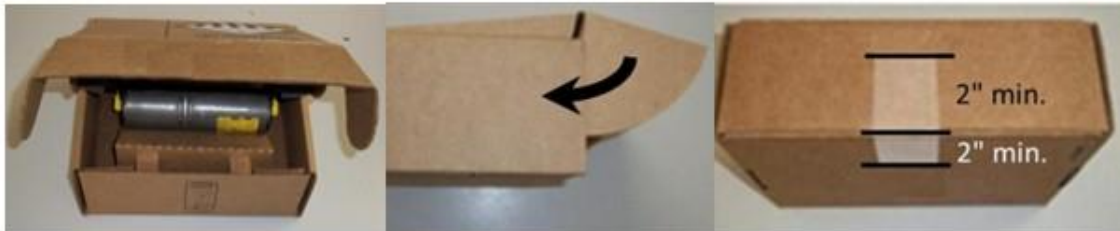
2. Closure Instructions: Close the top box flap, per box closure instructions located on front panel of box. Use a 2" wide x 4" long piece of clear packing tape to seal the box as shown below.
