Product Safety Recall

15818 Front Passenger Air Bag Inflator

Release Date: November 2018

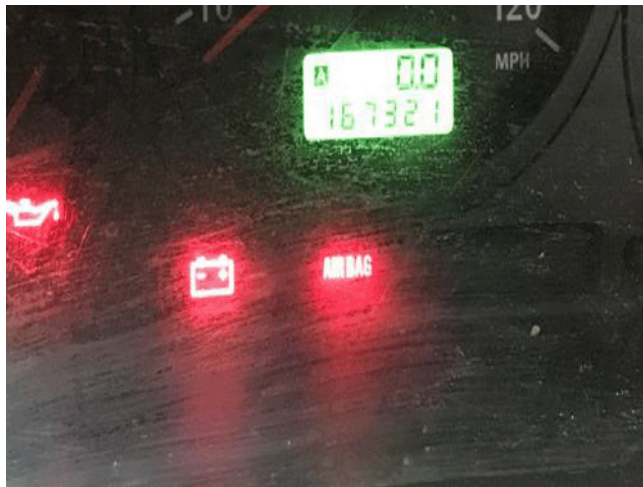
5145828

- 1.4 Watch the “AIRBAG” warning light in the cluster. It will begin to blink.
- 1.5 The long segments (1.2 seconds on) indicates a “ten”, and the short segment (0.3 seconds on) indicates a “one”. The warning light flashes a code corresponding to the fault.
- 1.6 There will be a brief pause approximately 6 seconds long between each DTC (No Light).
- 1.7 Read all codes until they begin to repeat. Write down all the codes.
- 1.8 See **DTC Code Listing chart – Table 1** at bottom of document for DTC code descriptions.

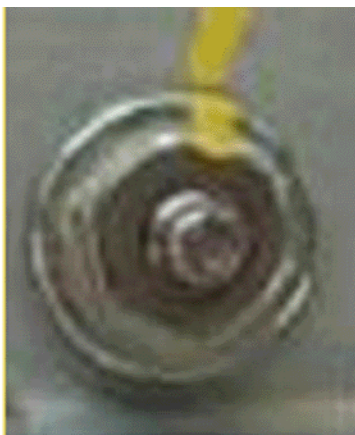
5145865

18. Remove the 2 nuts still installed on the mounting bracket and replace them with 2 **NEW** self-locking nuts. Once all 4 **NEW** nuts are in place, torque to 31-38-inch pounds in the new sequence shown below. Use a marker to mark the nuts after torquing indicating they have been fully tightened.

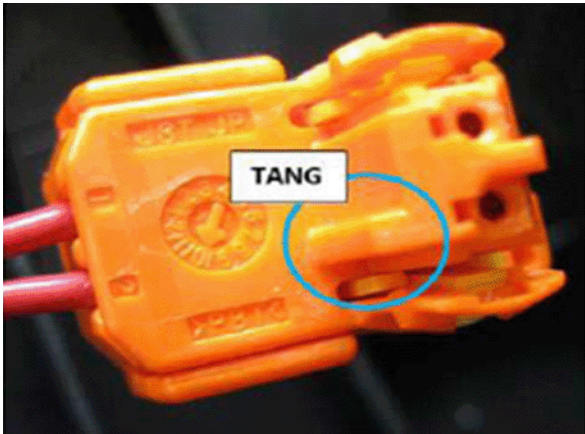
5145867

19. Peel off the white dust cover and **CAREFULLY** align the tang of the new harness connector with the receiving slot in the inflator connector. This assures proper routing of the harness in relation to the air bag assembly mounting brackets.
