Product Safety Recall

15442 Front Passenger Air Bag Inflator

Release Date: November 2018

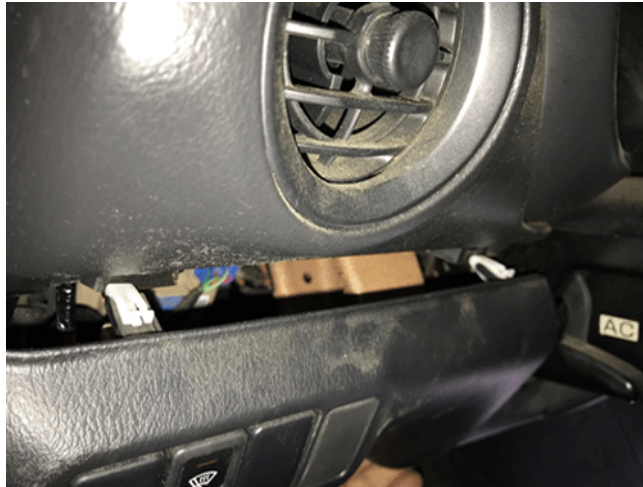
5145832

- 1.9 Snap the trim panel back into place.
- 1.10 Reinstall the 3 Phillips screws.
- 1.11 Turn Ignition Switch on.
- 1.12 Verify that the "AIRBAG" warning light comes on for 3 seconds and then goes out.

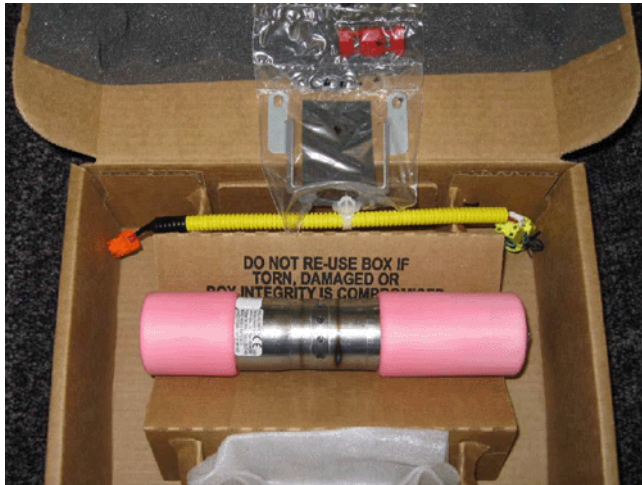
5145838

6. Open the front passenger air bag inflator kit box and confirm all the necessary components are included:
- 4 Self-Locking nuts
 - New Type 2 Inflator (pink collars on each end identify it as the replacement part)
 - New Inflator Harness
 - New Stopper Plate
 - Electro-Tap (red shorting crimp connector)
 - 1 ½" X 2 ¼" piece of self-adhesive Sponge Tape
 - Shipping Documentation and Instructions

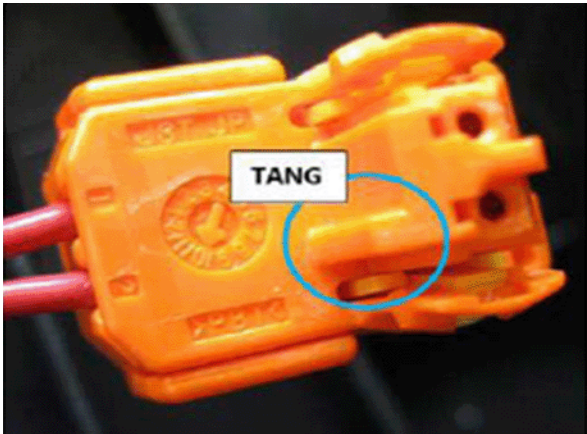
5145867

19. Peel off the white dust cover and **CAREFULLY** align the tang of the new harness connector with the receiving slot in the inflator connector. This assures proper routing of the harness in relation to the air bag assembly mounting brackets.

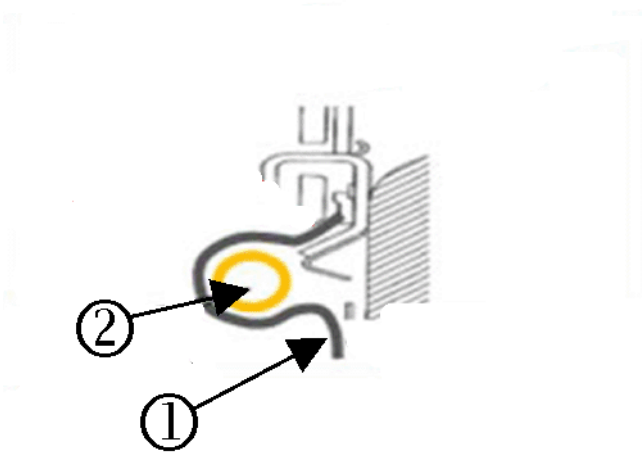
IMPORTANT: Cross section of the sponge tape installation. The sponge tape (1) must be installed more than half way around the yellow harness tube (2).
