# SAFETY RECALL BULLETIN

<b>SUBJECT:</b> <b>CVT HESITATION – SAFETY RECALL CAMPAIGN</b>				No:	<b>SR-16-006</b>
				DATE:	<b>August, 2016</b>
				MODEL:	<b>SEE BELOW</b>
<b>CIRCULATE TO:</b>	<input checked="" type="checkbox"/> GENERAL MANAGER	<input checked="" type="checkbox"/> PARTS MANAGER	<input checked="" type="checkbox"/> TECHNICIAN		
<input checked="" type="checkbox"/> SERVICE ADVISOR	<input checked="" type="checkbox"/> SERVICE MANAGER	<input checked="" type="checkbox"/> WARRANTY PROCESSOR	<input checked="" type="checkbox"/> SALES MANAGER

This Safety Recall Bulletin provides instructions for reprogramming the CVT–ECU with a modified software. The modified software ignores the momentary loss of the range switch signal.

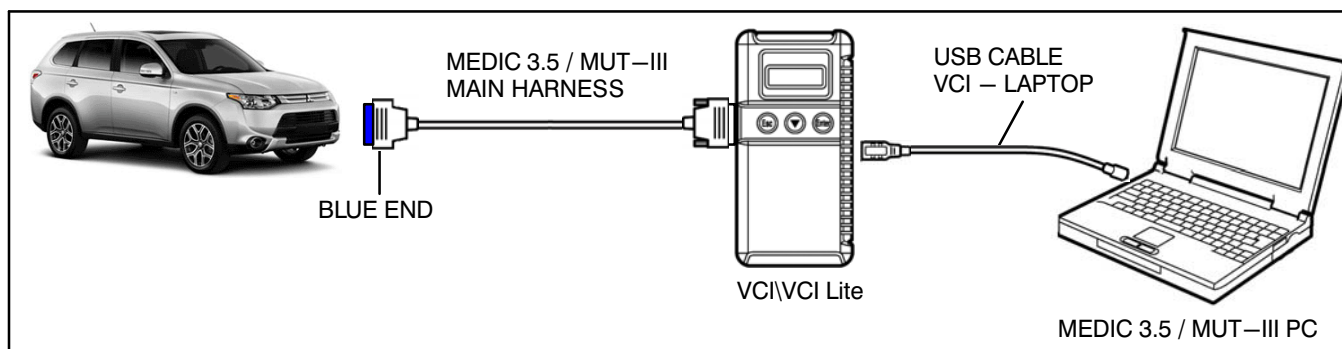
1. Connect the equipment as follows:

- Turn the MEDIC PC/tablet on. If the battery indicator in the lower right hand corner of the screen does not show a full charge, it is recommended that either the battery be charged prior to beginning, or be used with the A/C power adaptor connected.
- Connect the USB cable to the VCI/VCI Lite.
- When the laptop/tablet displays the MUT-III main screen, connect the USB cable to the device.
- Connect the MUT-III main harness with the blue DLC connection to the VCI/VCI Lite.
- Connect the blue connection of the MUT-III main harness to the vehicle's data link connector.
- Turn the VCI power switch ON . Verify that the indicator lamp in the upper right corner of the screen is green.

**NOTE:** VCI and MEDIC 3.5 Laptop shown for illustration purposes only.
