RECALL ACTION

Reference number:	RA-13-0025	Issued: 6 July, 2017
Subject:	Incorrect Configuration for TPMS	
Model(s):	DB11	
VIN range:	Refer to the separately published list of VINs	
Applicable to:	All Dealers	
Distribute to:	After Sales Manager Executive Manager Service Manager Sales Manager	Warranty Staff Technician(s) Parts Staff

Reason for this Recall Action

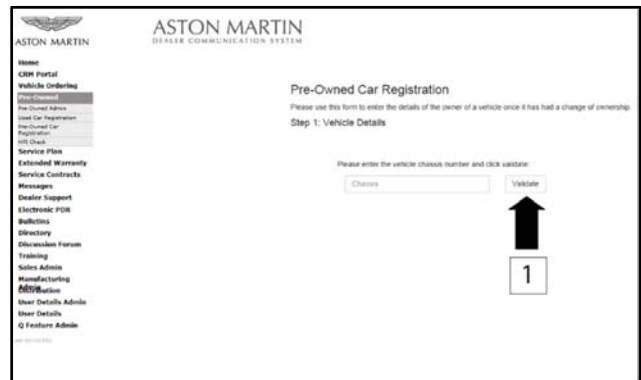
Figure 1

1. Enter the vehicle's 6-digit chassis number into DCS (amdealers.com) and click "Validate" (refer to Figure 1).

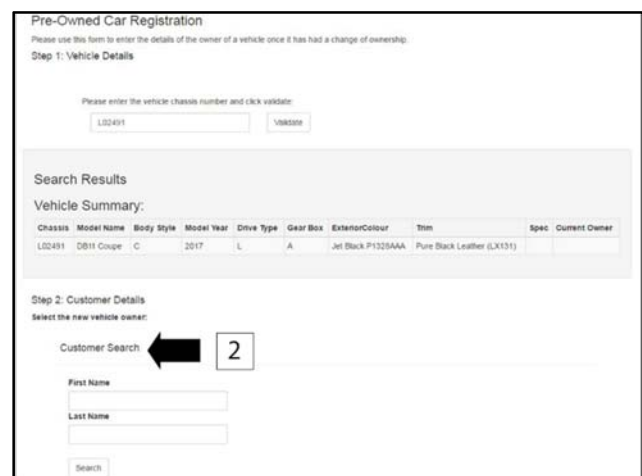
Figure 2

2. Make sure that the vehicle details are correct. If the current owner is correct, no action is necessary.
3. Make sure that the Customer name is correct. If the data is correct, then no action is necessary.
4. To update the Customer details, use the search feature to find the customer in your Synergy database (refer to Figure 2).

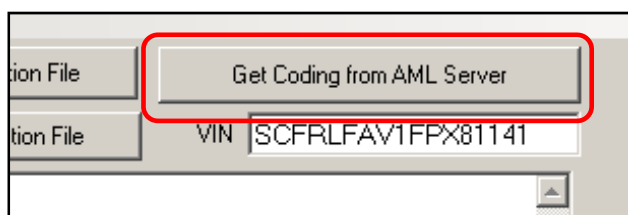
Figure 5

5. Select “Get Coding From AML Server” (refer to Figure 5)

Note: The VIN for the connected vehicle will be shown.
