P083NAS2

TECHNICAL BULLETIN

501-20B: Supplemental Restraint System

SAFETY RECALL: Takata Passenger Airbag

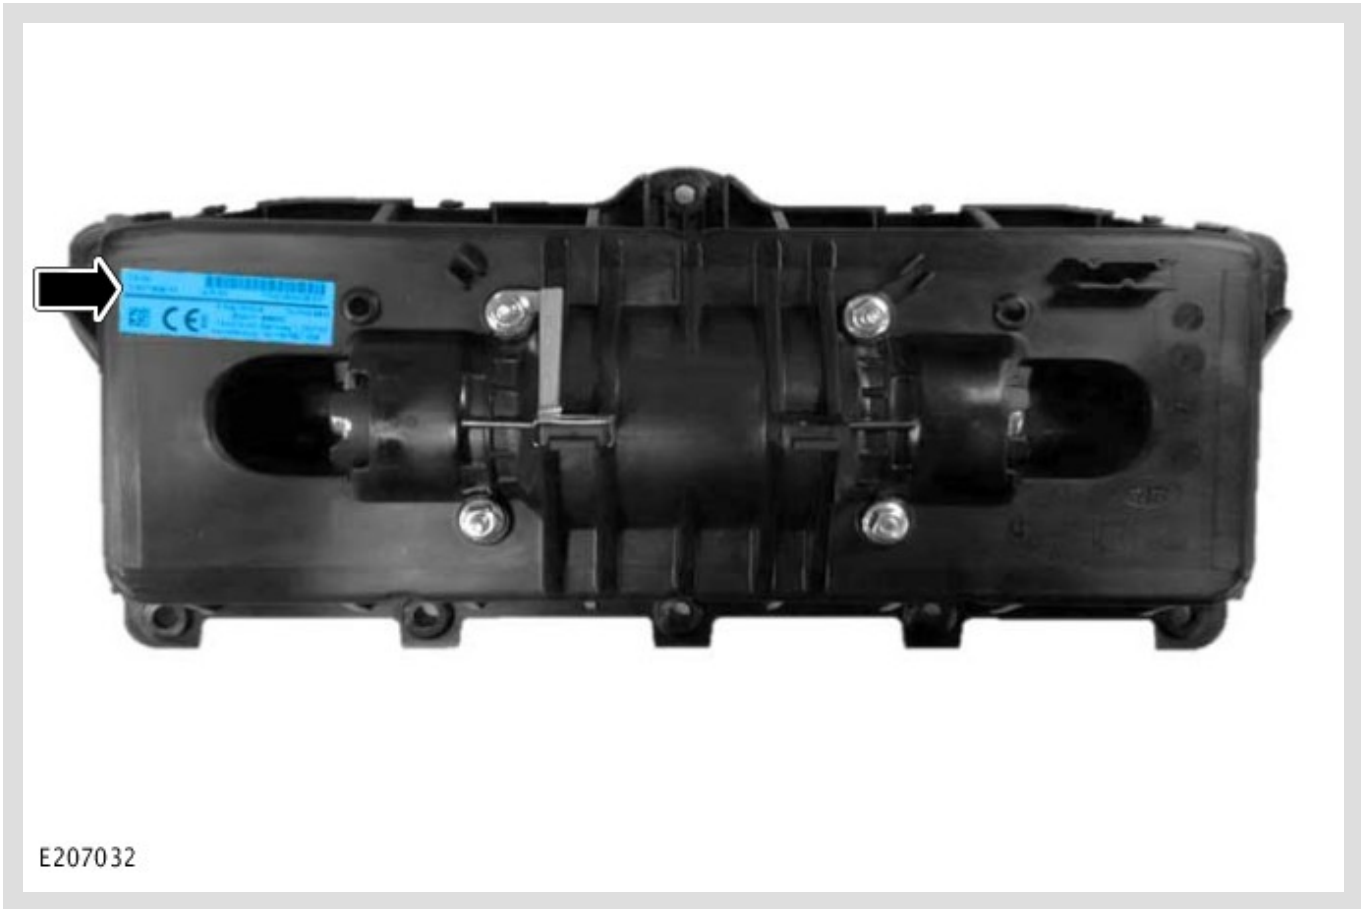
1

Locate the label on the rear side of the replacement passenger airbag module.

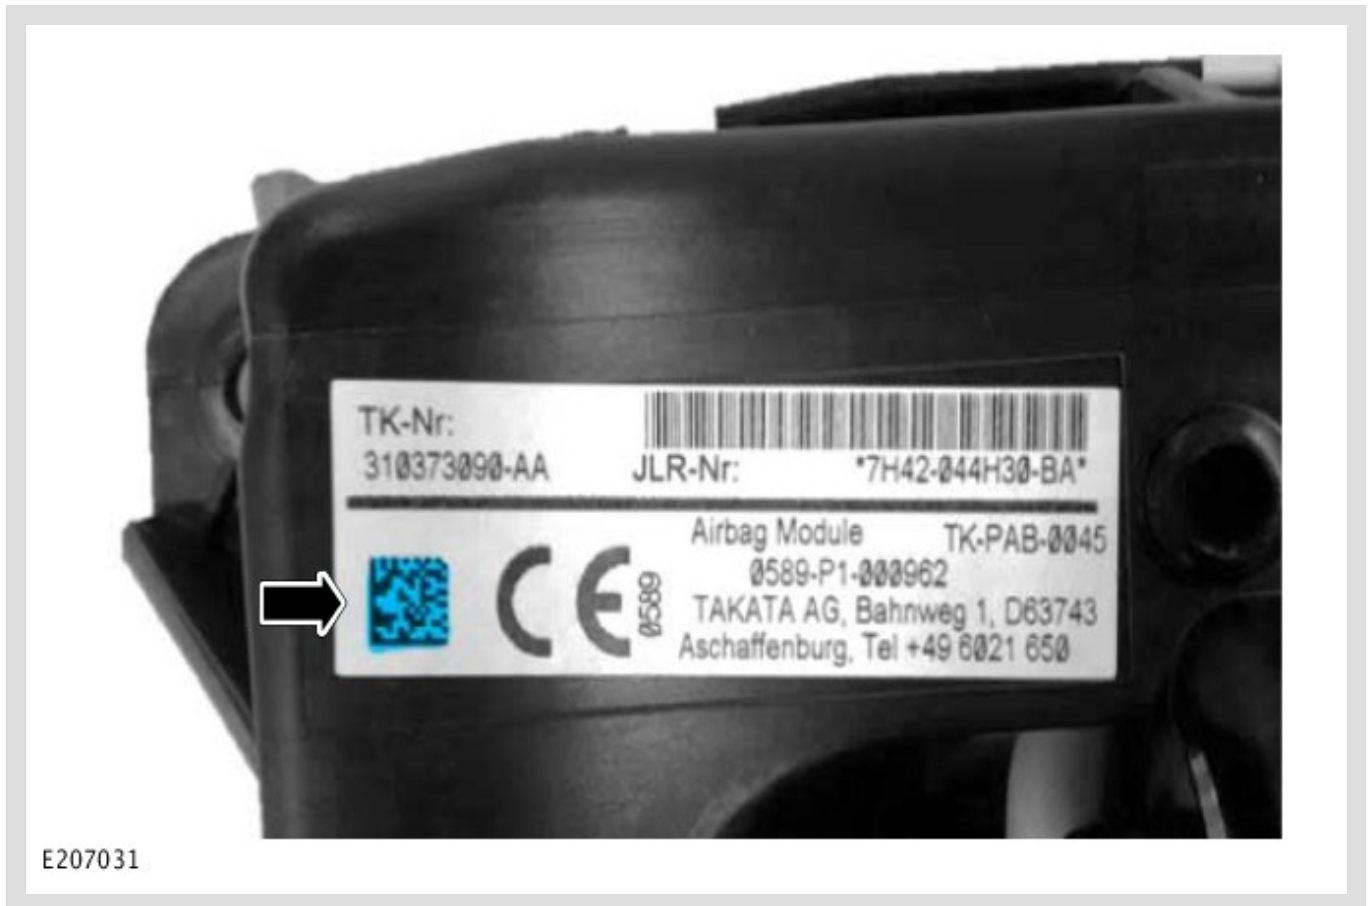
2

Locate the QR code on the label as illustrated.
