2009-2010 RX-8 - PASSENGER AIR BAG SAFETY RECALL 2018A

Passenger-Side Air Bag Inflator Replacement Procedure:

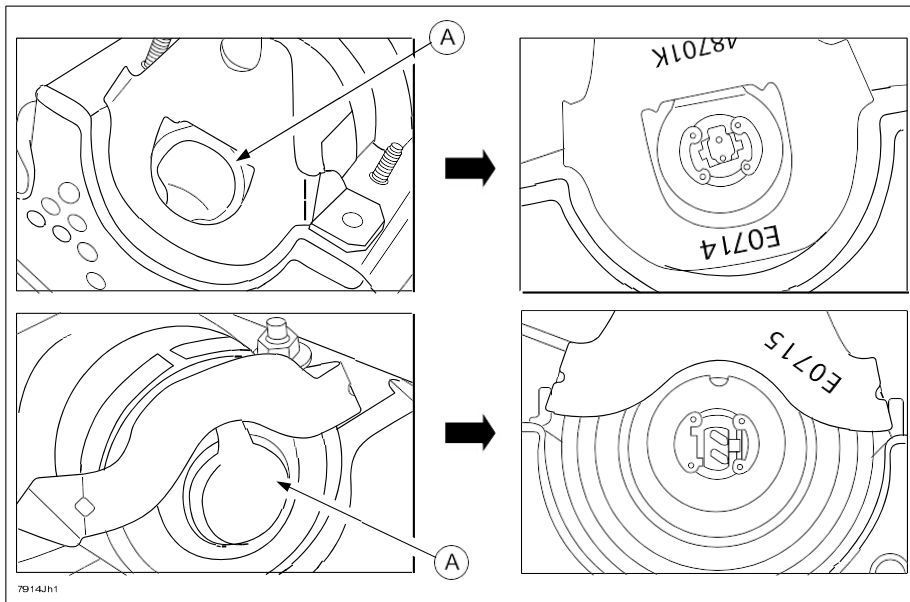
13. Remove the seal (A) from the end of the inflator on both sides.
