TO: Mercedes-Benz Dealer Principals, General Managers, Sales Managers, Service Managers, Parts Managers	FROM: Gregory Gunther, Department Manager, Vehicle Compliance and Analysis, Engineering Services
RE: Recall Campaign 2018100009 Takata- Priority Group 5 Phase 2 All Zones Replace Driver-side and Passenger-side Airbags -Certain MY10 W207 (E-Class Coupe), MY08-09 204 (C-Class), and MY 2010 X204 (GLK-Class) vehicles	DATE: October 29, 2018

IMPORTANT TAKATA RECALL INFORMATION

SUBJECT: **Model 204, X204 and 207**
Model Years 2008 – 2010
Replace Driver-Side and Front Passenger-side Airbag

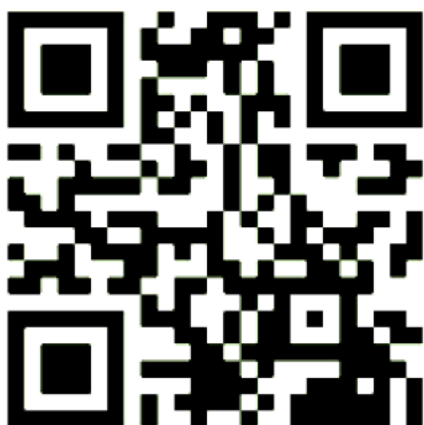
Figure 1

- To install and transmit the data a WiFi connection is required.
- After downloading the App, a one-time security authentication is required by means of encrypted QR code. Verification can be performed by scanning the QR code below, before using the application.

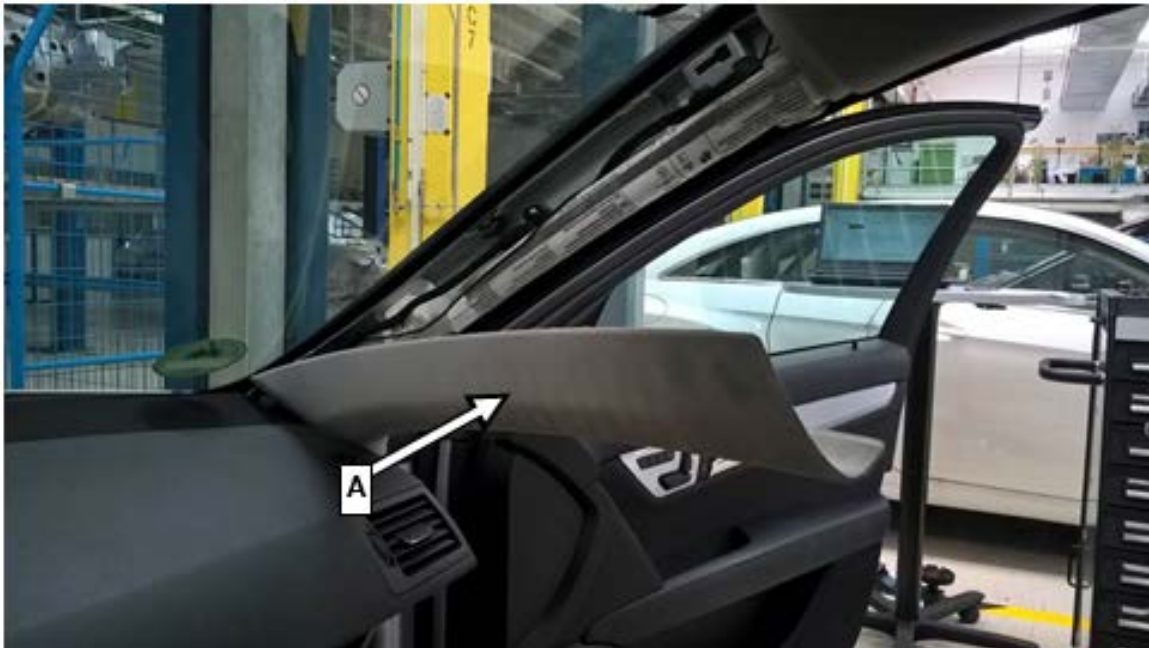
Figure 2

3. Remove right A-pillar trim (**A, figure 2**).

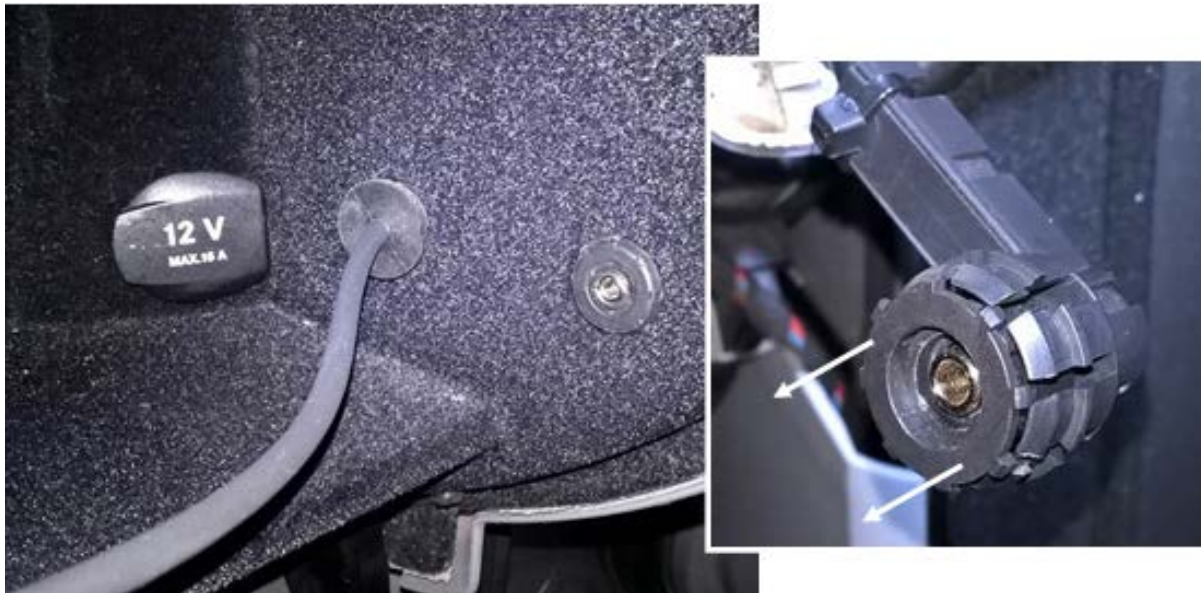
Figure 3

i Release inner retaining ring (**figure 3**) at the AUX connection towards the inside. The connection can then be removed from the glove box housing.

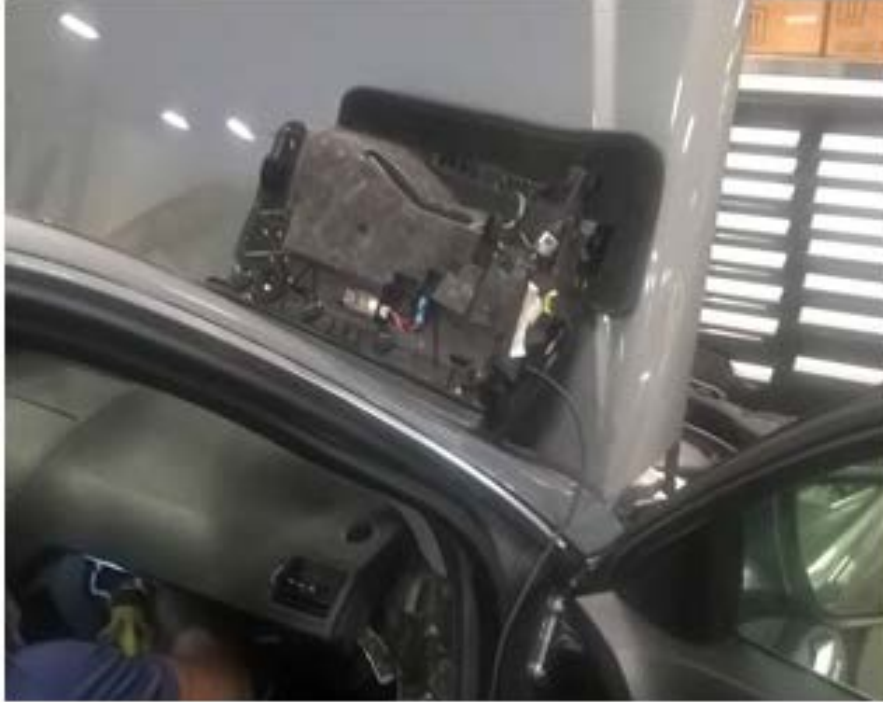
Figure 4

i Pull out the iPod cable as far as possible and set down glove box housing on the windshield **with** exterior iPod cable connected (**figure 4**).

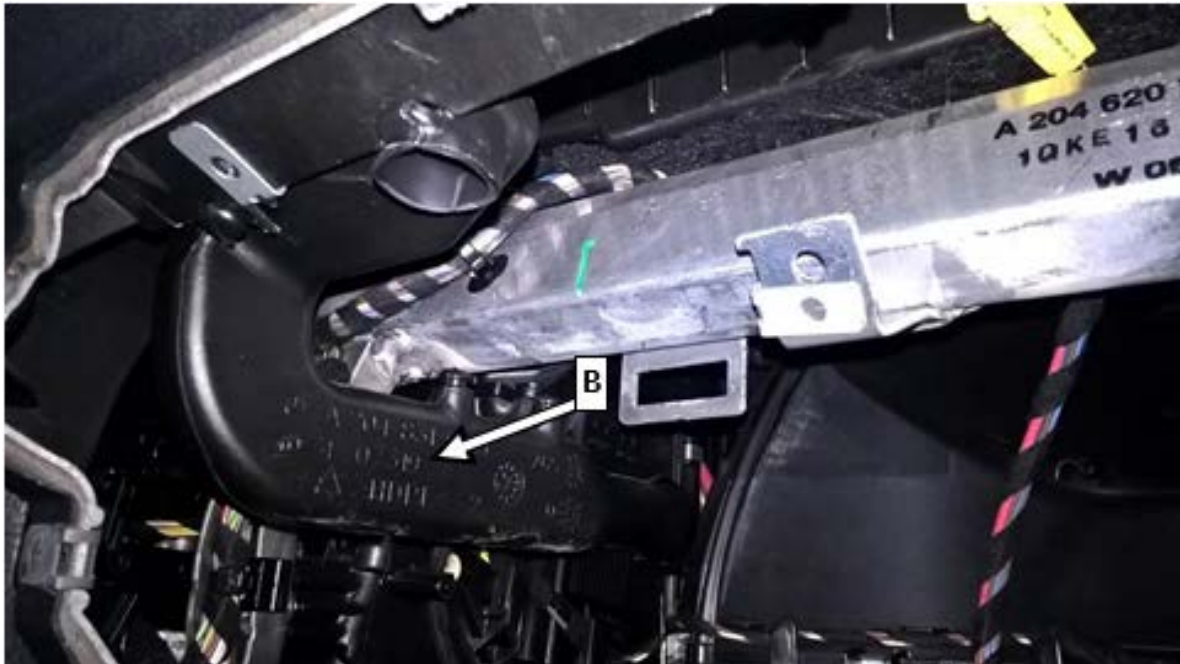
Figure 5

5. Remove air duct (**B**, figure 5) above the glove compartment.

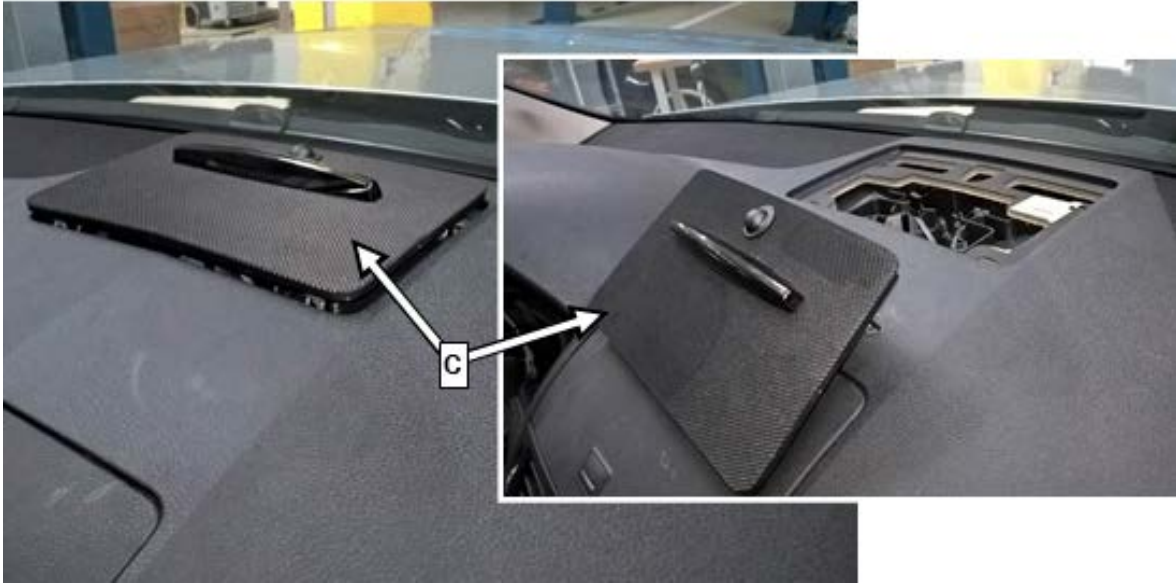
Figure 6

6. Unclip and remove cover (**C**, figure 6) at the instrument panel on top.
 - i** With a sound system, also remove speaker under the cover.

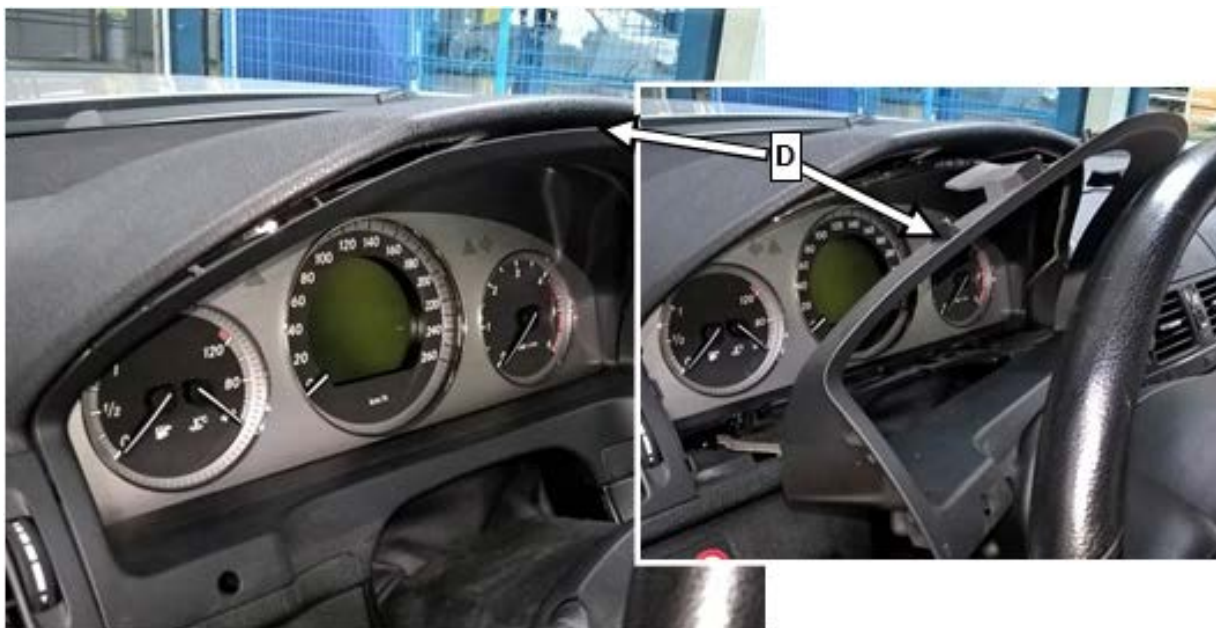
Figure 7

7. Remove center console (**AR68.20-P-2000CW**).
8. Remove automatic climate control and operating unit.
 - i** For basic data of model 204, see **AR83.40-P-6350CW**
 - i** For basic data of model 207, see **AR83.25-P1124EC**
9. Remove trim (**D, figure 7**) around the instrument cluster.
 - i** For basic data of model 204, see **AR54.30-P-6015CW**.
 - i** For basic data of model 207, see **AR54.30-P-6015EZ**.

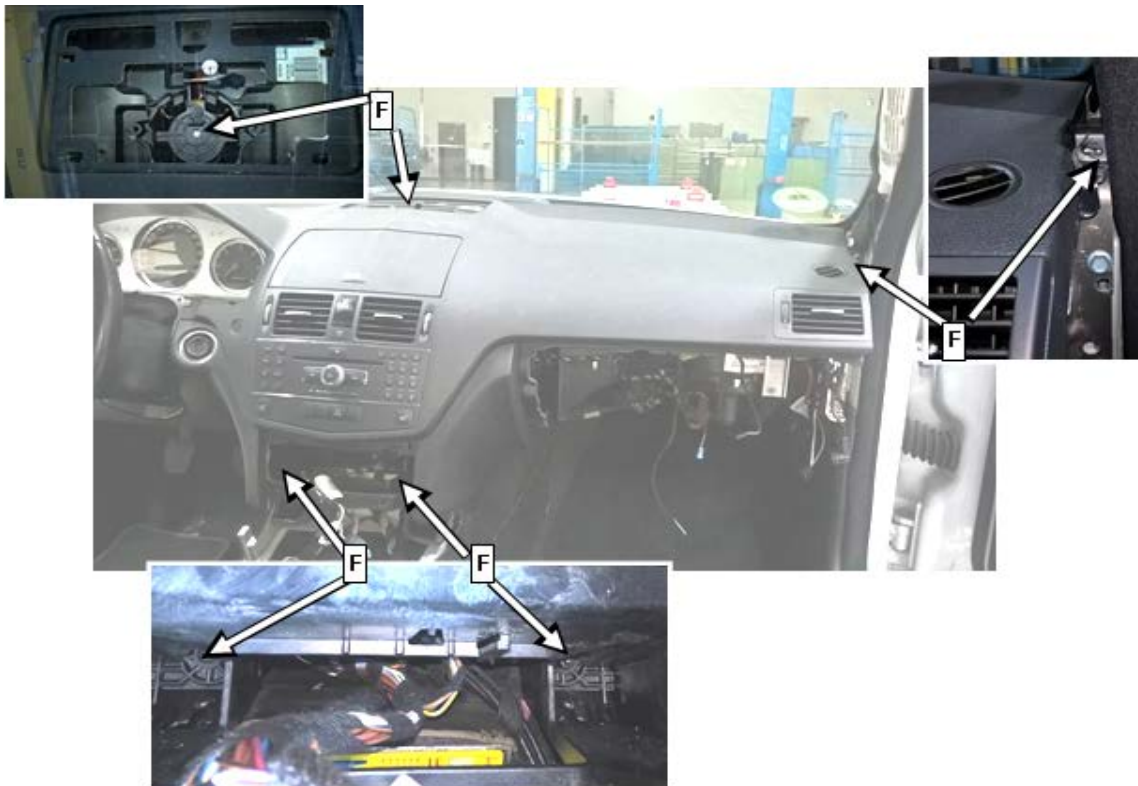
Figure 9

11. Remove four screws (**F, figure 9**) for fastening the instrument panel

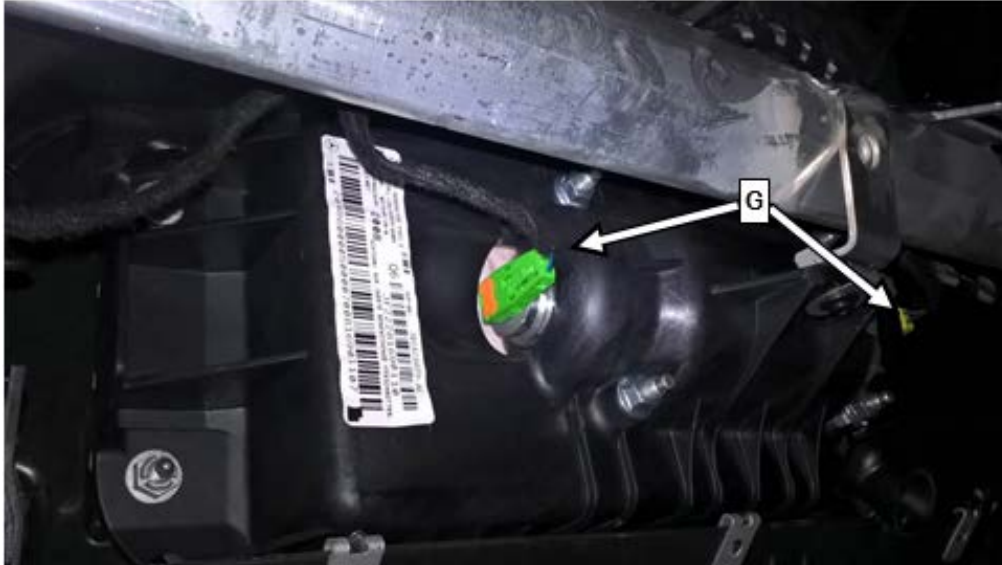
Figure 10

12. Disconnect electrical contacts (**G**, **figure 10**) at the front passenger airbag.

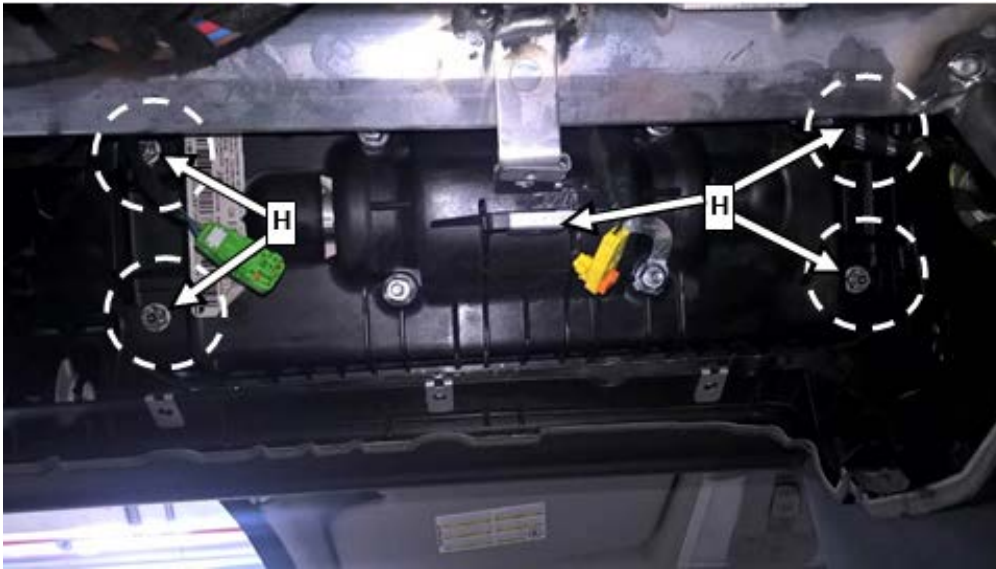
Figure 11

13. Remove lock nuts (**H**, **figure 11**) for the front the passenger airbag.

i Lock nuts should only be replaced if they are damaged. For more info see: **AH00.00-N-0001-01A / Modification notes 27.10.2016**

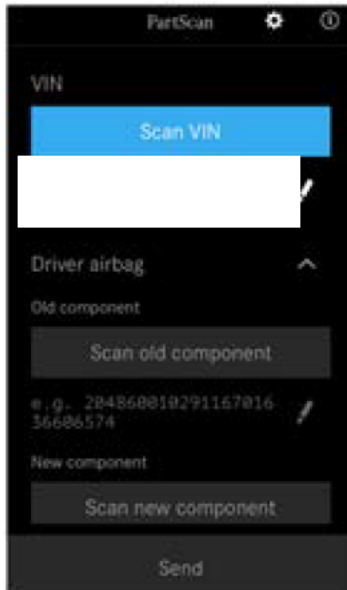
Figure 12

14. Slightly raise instrument panel at the front passenger side and remove the front passenger airbag in a downwards direction. Take special care not to crack the dashboard material. **DO NOT REMOVE THE DASHBOARD**
15. Use the "Scan VIN" button (**figure 12**) to scan the vehicle identification number either by the barcode or the text field.
- i** After scanning, compare the vehicle identification number that has been read in the app any correct any scanning errors manually.

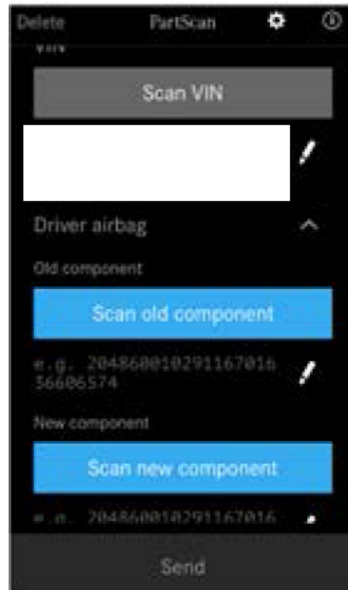
Figure 13

16. Scan barcodes of the removed driver airbag using the button "Scan old component" (figure 13).

17. Scan the barcodes of the new driver airbag using the button "Scan new component" (figure 13).

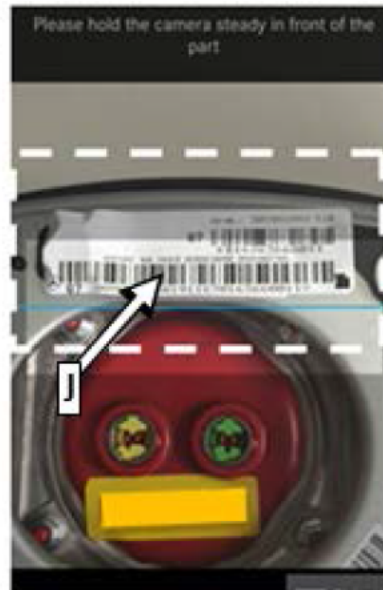
Figure 14

i Ensure that the lower barcode (J, figure 14) is scanned.

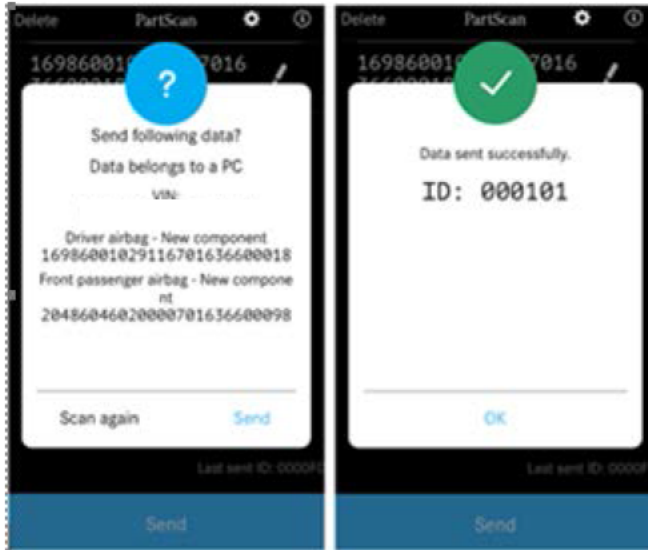
Figure 15

19. Create a scan ID via the "Send" button (figure 15).

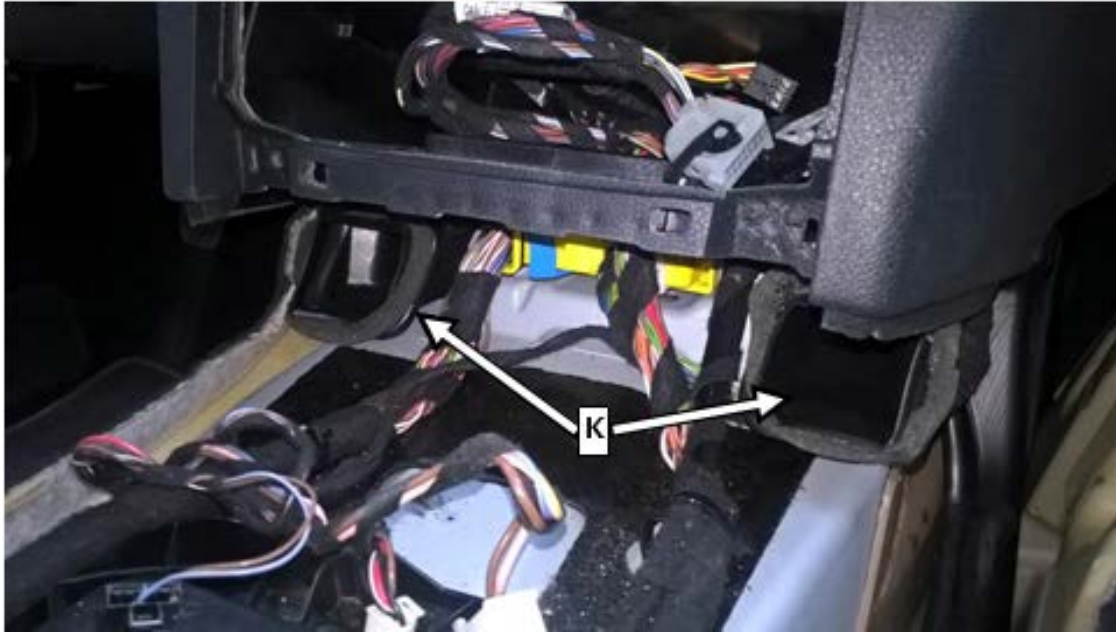
Figure 17

22. Place instrument panel back into position and install the air ducts (K, figure 17) correctly.

i The air ducts are pulled out when the instrument panel is raised.

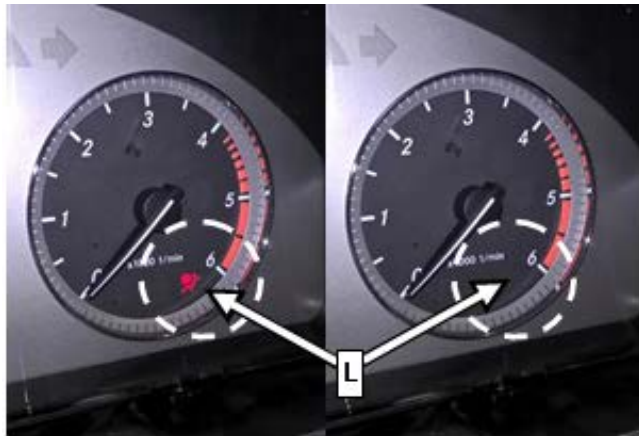
Figure 18

25. Turn the transmitter key in the electronic ignition lock to **position 1** and check whether the airbag indicator lamp (**L, figure 18 or 19**) remains on after a few seconds.

i The SRS check is thus completely ensured after airbag replacement.

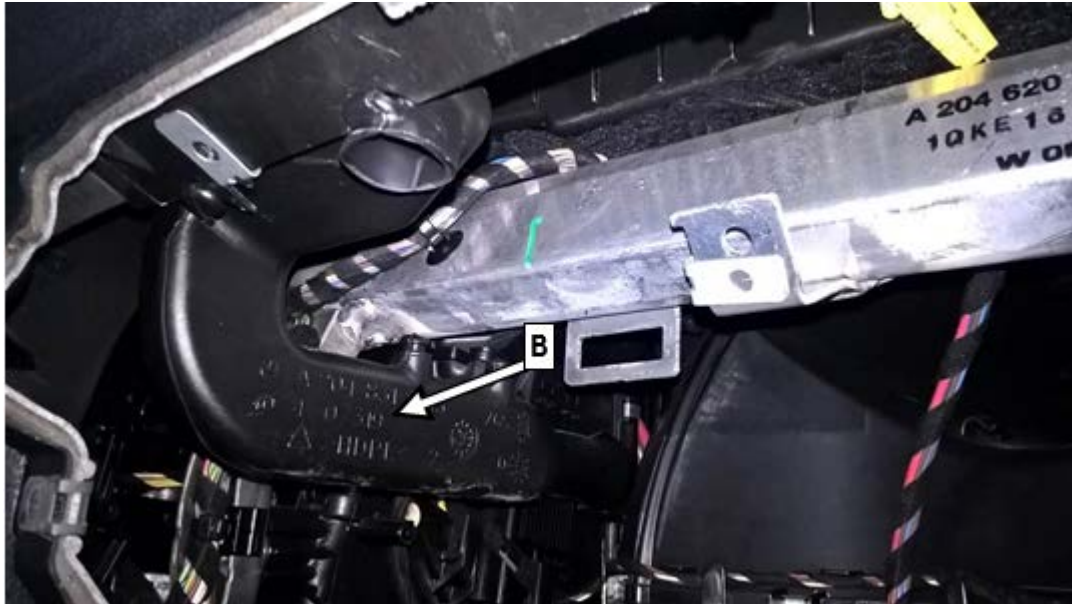
**Figure 1**

1. Disconnect ground line from the on-board electrical system battery.
2. Remove driver airbag at the steering wheel.
i For basic data of model X 204, see **AR91.60-P-0660CW**
3. Remove glove compartment housing (**AR68.10-P-1200CY**).
4. Remove air duct (**B, figure 1**) above the glove compartment.

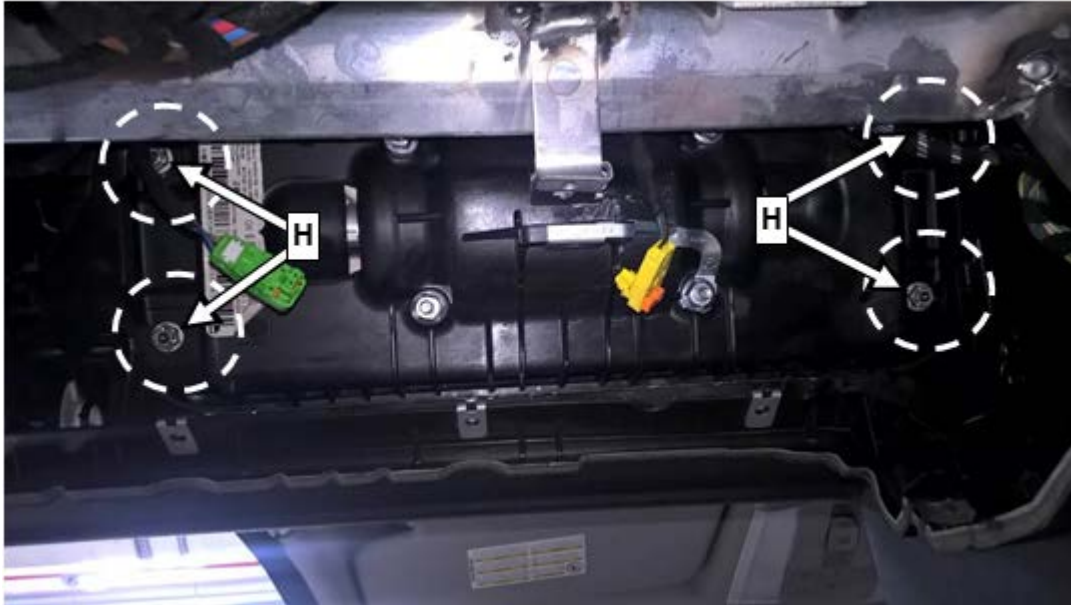
Figure 3

6. Remove threaded connections (**H**, figure 3) for the front the passenger airbag.

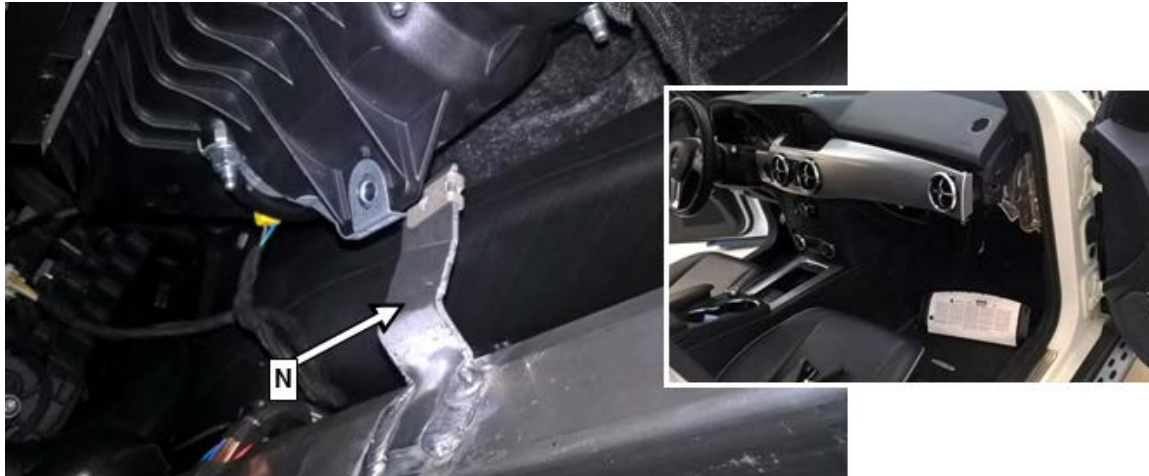
Figure 5

8. Remove passenger airbag unit.

i To remove the front passenger airbag, slightly push the bracket (**N**, figure 5) forward.

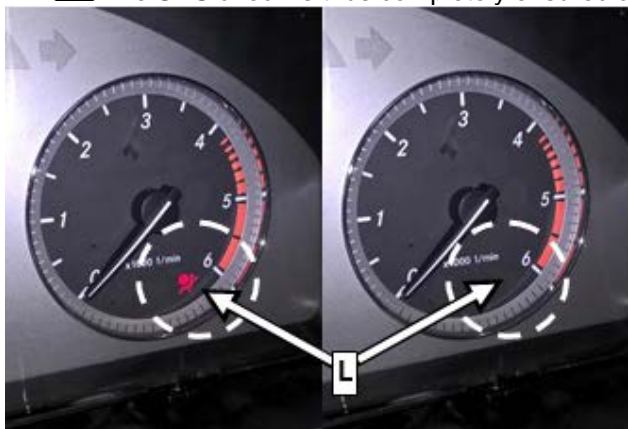
Figure 6

14. Turn the transmitter key in the electronic ignition lock to **position 1** and check whether the airbag indicator lamp (**L**, figure 6 or 7) remains on after a few seconds.

i The SRS check is thus completely ensured after airbag replacement!

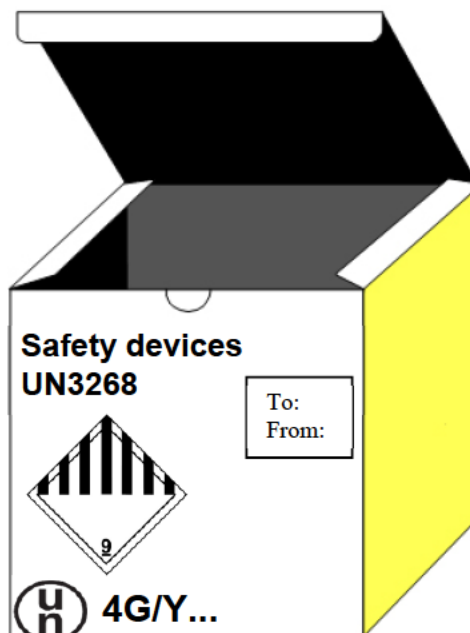
- Note:** The Packing Group and the EX# are no longer required to be printed on the HAZMAT bill of lading.
- Package example:**

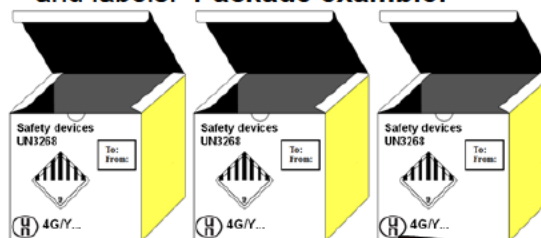
- Package each airbag in a separate UN spec box prepared with the labels/markings described above.
- Place each individual airbag box inside a larger non-UN spec box to keep the shipment together.
- This larger box is called an "OVERPACK."

- The OVERPACK must have the identical markings and label as the boxes contained inside.
- The OVERPACK must have the "OVERPACK" statement on the same face as the hazard markings and labels. **Package example:**
