# Safety Recall Code: 69R6

Subject	Driver Fronta	al Airbag Inflato	r (Takata)				
Revision Summary	Updated inst	tructions for the	mandatory Takata parts return process in Append	lix B.			
Release Date	July 21, 2018	5					
Affected Vehicles	U.S.A. & Ca airba		009-2013 MY Audi vehicles equipped with a Taka	nta driver frontal			
			n Elsa on the day of repair to verify that a VIN qualifies for repair iry & verification source.	under this action.			
	✓ Camp						
	<ul> <li>If Elsa shows other open action(s), inform your customer so that the work can also be completed at the same time the vehicle is in the workshop for this campaign.</li> </ul>						
Problem Description	The driver airbag may explode in a crash with airbag deployment. Sharp metal fragments can hit people and cause serious injury or death. Owners should schedule this recall repair immediately, even if an interim repair was recently done.						
Corrective Action	Replace the o	Replace the driver frontal airbag inflator (final remedy repair).

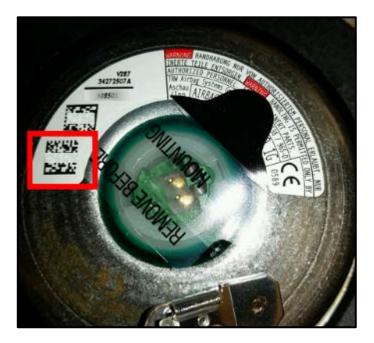
- Place the new inflator on the ESD mat.
- Scan the data matrix code of the new inflator at a distance of about 15 cm.
