September 21, 2018

Safety Recall: 2018 Accord: Rear Backup Camera

Supersedes 18-092, dated September 14, 2018, to revise the information highlighted in **yellow**

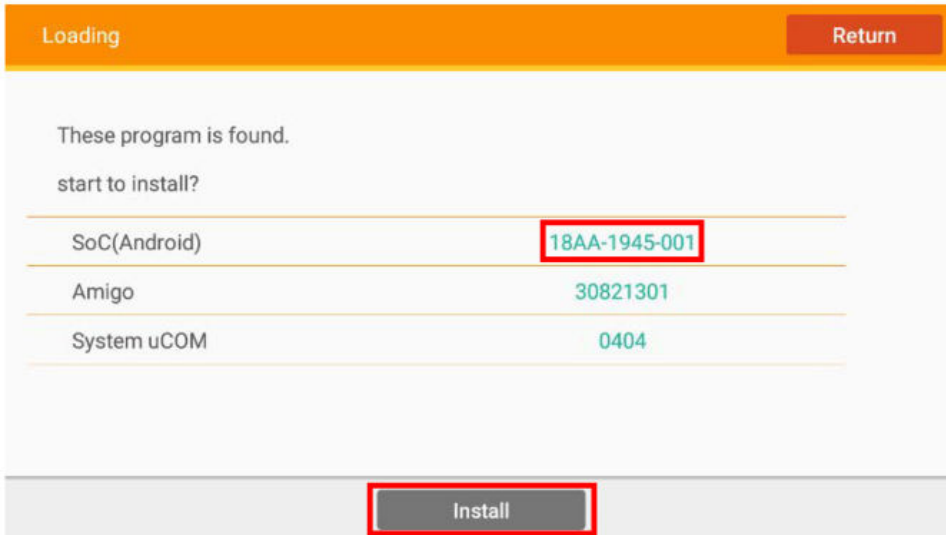
8. Verify that the software version is **18AA-1945-001**. If the version is correct, select **Install** to begin the update.
