**September 21, 2018**

## Safety Recall: 2019 Insight: Rear Backup Camera

Update the audio unit/audio navigation unit software using the audio-navigation system update USB flash drive.

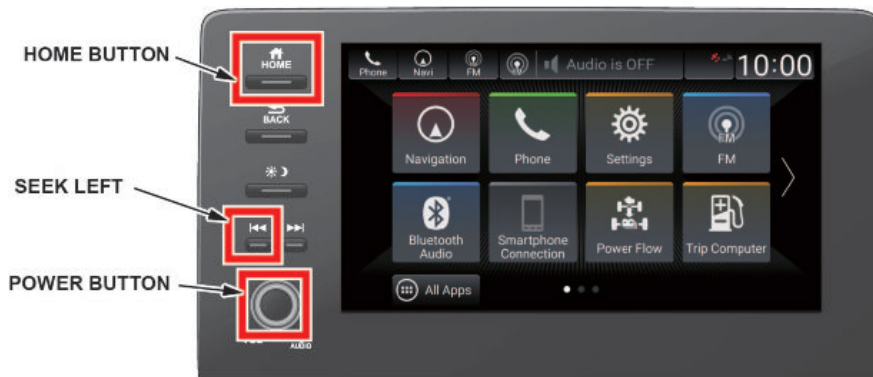
- From the **Home** screen, press and hold the **HOME+POWER+SEEK LEFT** for at least **5 seconds** to enter the **Diagnosis Menu**.

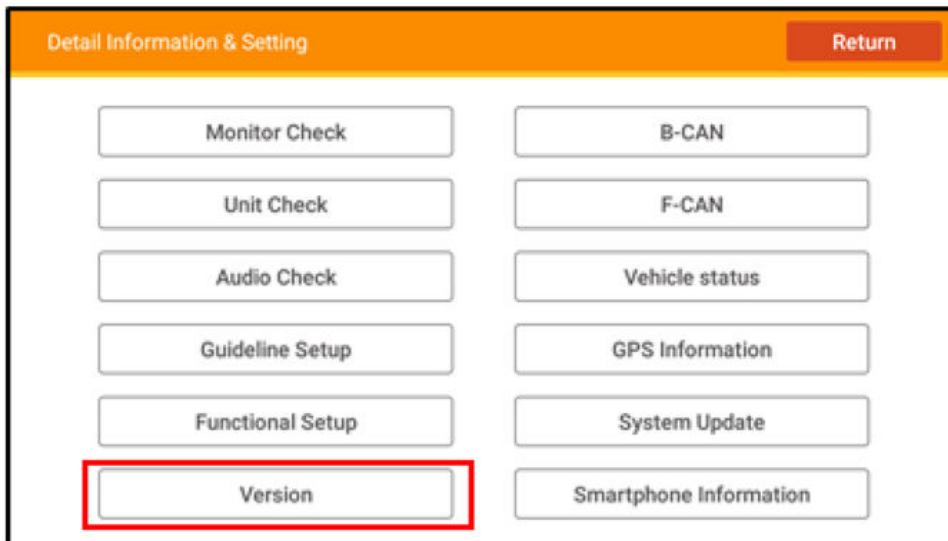
6. Select **Version**.

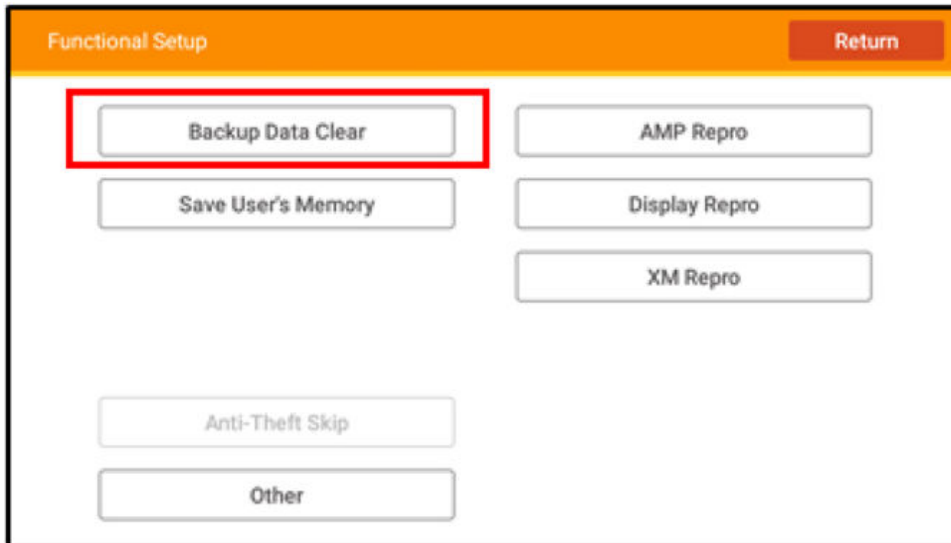
4. Select **Backup Data Clear**.

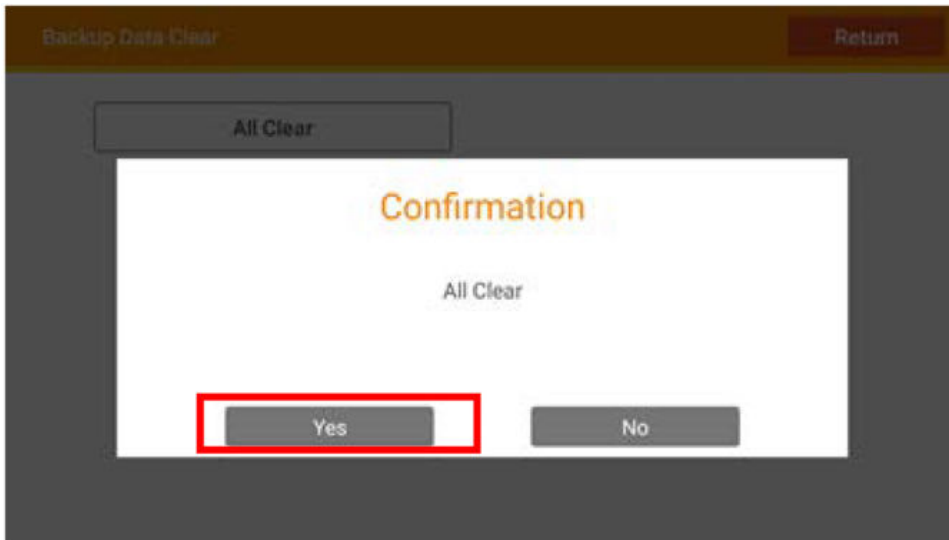
- When you see the **Confirmation All Clear** message, press **Yes**. Do not turn the engine or ignition off during the data reset.

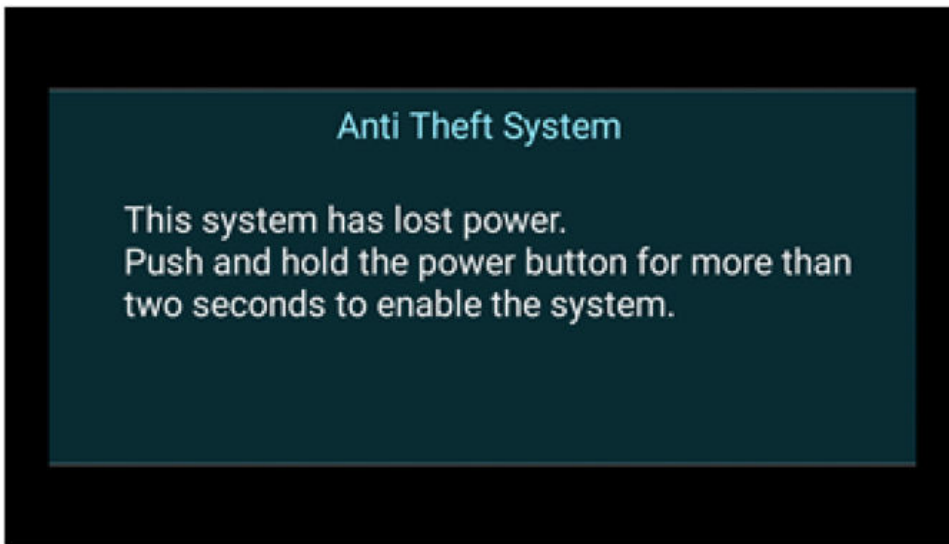
- After the **Backup Data Clear** is complete, the **Anti-Theft System** screen will display. With the engine on, press and hold the Power button to bypass the screen.
