September 14, 2018

Version 1

Safety Recall: 2018 Accord: Rear Backup Camera

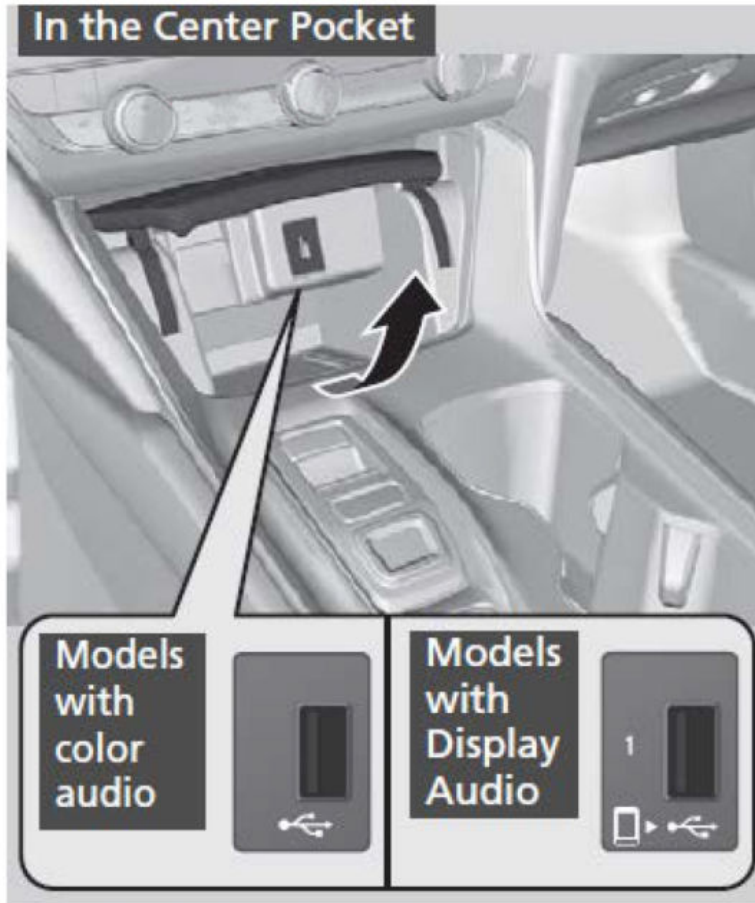
1. Before updating the software, write down the customer's audio unit presets.
2. Prepare the vehicle for the update by doing either of the following:
 - If the engine will be running, park the vehicle in a well-ventilated area or attach an exhaust vent.
 - If the engine will not be running, connect an active charger to the battery so it does not die during the update.
3. Insert the USB flash drive into USB Port 1.

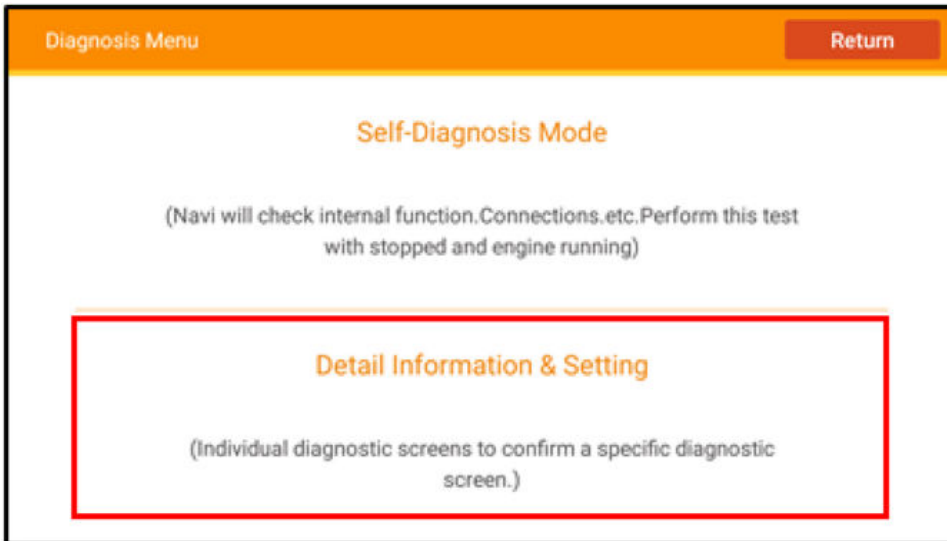
5. From the **Diagnosis Menu**, select **Detail Information & Setting**.

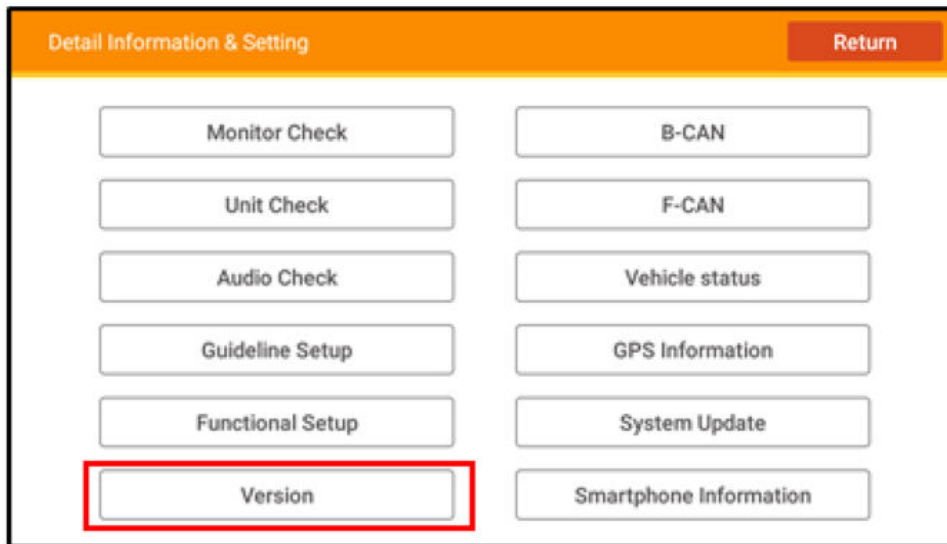
6. Select **Version**.

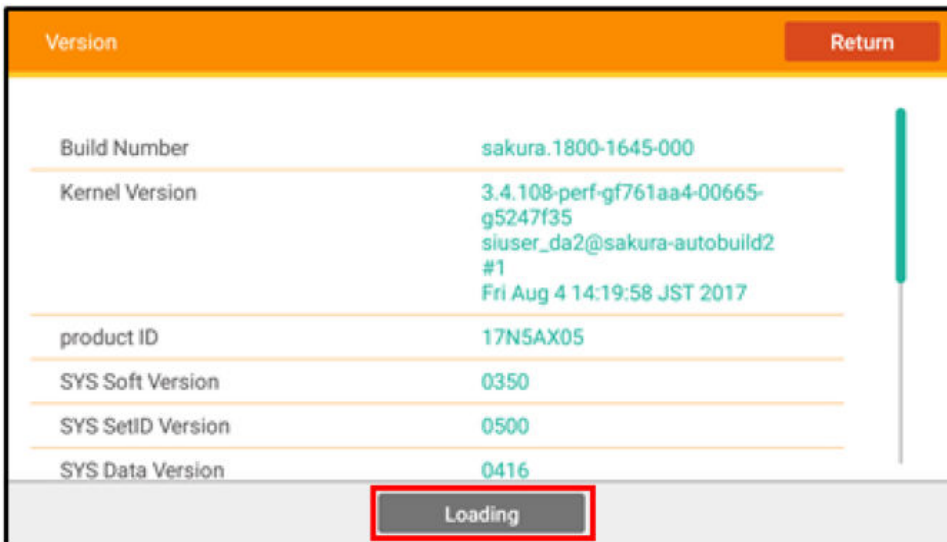
7. Select **Loading**.

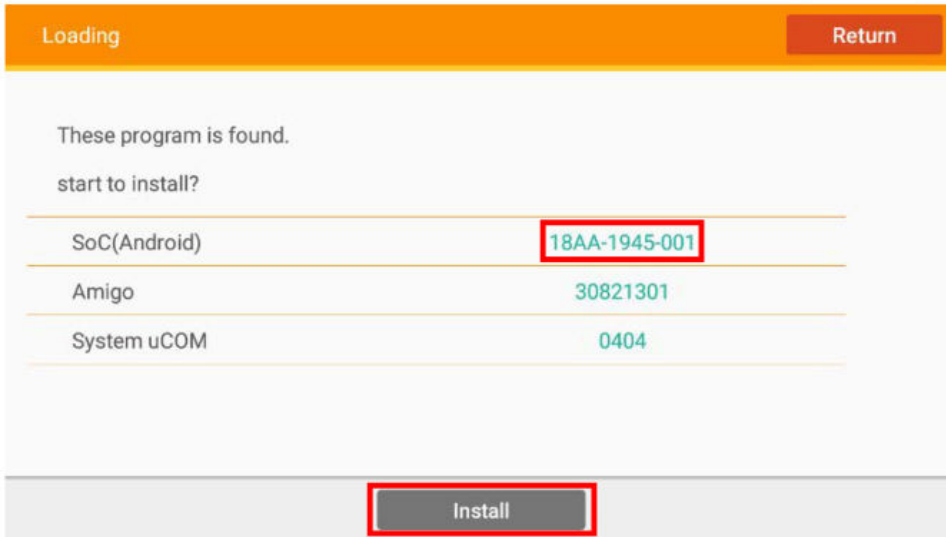
8. Verify that the software version is **18AA-1945-001**. If the version is correct, select **Install** to begin the update.

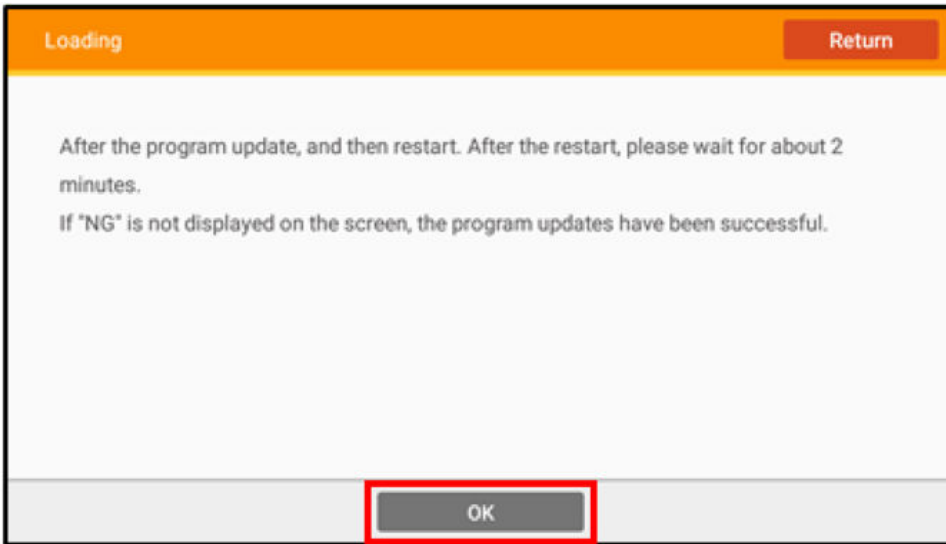
9. Once you select **Install**, a notification will appear. Press **OK**.

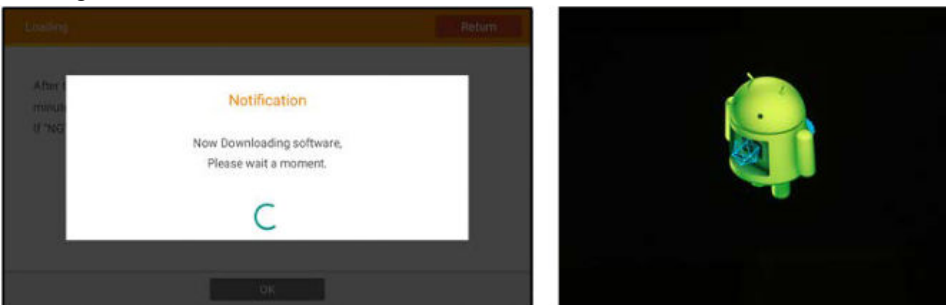
During the updating process, the audio unit will reset several times. Do not remove the USB flash drive and/or turn the engine off.

Once complete, the system will reboot and load to the **Home** screen.

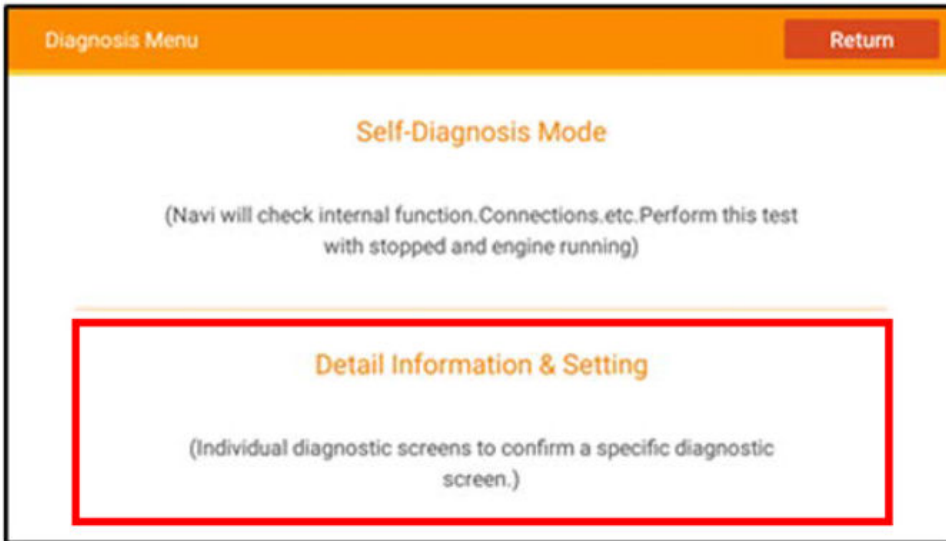
1. From the Home screen, press and hold the **HOME+POWER+SOURCE** for at least **5 seconds** to enter the **Diagnosis Menu**.
2. From the **Diagnosis Menu**, select **Detail Information & Setting**.

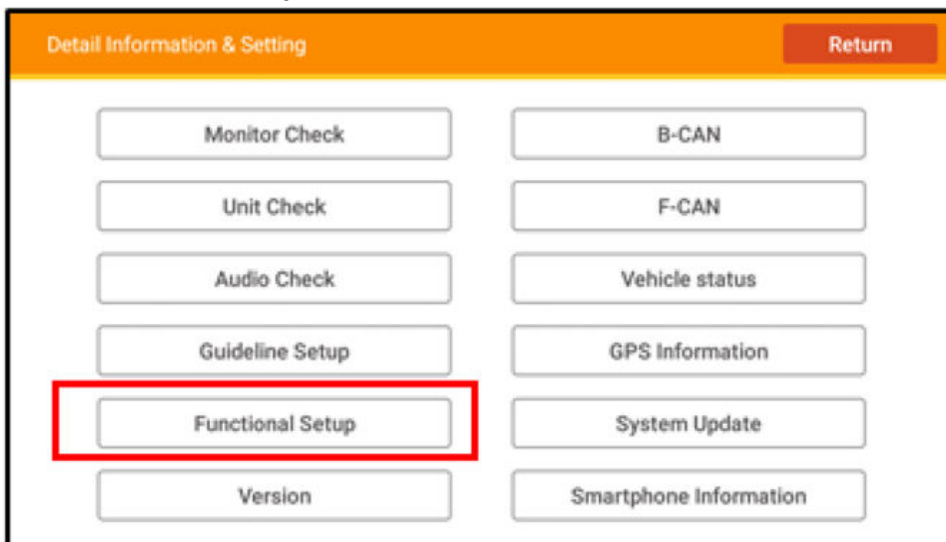
3. Select **Functional Setup**.

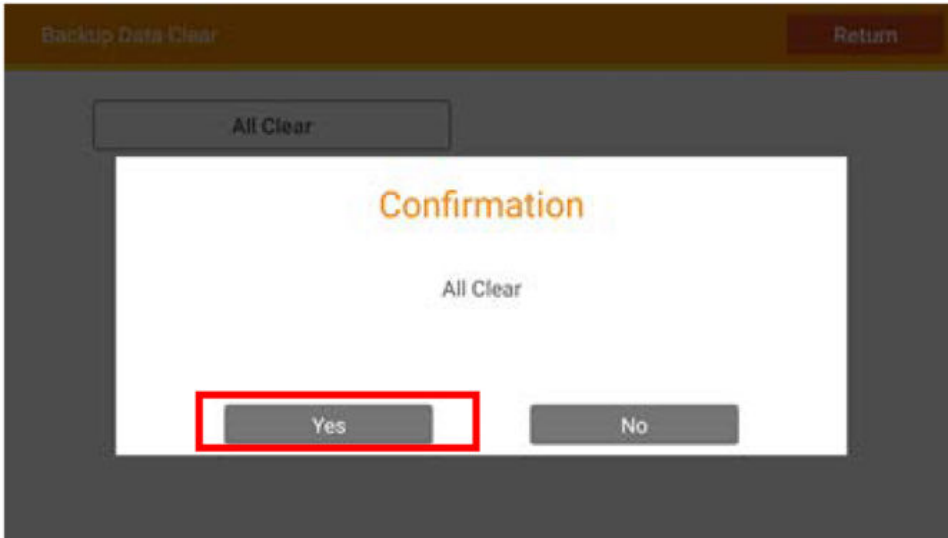
6. When you see the **Confirmation All Clear** message, press **Yes**. Do not turn the engine or ignition off during the data reset.

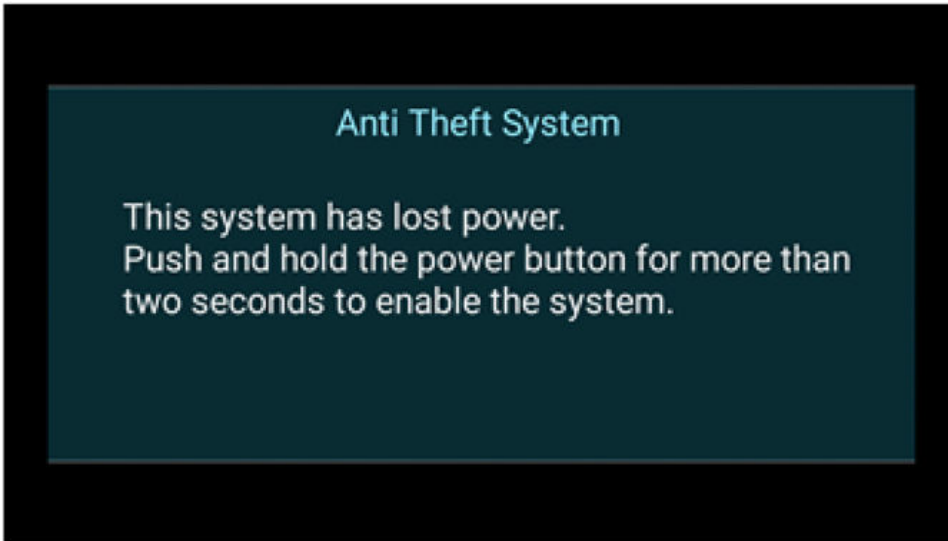
7. After the **Backup Data Clear** is complete, the **Anti-Theft System** screen will display. With the engine on, press and hold the Power button to bypass the screen.

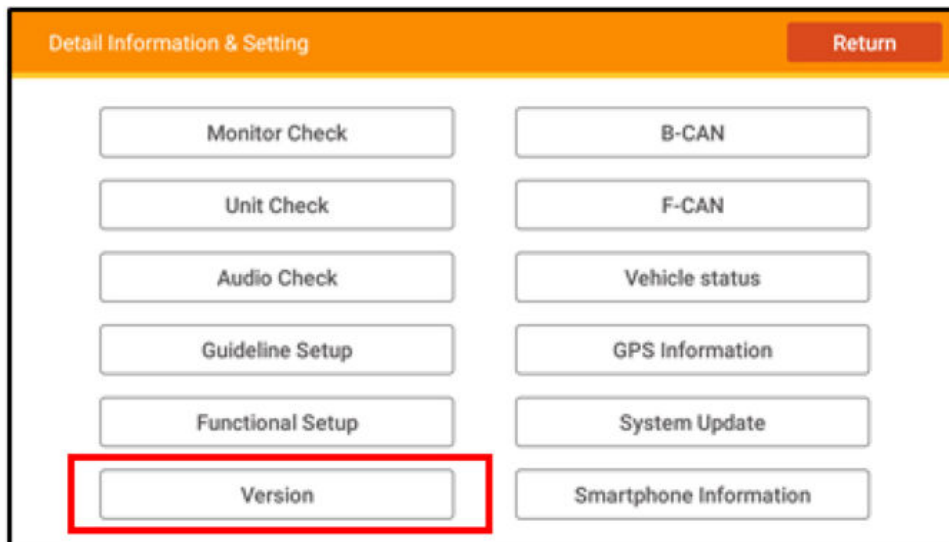
3. Select **Version**.

4. Make sure the **Build Number** reads **18AA-1945-001** .
