**PRODUCT CAMPAIGN BULLETIN**

**SUBJECT:** Harman Kardon Head Unit FMVSS 111 Noncompliance Recall

**NUMBER:** WTZ-85R

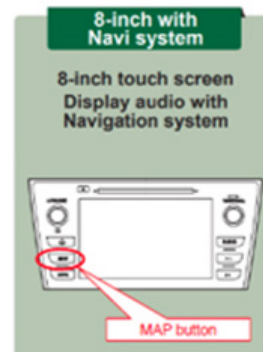
Multimedia System Type	Descriptive Features
8.0 Inch Audio / Navigation System	Map Button in Top Row Center

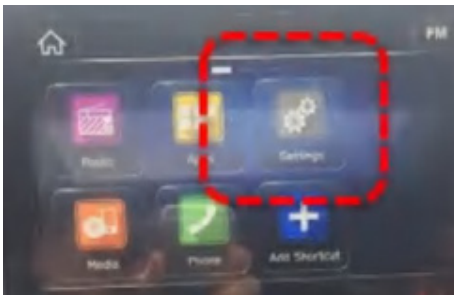
- After starting the engine, from the HOME screen, touch “Settings”.

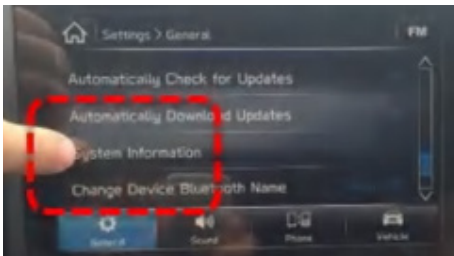
- From the Settings > General screen, scroll down to and then touch “System Information”.

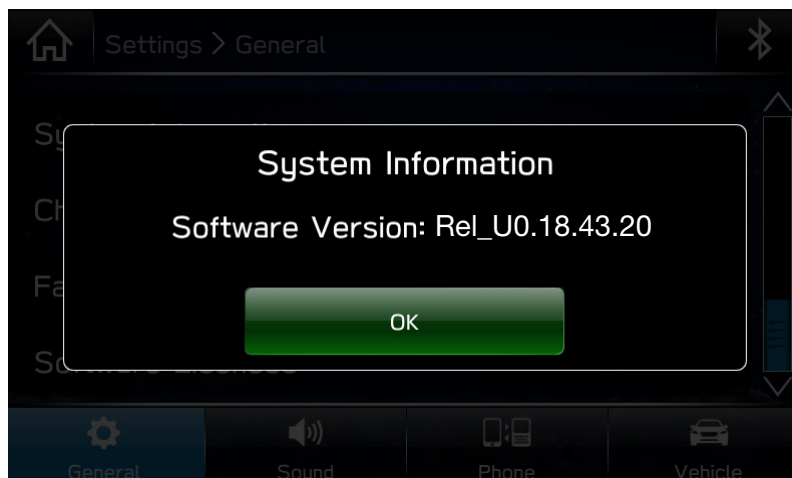
- Confirm Software Version is now “Rel\_UO.18.43.20”.
