**PRODUCT CAMPAIGN BULLETIN**

**APPLICABILITY:** 2018 Model Year Legacy, Outback, and BRZ Vehicles

**NUMBER:** WTZ-85

**SUBJECT:** Harman Kardon Head Unit FMVSS 111 Noncompliance Recall

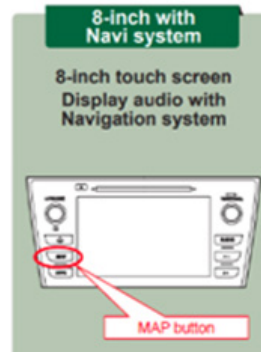
Multimedia System Type	Descriptive Features
8.0 Inch Audio / Navigation System	Map Button in Top Row Center

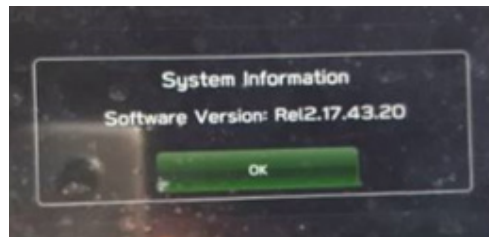
(EXAMPLE photo)

- Confirm the current Software Version ID. If the Current Version is **Rel\_UO.18.43.20**, **STOP** as this latest update has already been installed. If the Current Version is: **Rel1.16.46.20**, **Rel1.17.08.20**, **Rel2.17.20.20** or **Rel2.17.22.20**, continue with the remainder of the update procedure.
