PRODUCT CAMPAIGN BULLETIN

APPLICABILITY: 2018 Model Year Legacy, Outback, and BRZ Vehicles

SUBJECT: Harman Kardon Head Unit FMVSS 111 Noncompliance Recall

NUMBER: WTZ-85R
DATE: 01/03/19
NHTSA ID: 18V-935
REVISED: 05/23/19

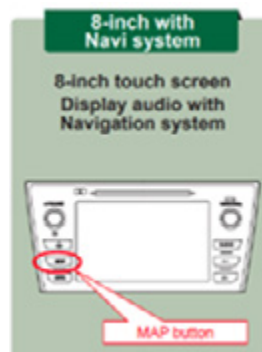
This procedure and the related reprogramming files apply to the following audio / navigation head unit:

Multimedia System Type	Descriptive Features
8.0 Inch Audio / Navigation System	Map Button in Top Row Center

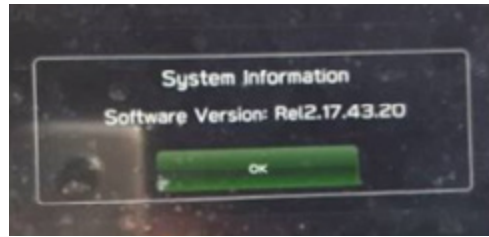
(EXAMPLE photo)

- Confirm the current Software Version ID. If the Current Version is **Rel_UO.18.43.20**, **STOP** as this latest update has already been installed. Otherwise, proceed to **Step 2** below.

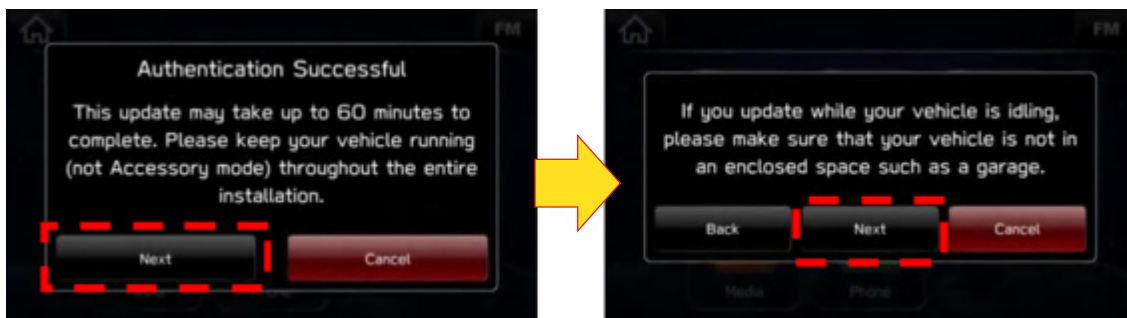
- After the unit “authenticates” the USB flash drive, press “Next” and after the second screen is displayed, press “Next” again.

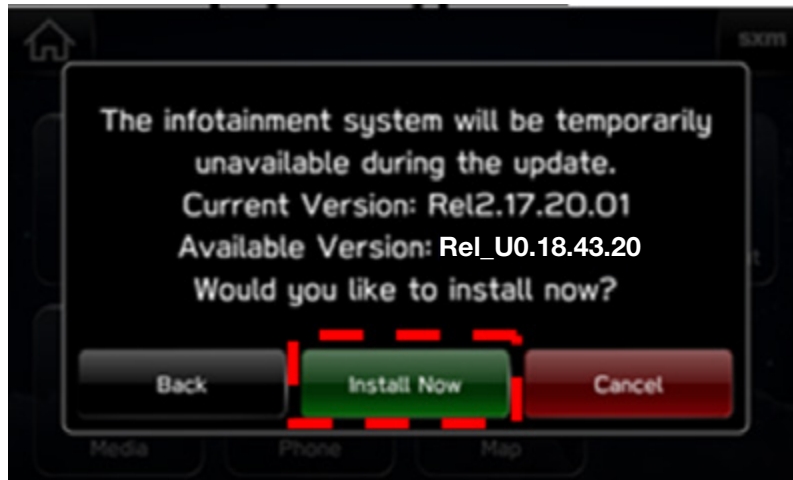
- The current and available software version information will be displayed. The Available Version I.D should be **Rel_U0.18.43.20**.

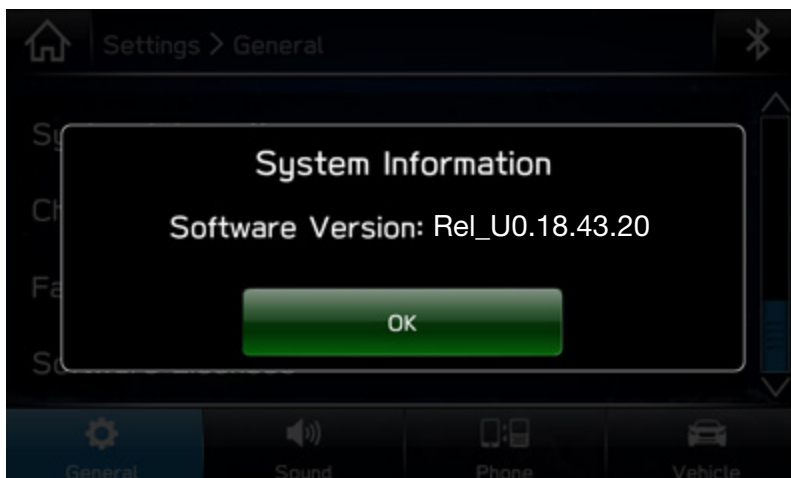
- Confirm Software Version is now “Rel_UO.18.43.20”.
