2016-2019 MX-5 (ND) Transmission Control Module Software Concern Safety Recall 3019A

A. VEHICLE INSPECTION PROCEDURE

B.REPAIR PROCEDURE: TCM REPROGRAMACTION TO BE TAKEN

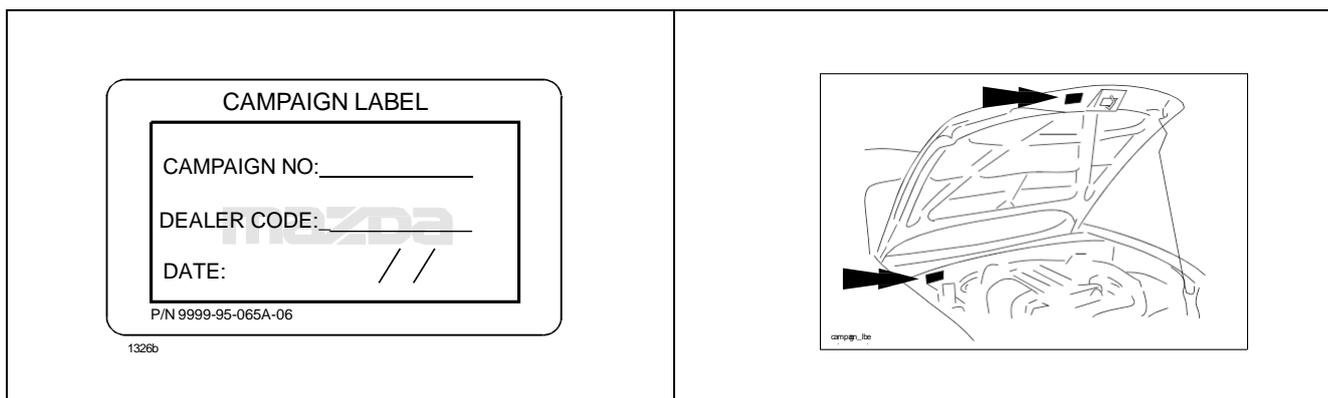
Perform a Warranty Vehicle Inquiry using your eMDCS System and inspect vehicle for Campaign Labels **Recalls 3019A** attached to the vehicle’s hood or bulkhead. Refer to eMDCS System - Warranty Vehicle Inquiry Results table below.

NOTE: Be sure to verify Recall number as the vehicle may have multiple Recall labels.

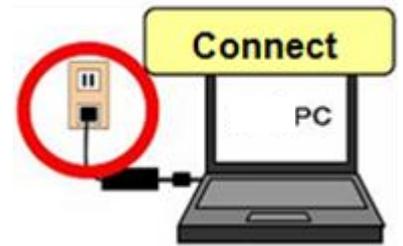
- a. Make sure that the following connections are firmly connected, and then do NOT touch the VCM and DLC cable to prevent from causing noise and poor connection.

- Between the vehicle-side connector and the DLC cable
- Between the PC-side connector and USB port of PC

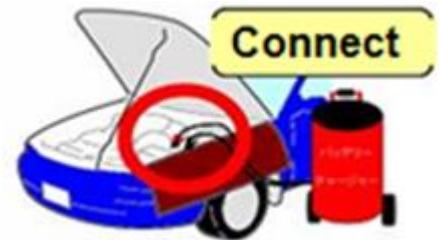
- b. Connect AC adapter to the PC in order to stabilize voltage fluctuation during reprogramming
Do NOT use vehicle battery outlet as power source for the PC.

- c. During reprogramming, connect battery charger (charge current maintained within 10 to 15A) to the vehicle to stabilize voltage fluctuation.
