SUBJECT: NEW VEHICLE DEMONSTRATION / DELIVERY HOLD

Compliance Recall 19C07 – *Supplement #2*

Certain 2018-2020 Model Year *Escape*, Explorer, F-150, Superduty, Expedition and Aviator Vehicles Equipped With Manual Reclining Seats
 Manual Recliner Seat Inspection

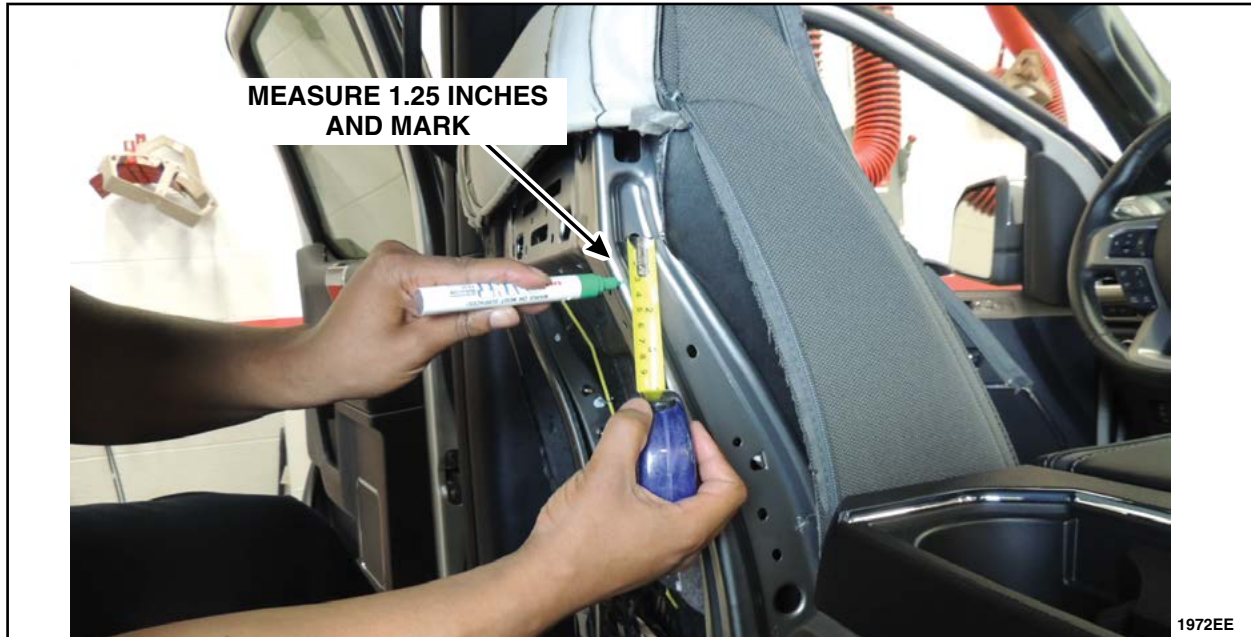
FIGURE 5

6. Measure 1.25 inches (32mm) down from the center of the upper attachment hole shown and mark frame as shown in Figure 5.

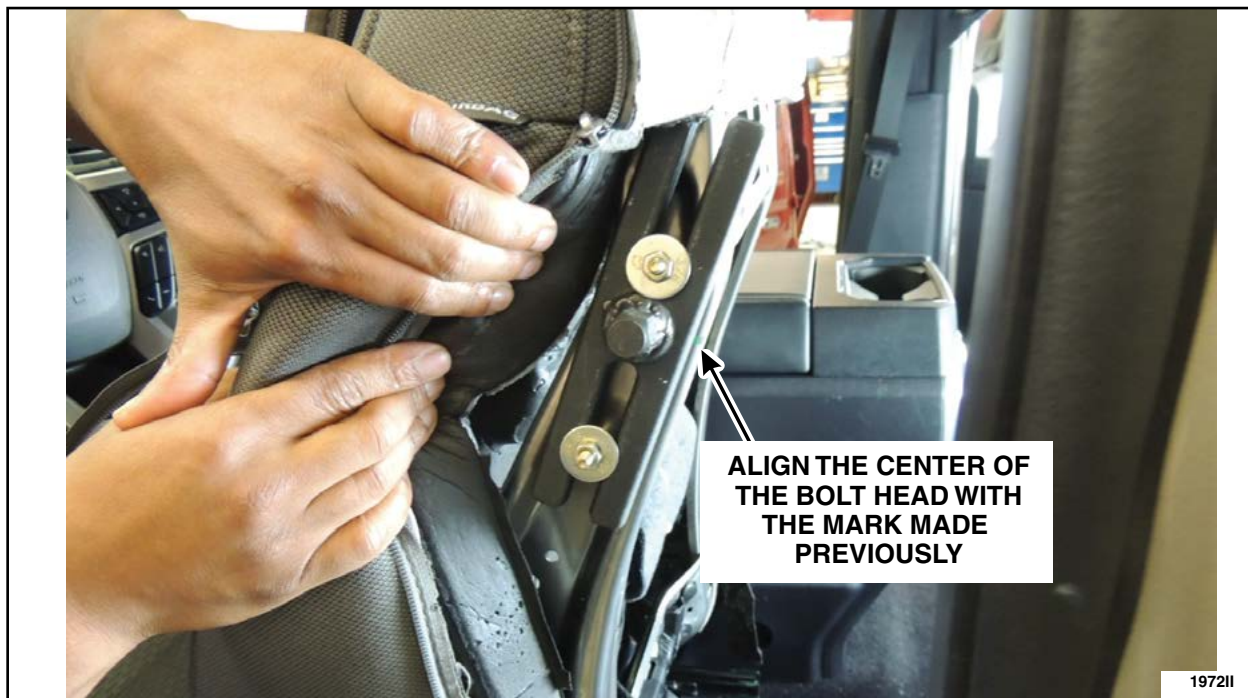
FIGURE 11

5. Install Torque Fixture onto the outboard side of the front seat backrest. See Figure 11.
 - a. Position a washer on the 6mm bolt, of suitable length, and install through the lower attachment hole.
 - b. Install a washer and nut onto the lower attachment bolt.
 - c. Position the Torque Fixture onto the lower attachment bolt between the frame and the outer washer.
 - d. Position a washer on the bolt and install through the upper attachment hole.
 - e. Install a washer and nut onto the upper attachment bolt.
 - f. Align the mark made on the backrest to the center of the Torque Fixture bolt.
 - g. Tighten down the Torque Fixture bolts and nuts so that the fixture can not move.

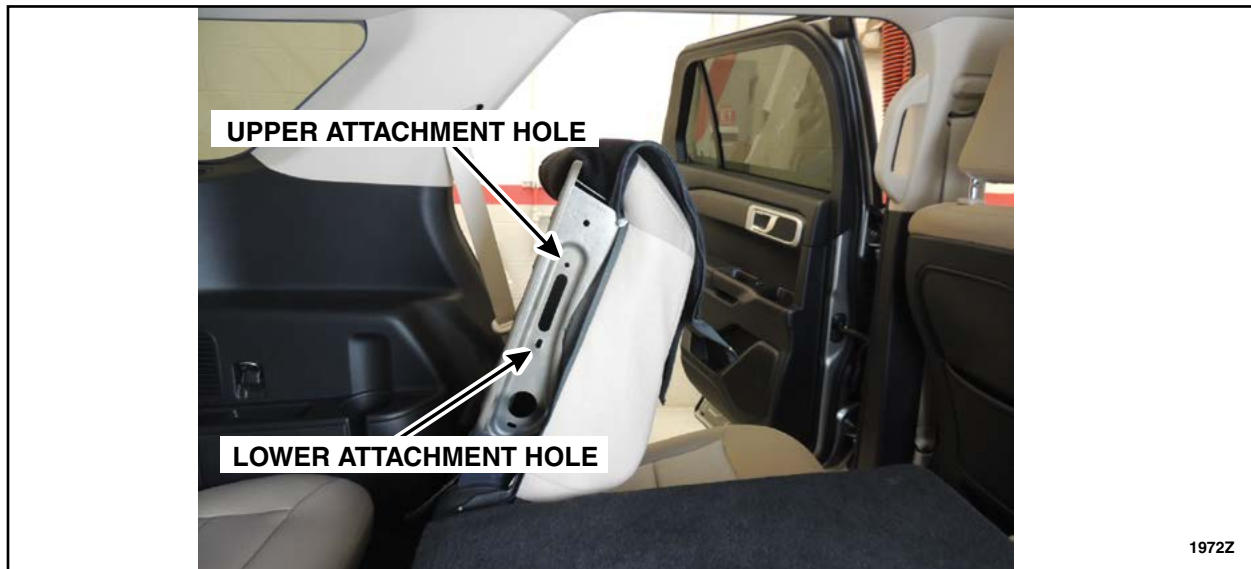
FIGURE 14

2. Partially remove the seat backrest cover enough to access the seat frame holes shown in Figure 14. Please follow the procedures within Workshop Manual (WSM) Section 501-10B - Rear Seat Backrest Cover.

- If equipped, remove the arm rest.
- Move the trim needed to position the backrest cover up and over the top of the seat backrest.
- Remove the backrest foam enough to access the seat frame.
- Removal of the head rest guide sleeves are not required for this procedure.
- Use caution during disassembly not to stretch or rip the backrest cover fabric or backrest foam.

3. The Torque Fixture will attach at the locations shown in Figure 14.

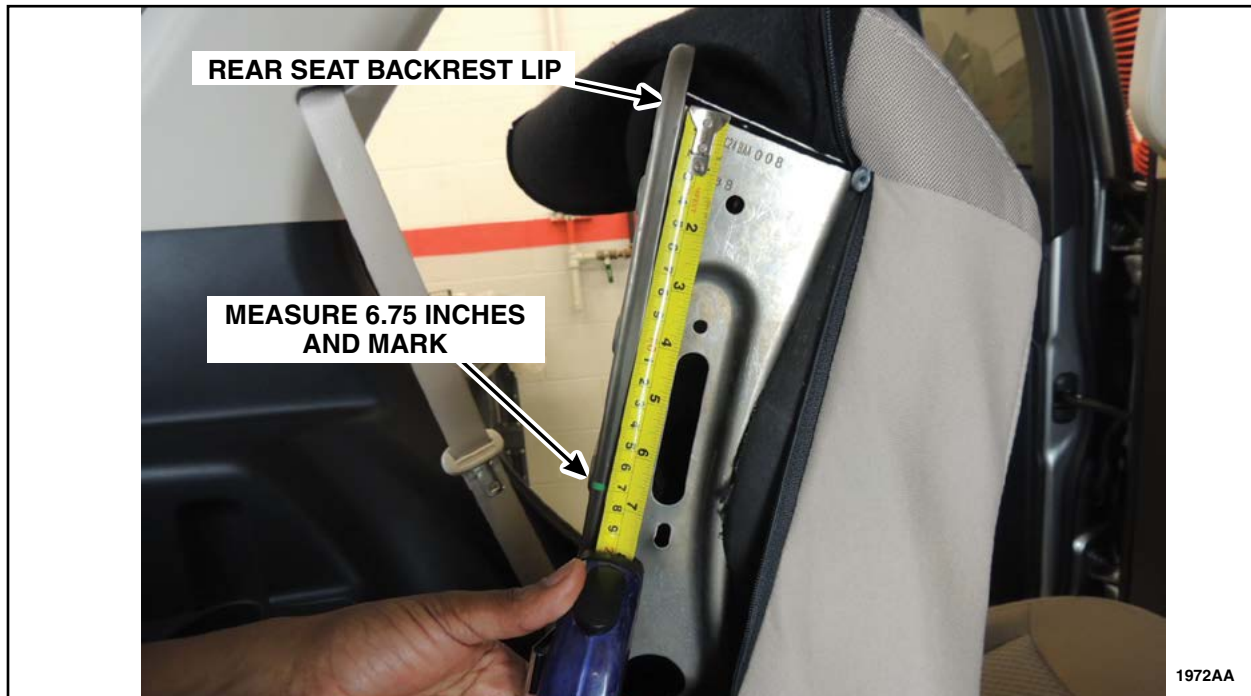
FIGURE 15

4. Measure 6.75 inches (171mm) from the top of the seat backrest frame and mark that measurement on the seat backrest lip for reference later in this procedure. See Figure 15.

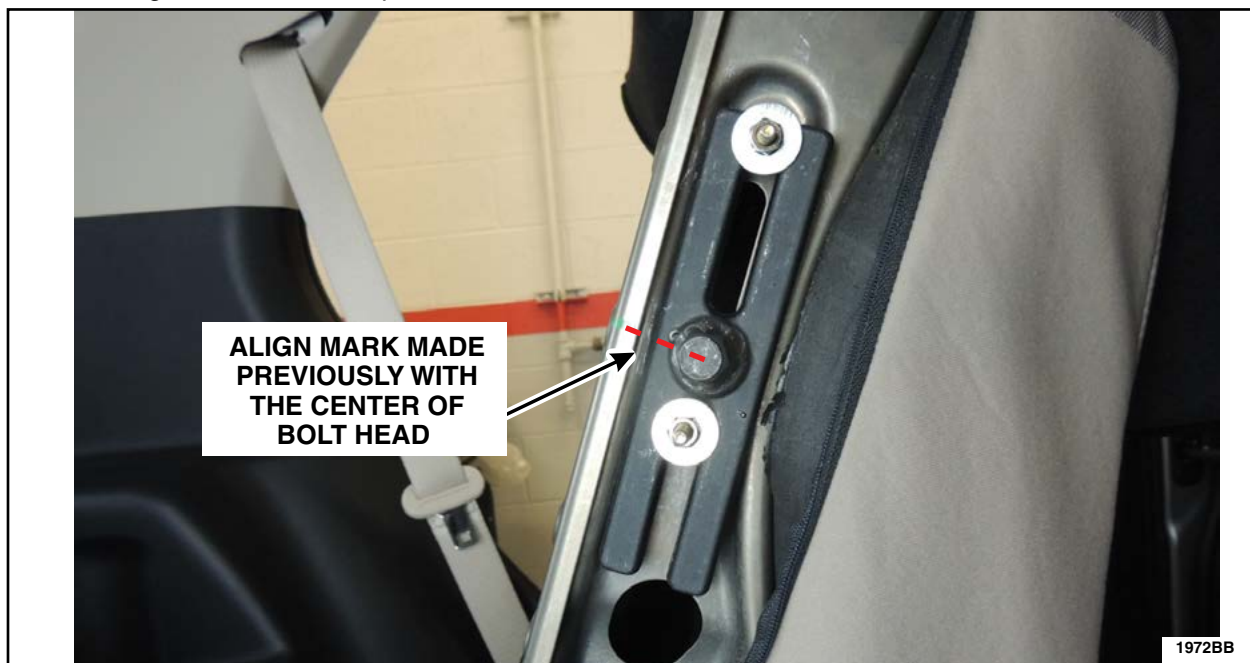
FIGURE 16

8. Install Torque Fixture onto the inboard side of the second row seat backrest. See Figure 16.
 - Position a washer on the 6mm bolt, of suitable length, and install through the lower attachment hole.

- Position a washer on the bolt and install through the upper attachment hole.
 - Install a washer and nut onto the upper attachment bolt.
 - Align the mark made on the backrest to the center of the Torque Fixture bolt.

- Tighten down the Torque Fixture bolts and nuts so that the fixture can not move.
