# RECALL CAMPAIGN BULLETIN

Classification: EL19-034	Reference: NTB19-095	Date: October 29, 2019
-----------------------------	-------------------------	---------------------------

## VOLUNTARY RECALL CAMPAIGN 2018 - 2019 VERSA NOTE; AV CONTROL UNIT (INFOTAINMENT) SOFTWARE UPDATE

**CAMPAIGN ID #:** R1911  
**NHTSA #:** 19V654  
**APPLIED VEHICLES:** 2018 - 2019 Versa Note (E12)

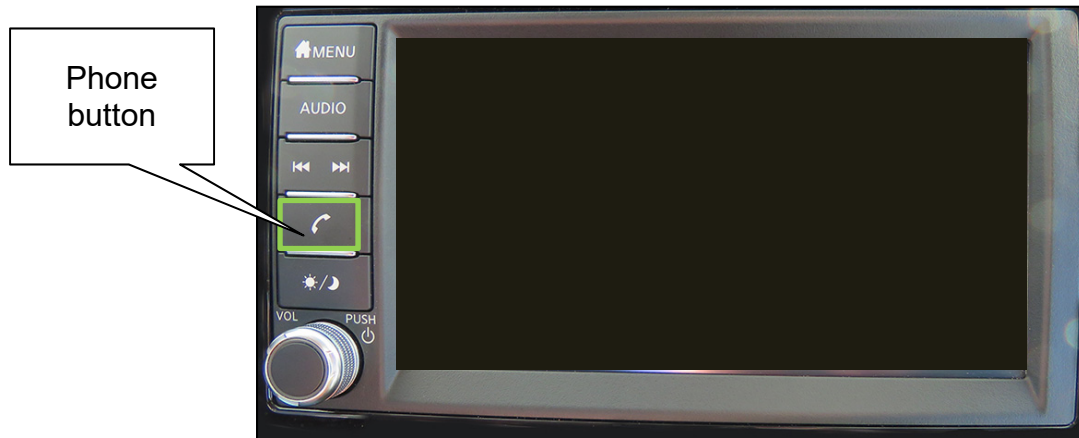
1. Determine which audio unit the vehicle is equipped with.
  - If there is a **Phone** button as shown in Figure 1 then continue to step 2 on the next page
  - If there is a **Back** button as shown in Figure 2 then skip to step 15 on page 7.
  - If there is a **NAV MAP** button as shown in Figure 3, then skip to step 23 on page 11.

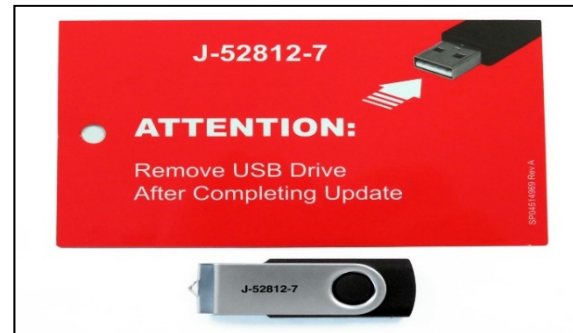
Figure 4

6. Turn OFF the audio.
7. Insert the special tool USB drive J-52812-7 into the USB media port.

**NOTICE** Do not insert the USB drive into a charging port. If used, the update software and/or USB drive may become damaged. Only insert the USB drive in a USB media port.

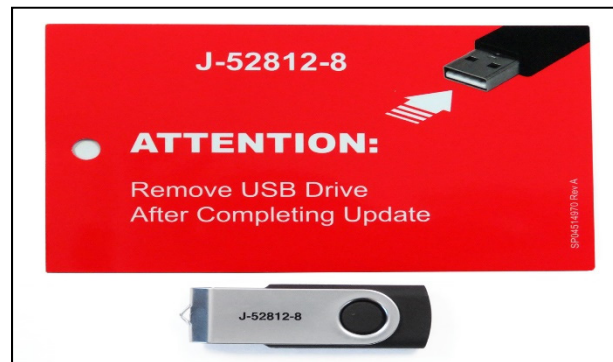
Figure 8

10. Insert the special tool USB drive J-52812-8 into the USB media port.

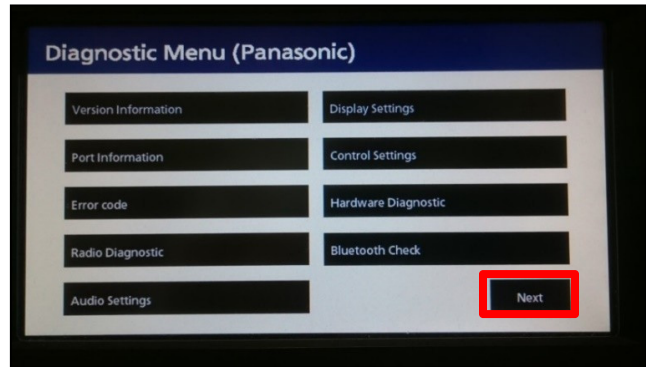
13. Perform audio unit initialization.
- a. Press and hold the “Menu” button.
  - b. Press and hold the “Audio” button.
  - c. Press the “Seek right” button 3 times.

**HINT:** A screen similar to the one in Figure 10 will appear.

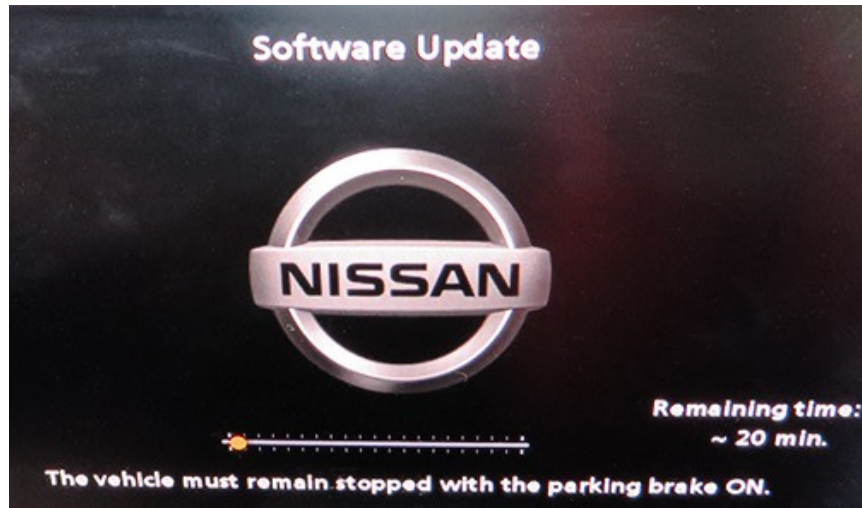
Figure 17

19. Wait for the update to complete.
  - Follow the on-screen instructions while waiting.

**HINT:** The update lasts 15-25 minutes.

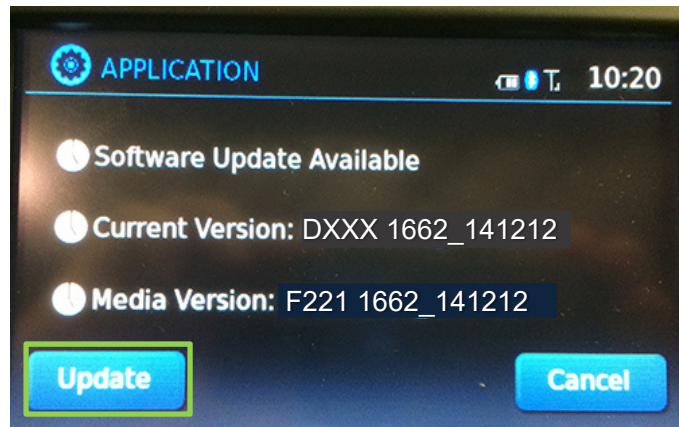
Figure 26

34. Wait for the **APPLICATION** screen to appear (Figure 26).

35. Select **Update**.

**HINT:** After selecting **Update**, the screen will go black for up to 1 minute. This is a normal part of the update.
