RECALL CAMPAIGN BULLETIN

VOLUNTARY RECALL CAMPAIGN 2018-2019 NV; AV CONTROL UNIT (INFOTAINMENT) SOFTWARE UPDATE

CAMPAIGN ID #: R1911
NHTSA #: 19V654
APPLIED VEHICLES: 2018-2019 NV (F80)

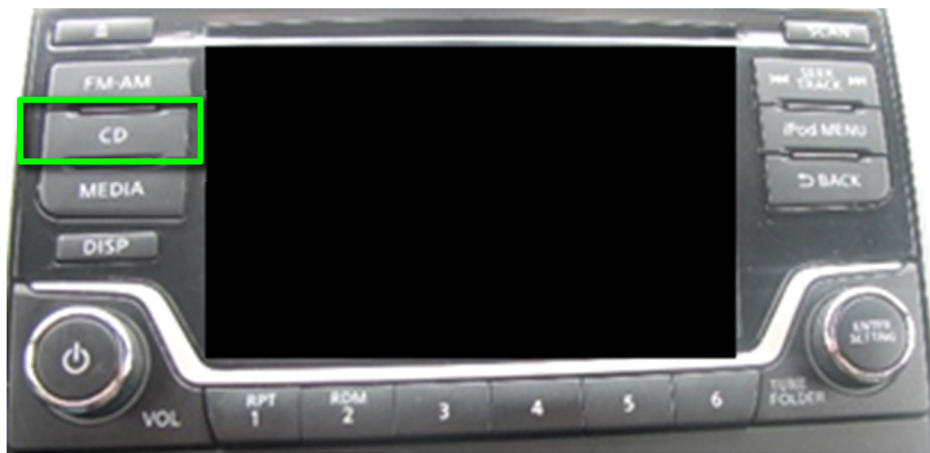
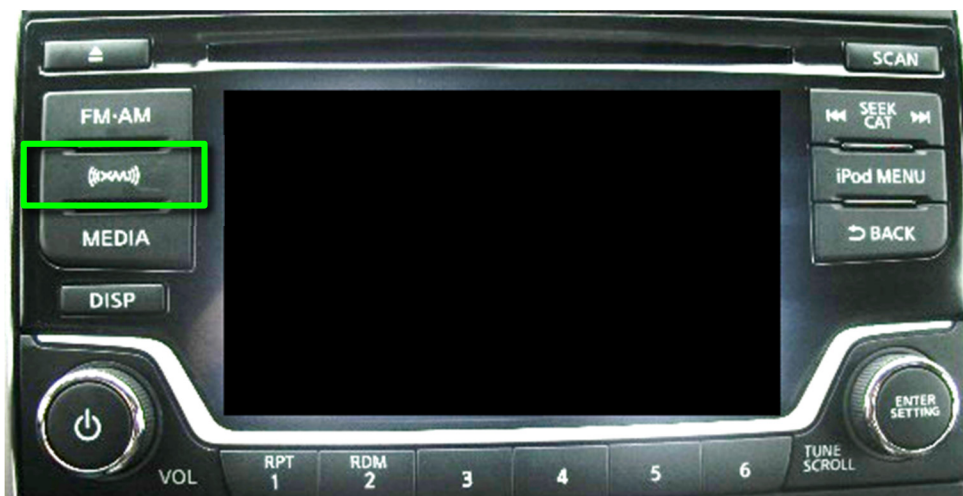
1. Determine if the audio system present in the vehicle is the type shown in Figure 1 or Figure 2.
 - If the audio system **is NOT** shown in Figure 1 or Figure 2, proceed to step 2 on page 4.
 - If the audio system **is** shown in Figure 1 or Figure 2, **this bulletin does not apply**. Software and repair procedures will be available in December 2019. **DO NOT** submit any claims on these vehicles.

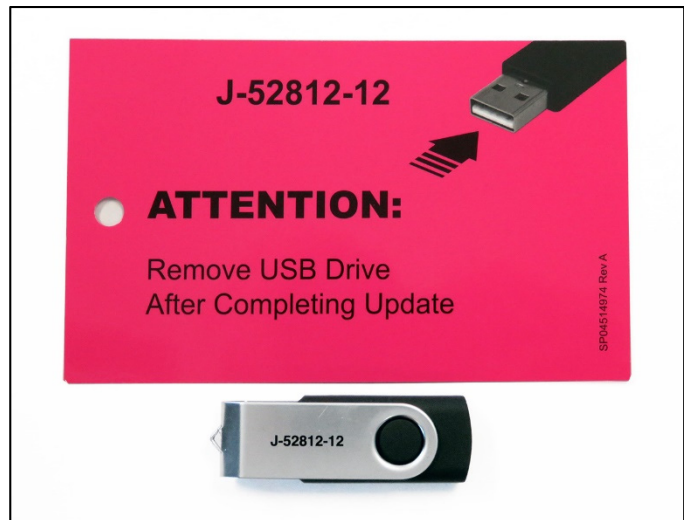
12. Insert special tool USB drive J-52812-12 into the vehicle's USB media port (see Figure 7 and Figure 8).
- DO NOT remove the USB drive during the software update until instructed.

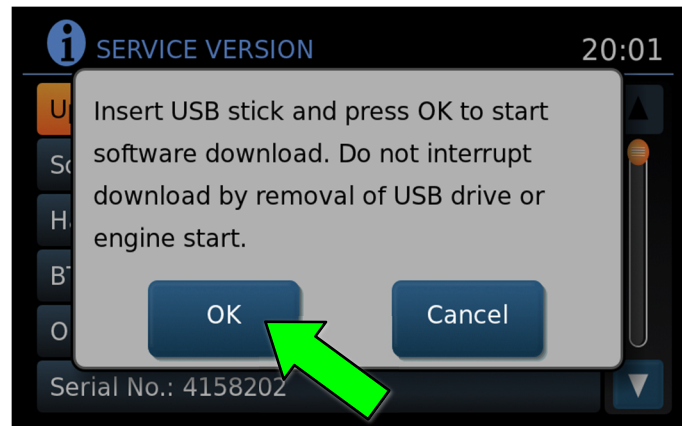
Figure 10

13. Select **OK**.

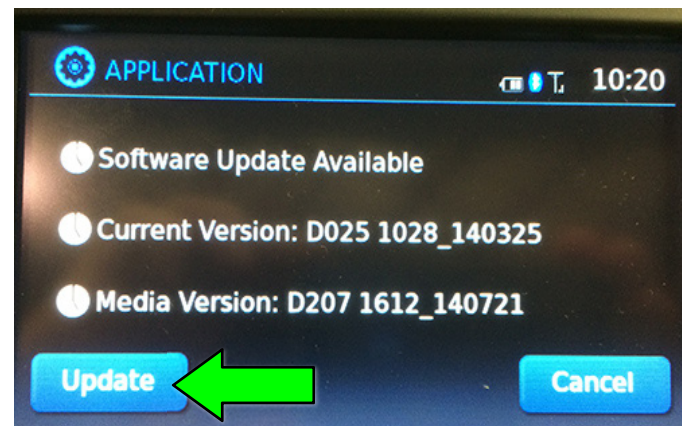
Figure 11

14. Wait for the **APPLICATION** screen to display (Figure 11).

15. Select **Update**.

HINT: After selecting **Update**, the screen will go black for up to 1 minute. **This is a normal part of the update.**

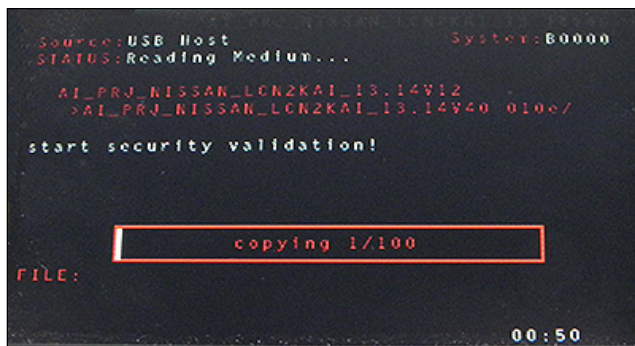
16. Wait until the update is complete (this can take up to 60 minutes).

- The screen in Figure 12 will be displayed during the update.
- Figure 13 may display before the update begins. **DO NOT** remove the USB drive during the update.

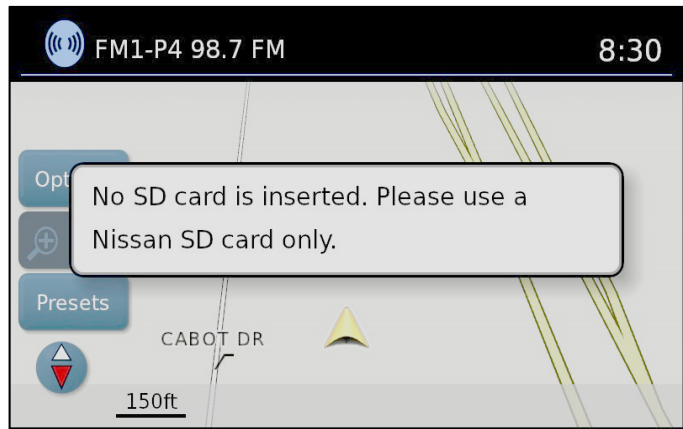
Figure 15

- If the message “No SD card is inserted. Please use a Nissan SD card only” is displayed (Figure 15), proceed to step 18 on page 9.

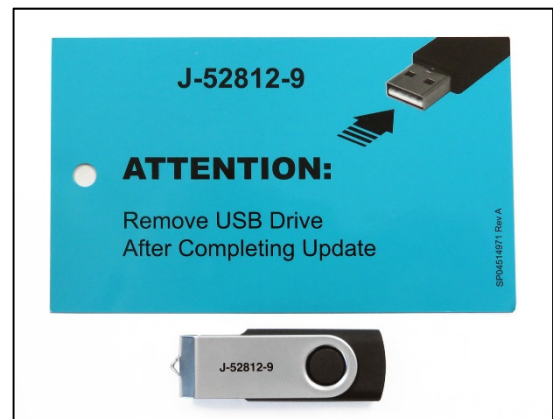
28. Turn the audio OFF.
29. Insert special tool USB drive J-52812-9 into the vehicle's USB media port (see Figure 20 and Figure 21).

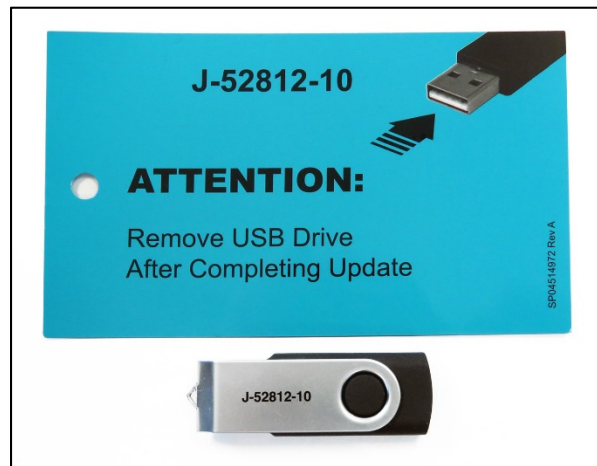
Figure 24

32. Insert special tool USB drive J-52812-10 into the USB media port.
