RECALL CAMPAIGN BULLETIN

VOLUNTARY RECALL CAMPAIGN 2018 FRONTIER; AV CONTROL UNIT (INFOTAINMENT) SOFTWARE UPDATE

CAMPAIGN ID #: R1911
NHTSA #: 19V-654
APPLIED VEHICLES: 2018 Frontier (D40)

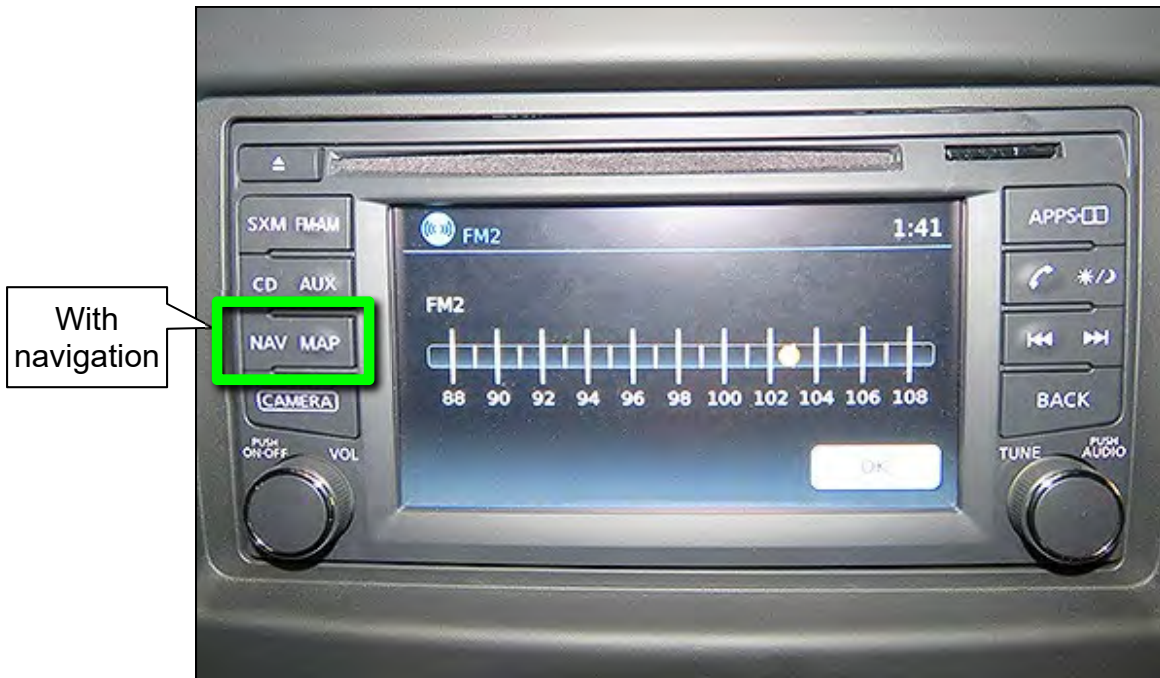
1. Confirm which audio system is equipped in the vehicle.
 - If the audio system is equipped with navigation (see Figure 1 below), go to step 2.
 - If the audio system is **NOT** equipped with navigation, skip to page 9, step 23.

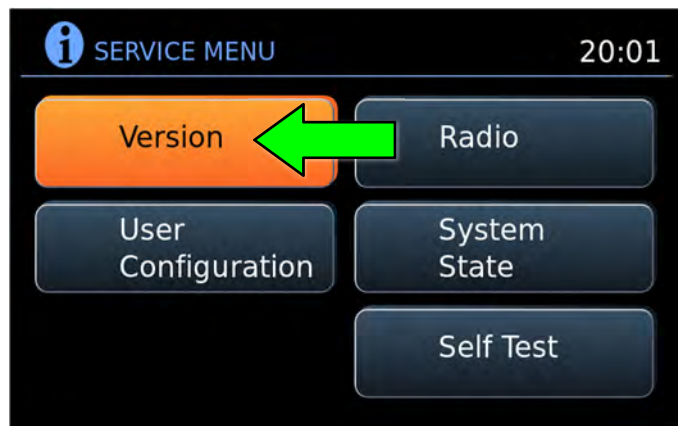
Figure 2

9. Select **Version**.

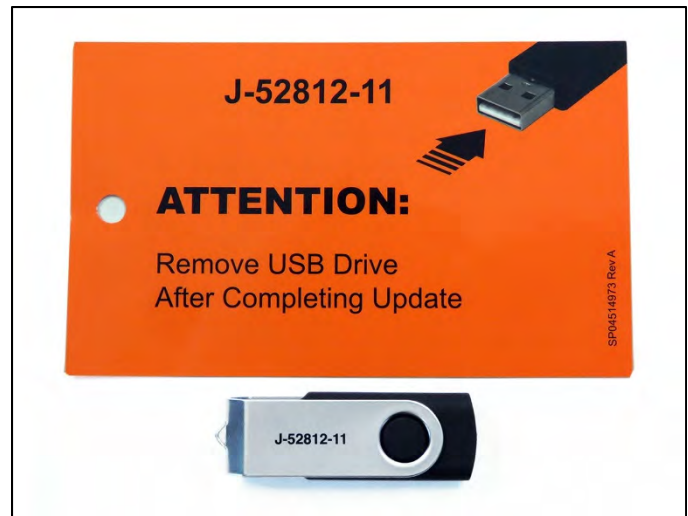
11. Insert special tool USB drive J-52812-11 into the vehicle's USB media port (see Figure 4 and Figure 5).

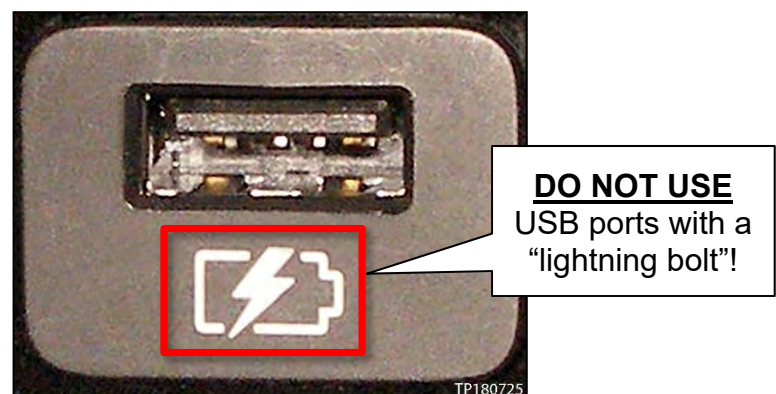
Figure 6

DO NOT insert the USB drive into a charging port (see Figure 6). Charging ports are marked in the vehicle with a “lightning bolt” symbol. If used, the software update and/or USB drive may become damaged. Only insert the USB drive in a USB media port.

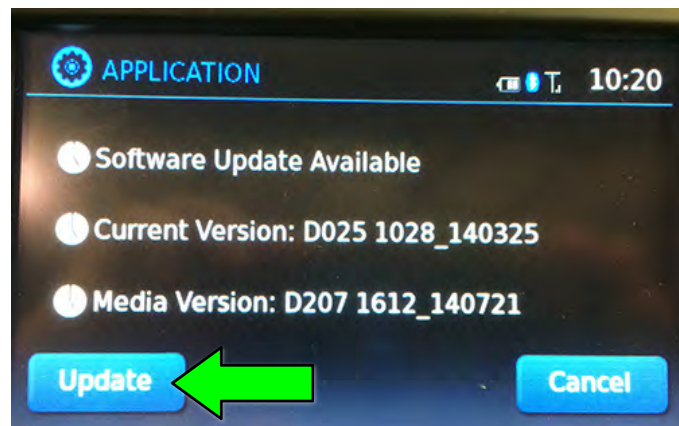
Figure 8

13. Wait for the **APPLICATION** screen to display (Figure 8).

14. Select **Update**.

HINT: After selecting Update, the screen will go black for up to 1 minute. **This is a normal part of the update.**

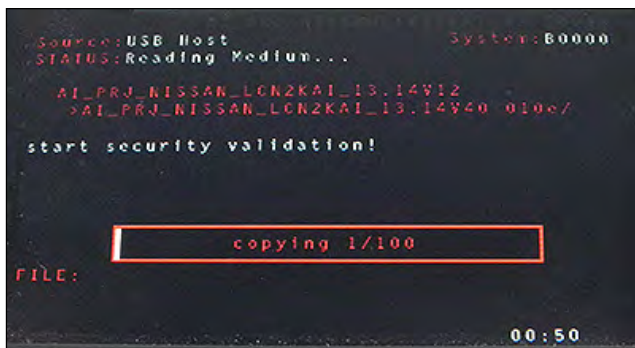
- The screen in Figure 9 will be displayed during the update.
- Figure 10 may display before the update begins. **DO NOT** remove the USB drive during the update.

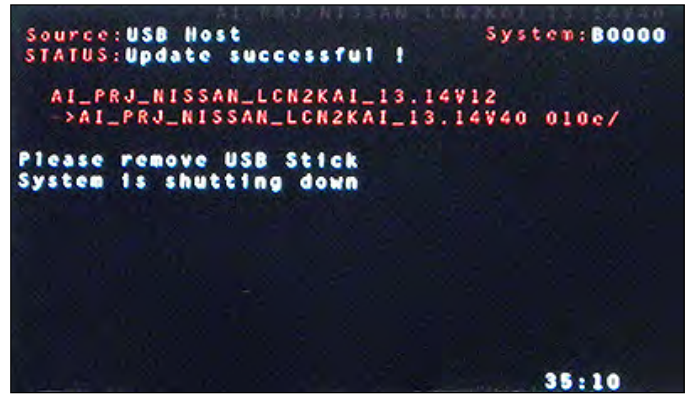
16. When Figure 11 is displayed, remove the USB drive to complete the update.

- This will cause the system to restart and may take up to 1 minute.

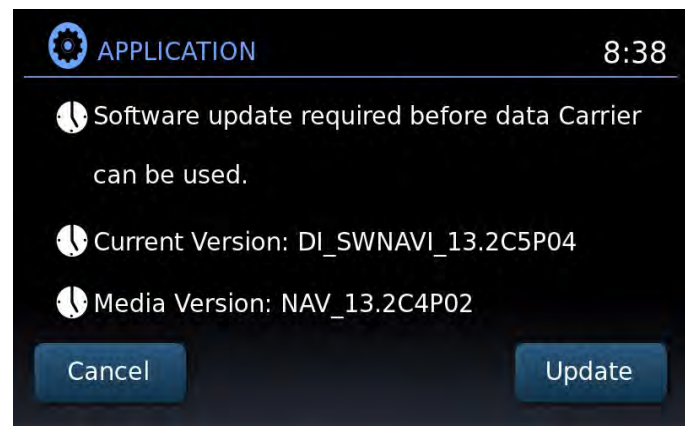
Figure 13

- If the **APPLICATION** screen is displayed (Figure 13), skip to step 18 on page 8.

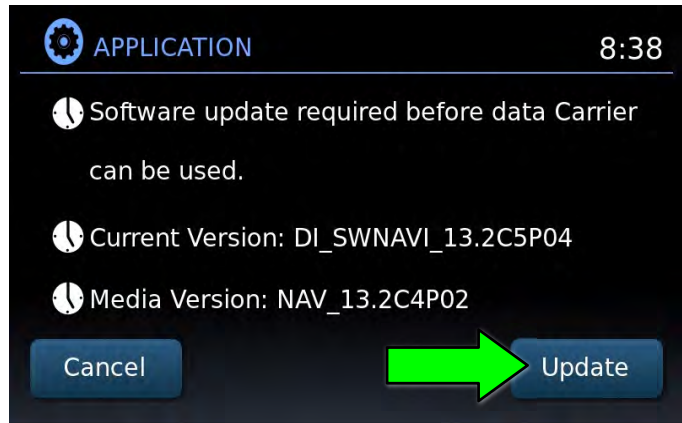
Figure 14

17. Remove and reinsert the map SD card from the card slot.
 - After the map SD card is reinserted, the **APPLICATION** screen will display (Figure 14).
18. Select **Update**.

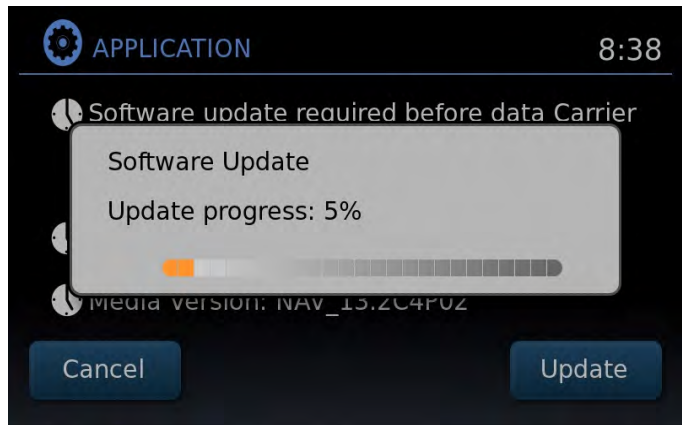
- After selecting **Update**, Figure 15 will display, taking about 1 minute to complete.

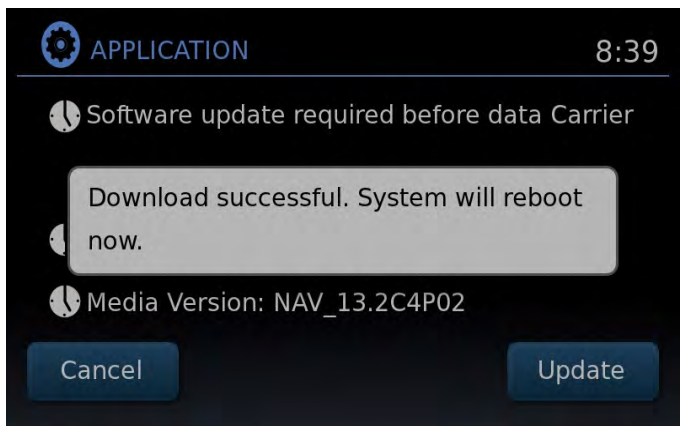
Figure 16

- The message “**Download successful. System will reboot now**” will display next and the audio unit will reboot (Figure 16).
- After the system reboots, the update is complete.

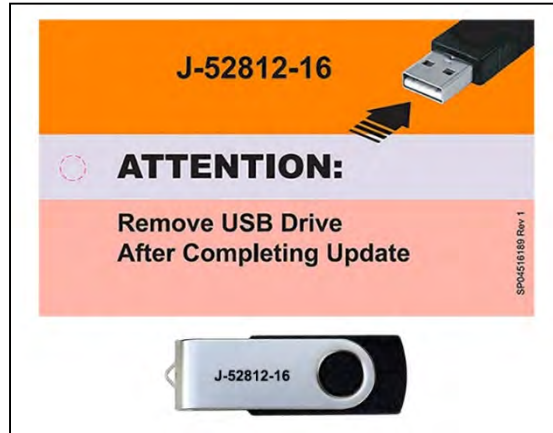
Figure 17

27. Insert the special tool USB drive J-52812-16 into the USB media port.

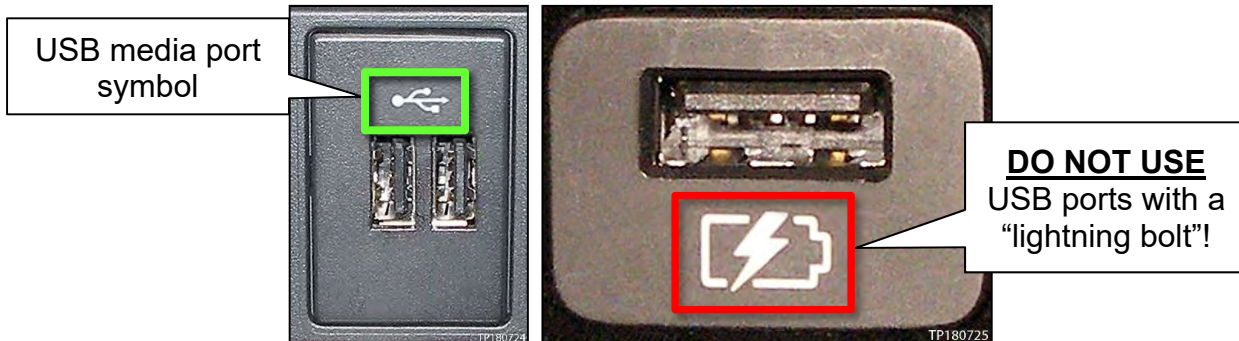
Figure 18

NOTE: Charging ports are marked in the vehicle with a “lightning bolt” symbol.

NOTICE Do not insert the USB drive into a charging port. If used, the update software and/or USB drive may become damaged. Only insert the USB drive in a USB media port.

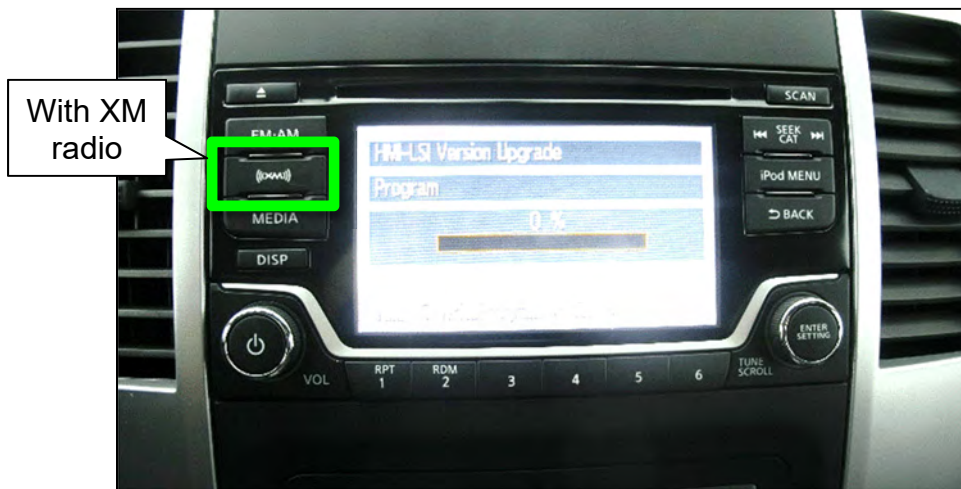
Figure 20

NOTE: Vehicles equipped with a XM radio will have a “XM” button as shown in Figure 20.

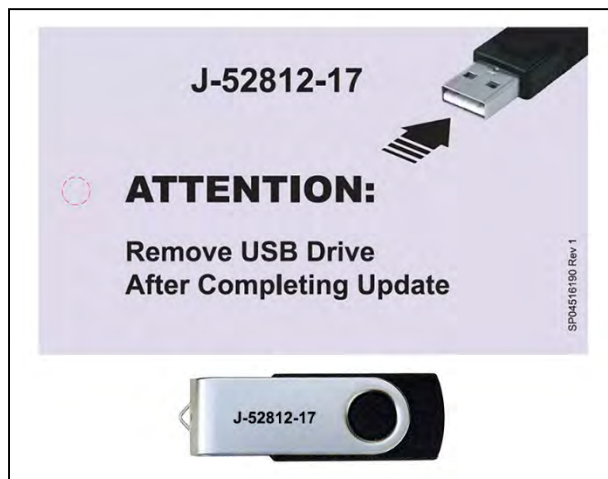
Figure 21

- If **EQUIPPED** with a XM radio, insert special tool J-52812-17 into the USB media port.
- If **NOT** equipped with a XM radio, insert special tool J-52812-19 into the USB media port.
