RECALL CAMPAIGN BULLETIN

VOLUNTARY RECALL CAMPAIGN 2019 FRONTIER AV CONTROL UNIT (INFOTAINMENT) SOFTWARE UPDATE

CAMPAIGN ID #: R1911
NHTSA #: 19V654
APPLIED VEHICLES: 2019 Frontier (D40)

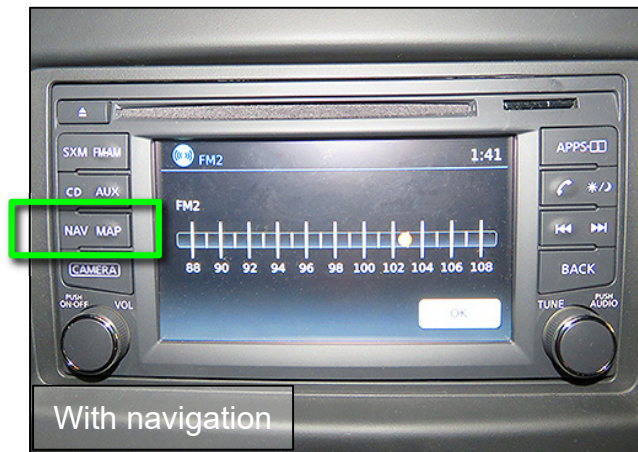
1. Confirm which audio system is present in the vehicle (see Figure 1 and Figure 2 below).
 - If the vehicle is equipped with navigation, as shown in Figure 1 below, continue to step 2.
 - If the vehicle is **NOT** equipped with navigation, as shown in Figure 2 below, skip to step 23 on page 10.

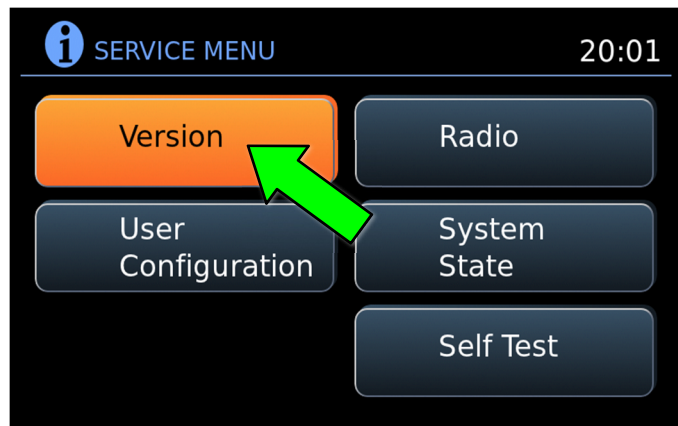
Figure 3

9. Select **Version**.

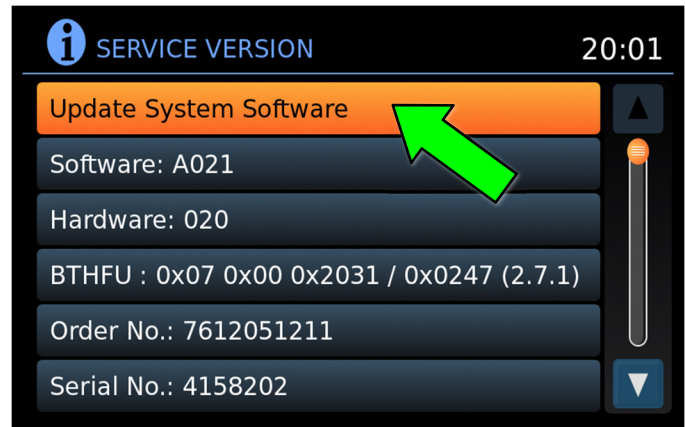
Figure 4

10. Select **Update System Software**.

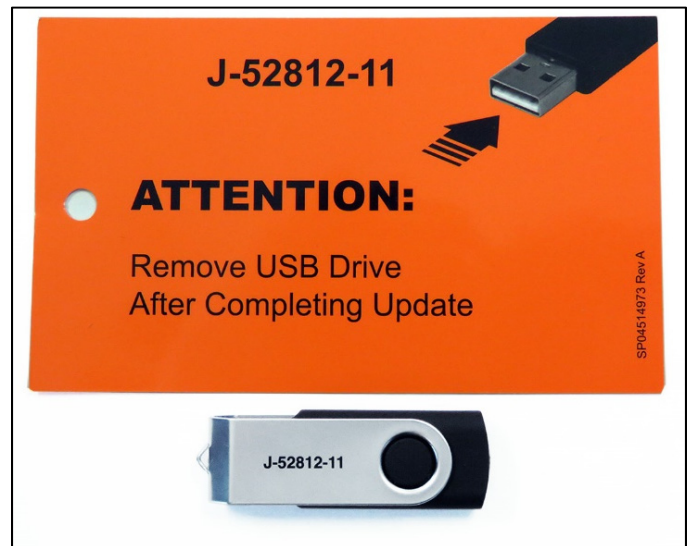
11. Insert special tool USB drive J-52812-11 into the vehicle's USB media port (see Figure 5 and Figure 6).

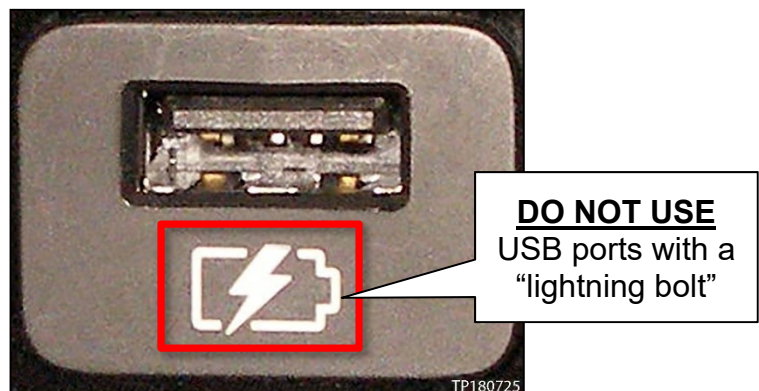
Figure 7

DO NOT insert the USB drive into a charging port (see Figure 7). Charging ports are marked in the vehicle with a “lightning bolt” symbol. If used, the software update and/or USB drive may become damaged. Only insert the USB drive in a USB media port.

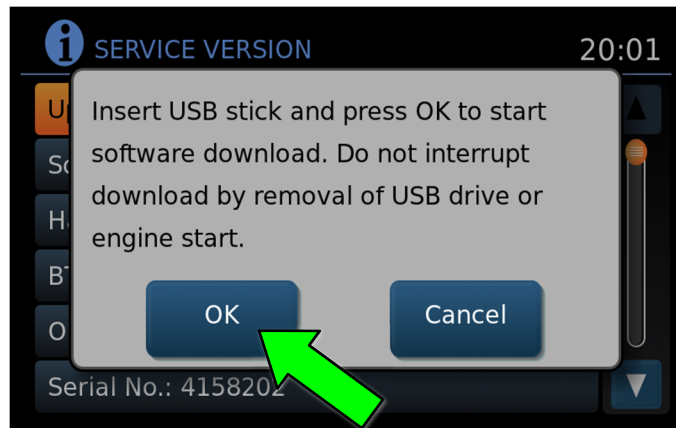
Figure 8

12. Select **OK**.

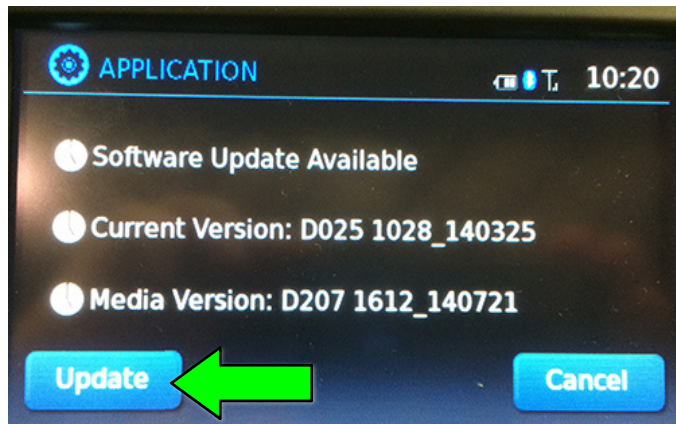
Figure 9

13. Wait for the **APPLICATION** screen to display (Figure 9).

14. Select **Update**.

HINT: After selecting **Update**, the screen will go black for up to 1 minute. **This is a normal part of the update.**

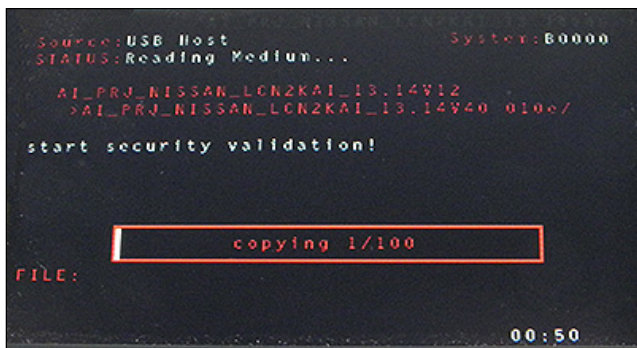
- The screen in Figure 10 will be displayed during the update.
- Figure 11 may display before the update begins. **DO NOT** remove the USB drive during the update.

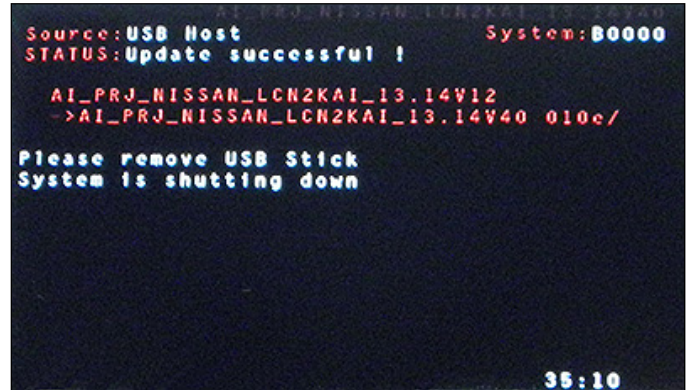
16. When Figure 12 is displayed, remove the USB drive to complete the update.

- This will cause the system to restart and may take up to 1 minute.

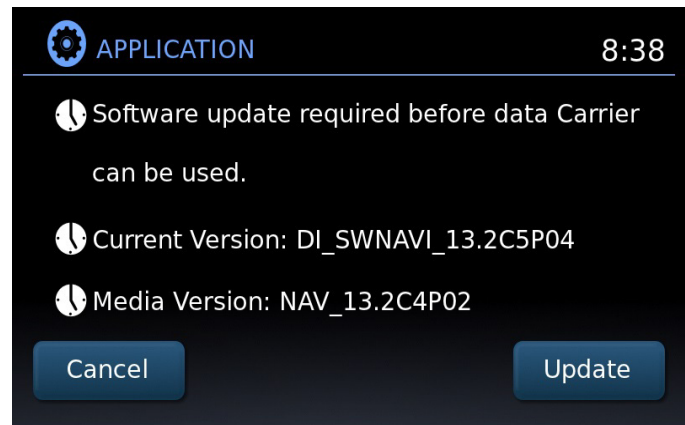
Figure 14

- If the **APPLICATION** screen is displayed (Figure 14), proceed to step 18 on page 8.

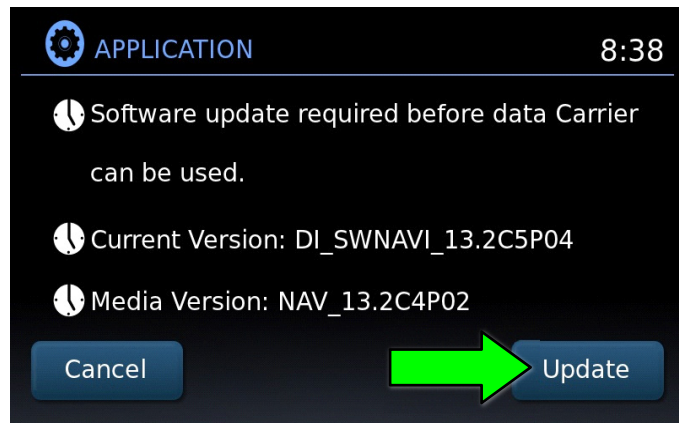
Figure 15

17. Remove and reinsert the map SD card from the card slot.
- After the map SD card is reinserted, the **APPLICATION** screen will display (Figure 15).

18. Select **Update**.

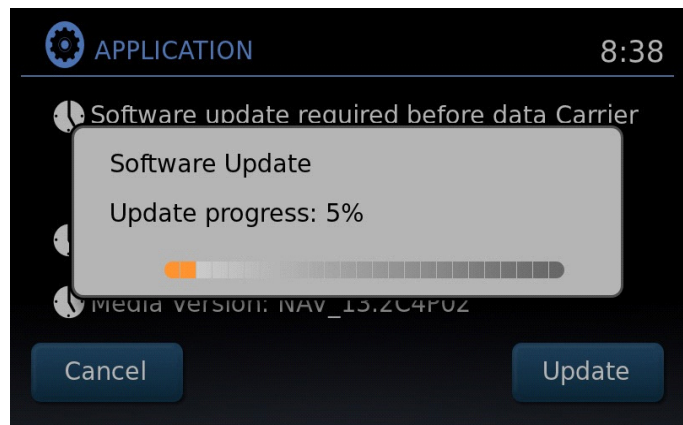
- The update will take about 1 minute to complete, and the screen in Figure 16 will display.

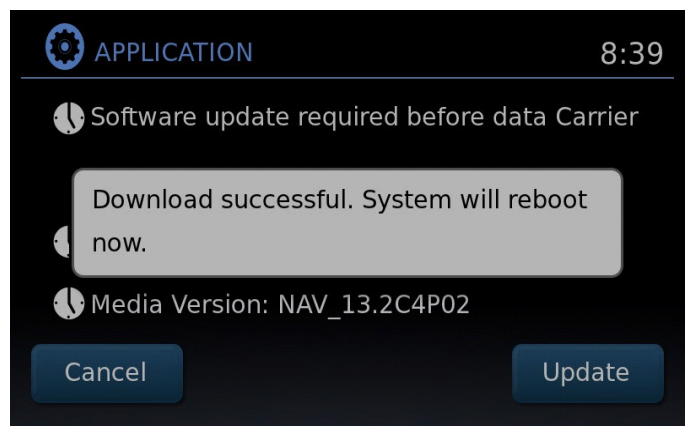
Figure 17

- The message "Download successful. System will reboot now" will display and the audio unit will reboot (Figure 17).
- After the system reboots, the update is complete.

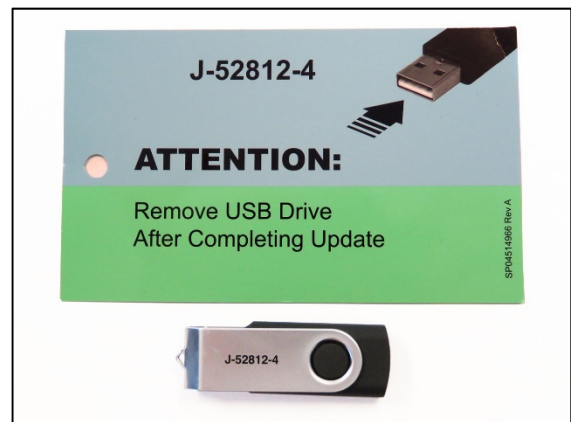
27. Turn the audio OFF.
28. Insert special tool USB drive J-52812-4 into the vehicle's USB media port (see Figure 18 and Figure 19).

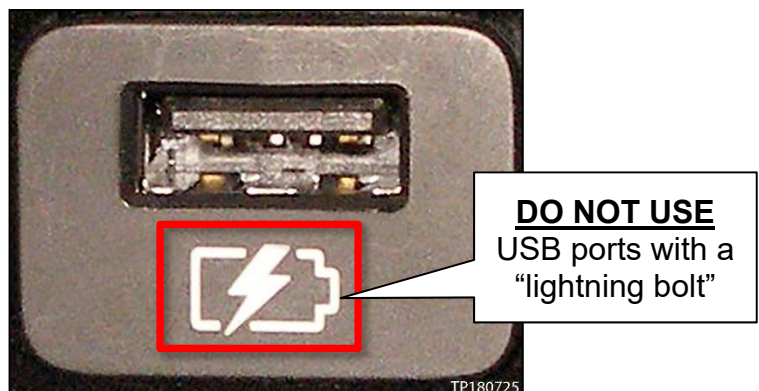
Figure 20

DO NOT insert the USB drive into a **charging port** (see Figure 20). Charging ports are marked in the vehicle with a "lightning bolt" symbol. If used, the software update and/or USB drive may become damaged. Only insert the USB drive in a USB media port.

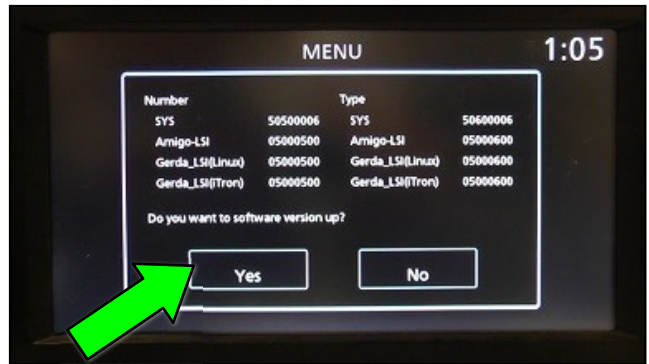
Figure 21

29. Select **Yes** to begin the reprogramming process.

- Reprogramming will take about 4-5 minutes.
- Wait until the audio unit reboots before moving to the next step.

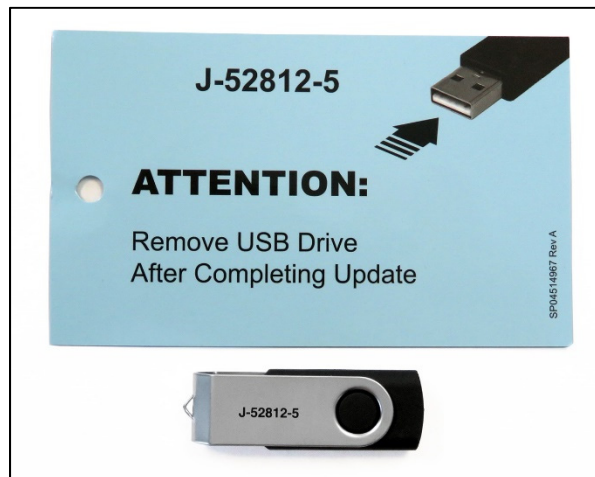
Figure 22

31. Insert special tool USB drive J-52812-5 into the USB media port.

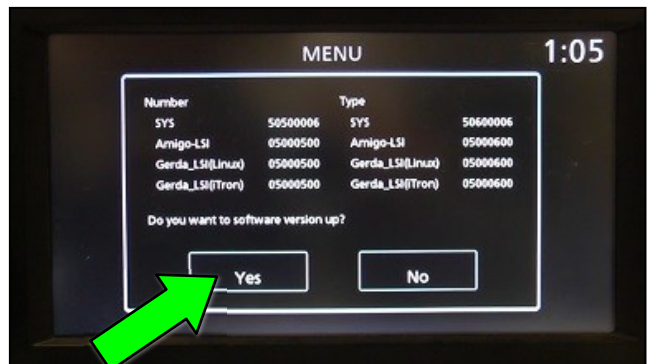
Figure 23

32. Select **Yes** to continue the reprogramming process.

- Reprogramming will take about 4-5 minutes.
- Wait until the audio unit reboots.

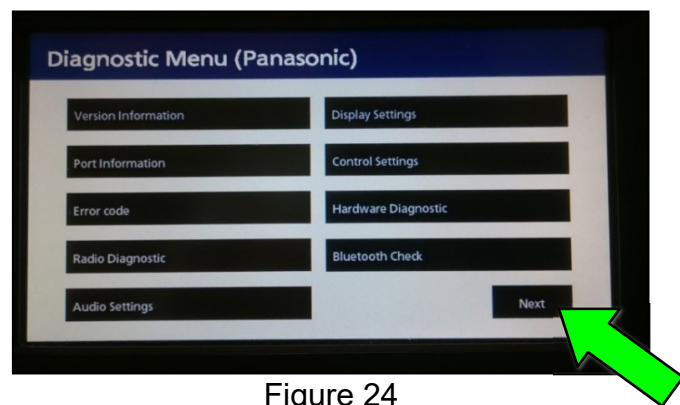
HINT: A screen similar to the one in Figure 24 will appear.

d. Select the **Next** at the bottom right side of the screen.

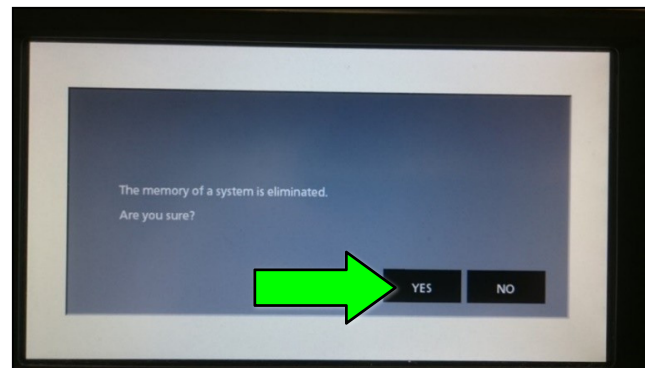
Figure 25

f. Select **YES** on the confirmation screen as shown in Figure 25.

NOTE: Initialization is complete after the audio unit reboots.
