RECALL CAMPAIGN BULLETIN

VOLUNTARY RECALL CAMPAIGN 2018-2019 FRONTIER; AV CONTROL UNIT (INFOTAINMENT) SOFTWARE UPDATE

CAMPAIGN ID #: R1911
NHTSA #: 19V654
APPLIED VEHICLES: 2018-2019 Frontier (D40)

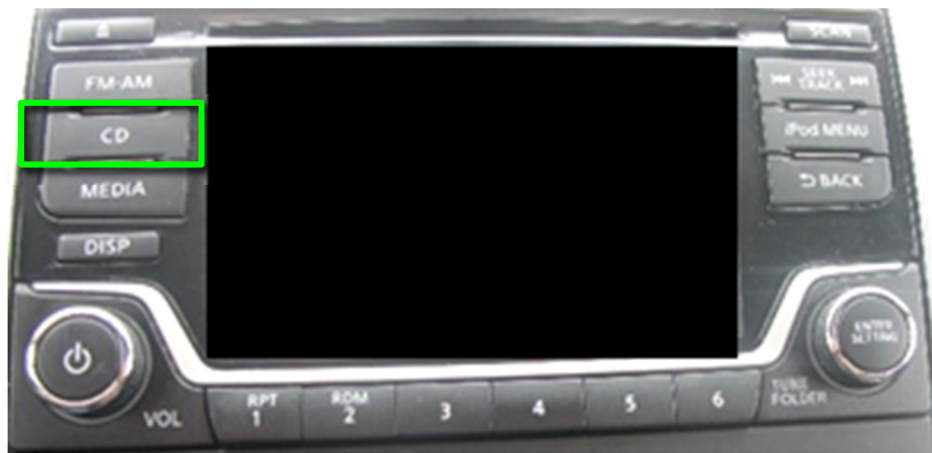
1. Determine if the audio system present in the vehicle is the type shown in Figure 1 or Figure 2.
 - If the audio system **is NOT** shown in Figure 1 or Figure 2, proceed to step 2 on page 4.
 - If the audio system **is** shown in Figure 1 or Figure 2, **this bulletin does not apply**. Software and repair procedures will be available in December 2019. **DO NOT** submit any claims on these vehicles.

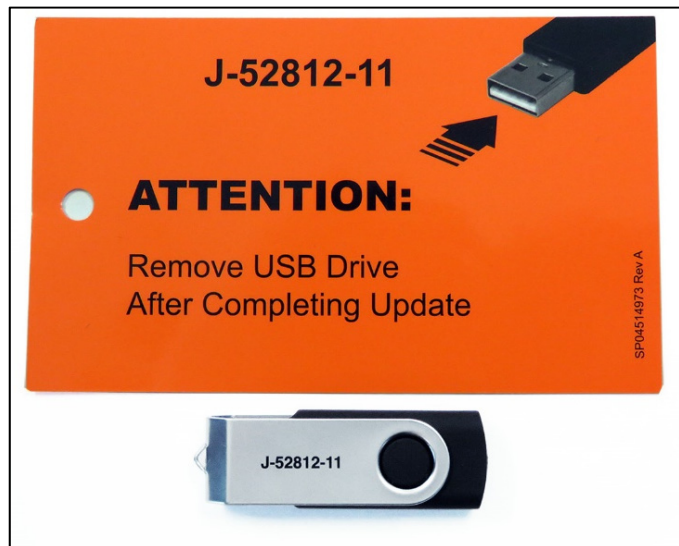
12. Insert special tool USB drive J-52812-11 into the vehicle's USB media port (see Figure 7 and Figure 8).

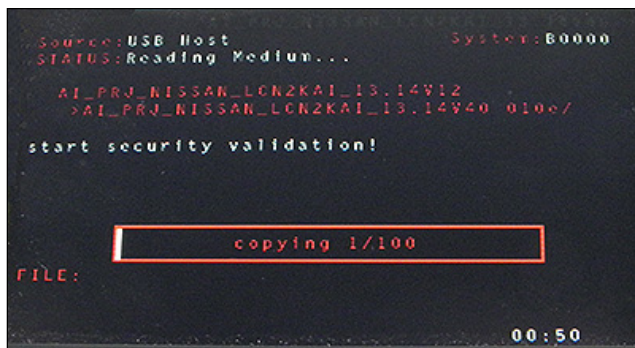
- The screen in Figure 12 will be displayed during the update.
- Figure 13 may display before the update begins. **DO NOT** remove the USB drive during the update.

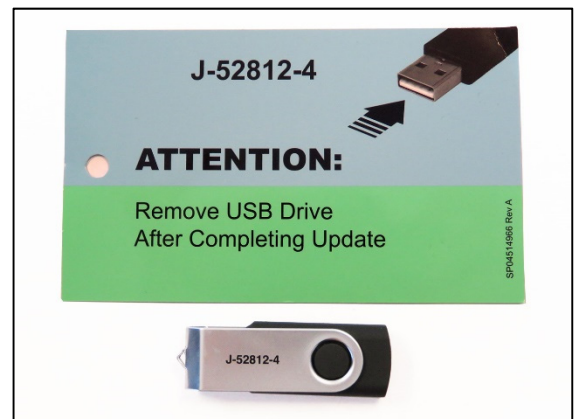
28. Turn the audio OFF.
29. Insert special tool USB drive J-52812-4 into the vehicle's USB media port (see Figure 20 and Figure 21).

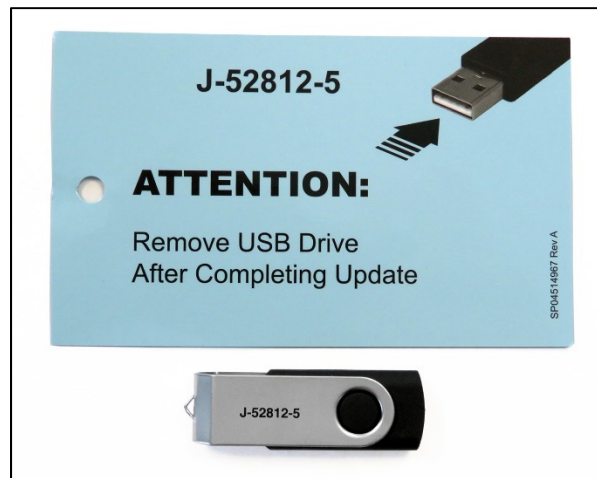
Figure 24

32. Insert special tool USB drive J-52812-5 into the USB media port.

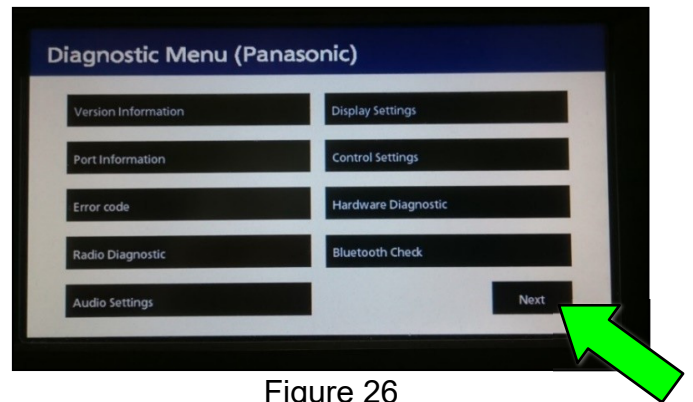
HINT: A screen similar to the one in Figure 26 will appear.
