# RECALL CAMPAIGN BULLETIN

Classification: EL19-032	Reference: NTB19-093	Date: October 29, 2019
-----------------------------	-------------------------	---------------------------

## VOLUNTARY RECALL CAMPAIGN 2018 - 2019 KICKS; AV CONTROL UNIT (INFOTAINMENT) SOFTWARE UPDATE

**CAMPAIGN ID #:** R1911  
**NHTSA #:** 19V654  
**APPLIED VEHICLES:** 2018 - 2019 Kicks (P15)

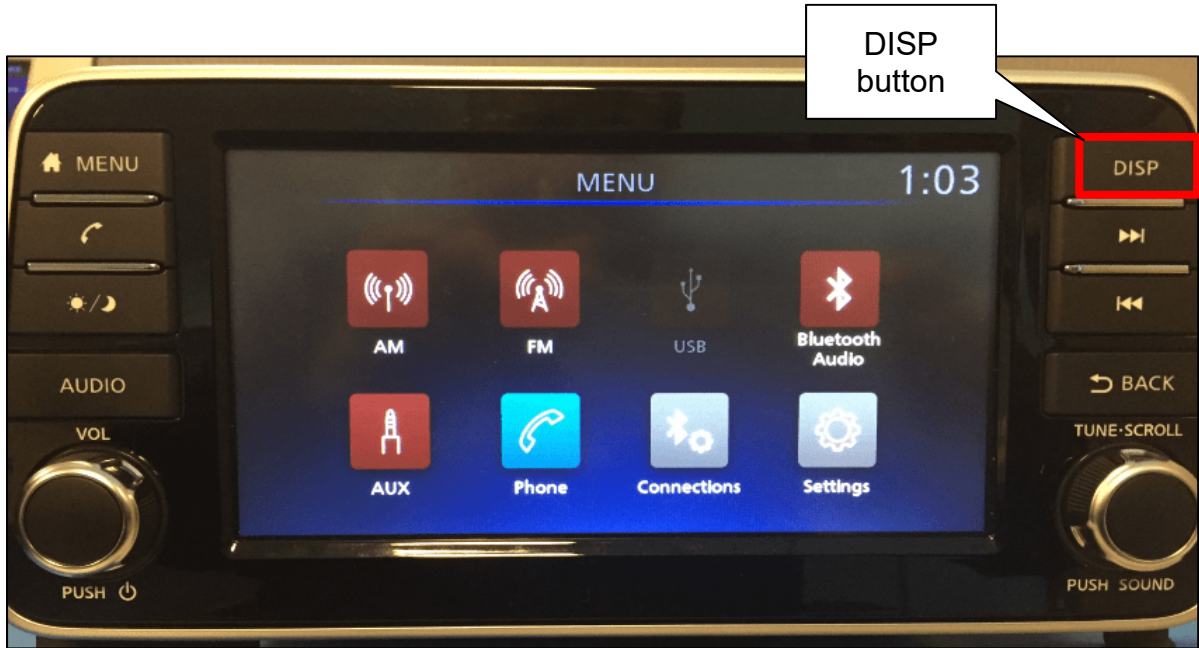
Figure 1

1. Determine which audio unit the vehicle is equipped with.
  - If there is a **DISP** button as shown in Figure 1, continue to step 2 on the next page.
  - If there is a **CAMERA** button as shown in Figure 2, skip to step 15 on page 7.

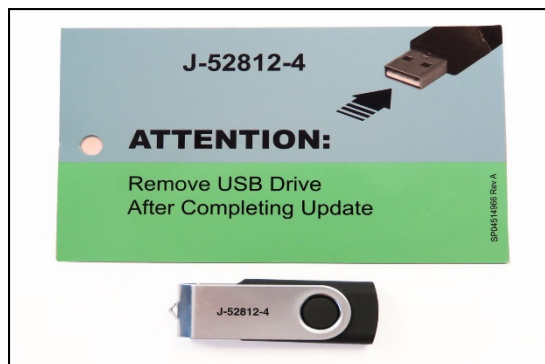
Figure 3

6. Turn OFF the audio.
7. Insert the special USB drive J-52812-4 into the USB media port.

**HINT:** Charging ports are marked in the vehicle with a “lightning bolt” symbol.

**NOTICE** Do not insert the USB drive into a charging port. If used, the update software and/or USB drive may become damaged. Only insert the USB drive in a USB media port.

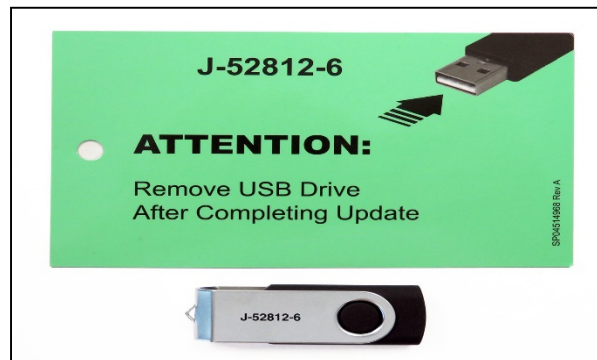
Figure 7

10. Insert the special USB drive J-52812-6 into the USB media port.

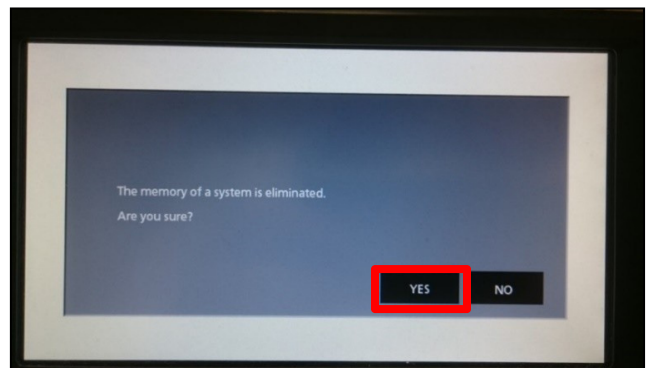
Figure 10

- d. Select the next button at the bottom right side of the screen.
- e. On the second page of the menu screen, press “**Factory Cold Start.**” (Screen not shown)
- f. Select **YES** on the confirmation screen as shown in Figure 10.

**NOTE:** Initialization is complete after the audio unit reboots.

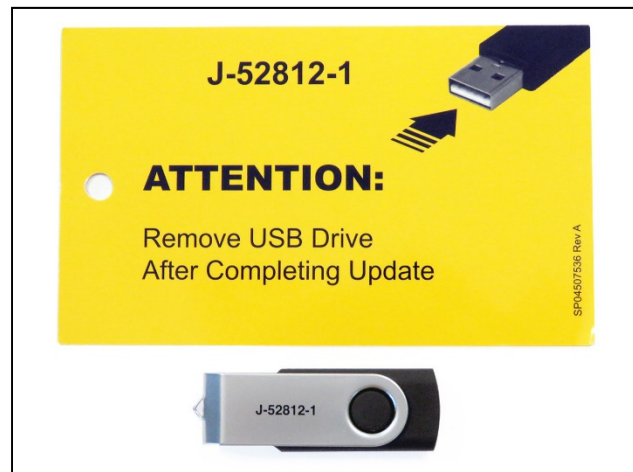
Figure 11

17. Insert the special USB drive J-52812-1 into the vehicle's USB media port.

**HINT:** Charging ports are marked in the vehicle with a “lightning bolt” symbol.

**NOTICE** Do not insert the USB drive into a charging port. If used, the update software and/or USB drive may become damaged. Only insert the USB drive in a USB media port.

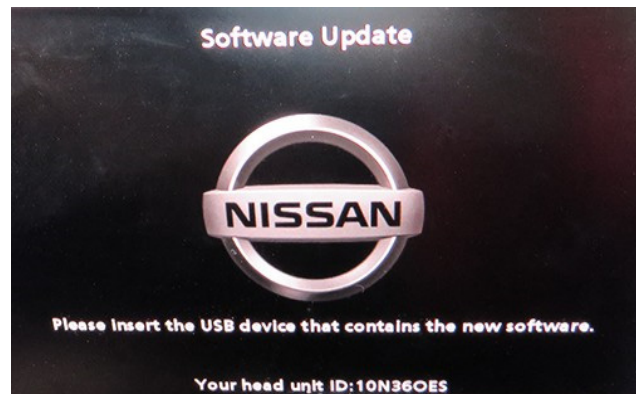
- The screen in Figure 15 may briefly appear. **Do not remove the USB.** The audio system will detect the USB and continue the update.

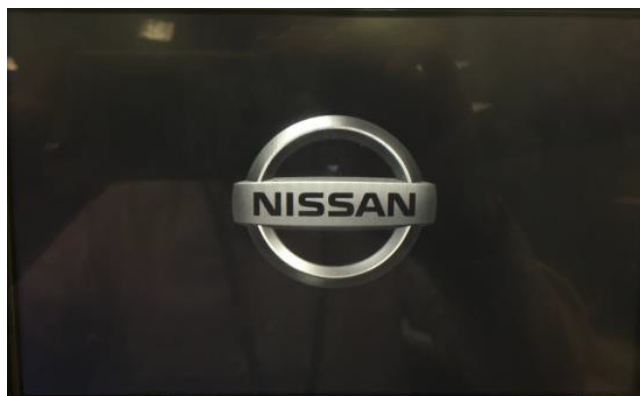
Figure 18

21. Allow the reboot to complete (approximately 30 seconds).
  - The Nissan logo will be displayed during the reboot.
