TECHNICAL INSTRUCTIONS

Safety (Noncompliance) Recall 19TA19 Certain 2020 Model Year Supra Vehicles Back Up Camera Display - Brightness and Contrast Settings

V. OVERVIEW OF REMEDY PROCEDURE (REPROGRAMMING USING ISTA)

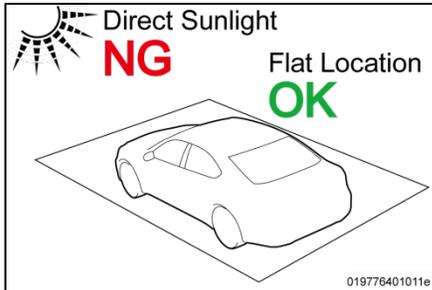
1. Vehicle must be parked on a flat location that is not subject to direct sunlight

The ambient temperature around the vehicle must be higher than 59 degrees Fahrenheit.

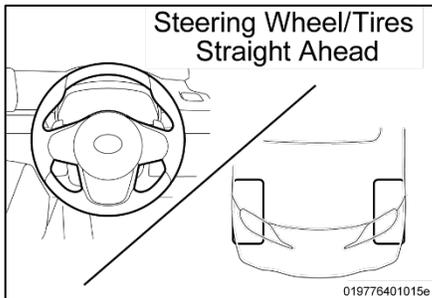
2. Set the steering wheel and tires in the strait ahead position.

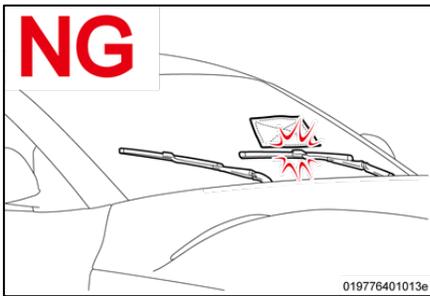
3. **DO NOT** place anything on the windshield so that the wiper can work normally, because the wiper may move automatically during reprogramming for initialization.

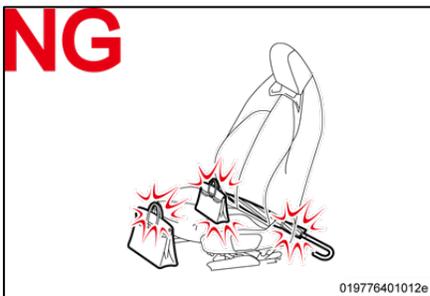
5. **DO NOT** place any on, in front of, or behind the front seats because the front seats move automatically during reprogramming for initialization.

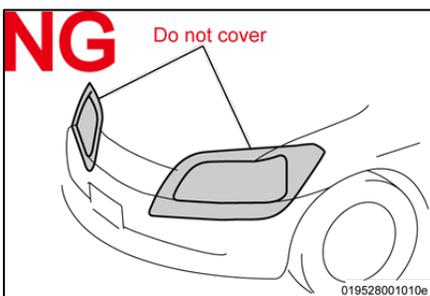
6. **DO NOT** cover the headlights with protective covers because temperature may rise and the headlights may be deformed or damaged.

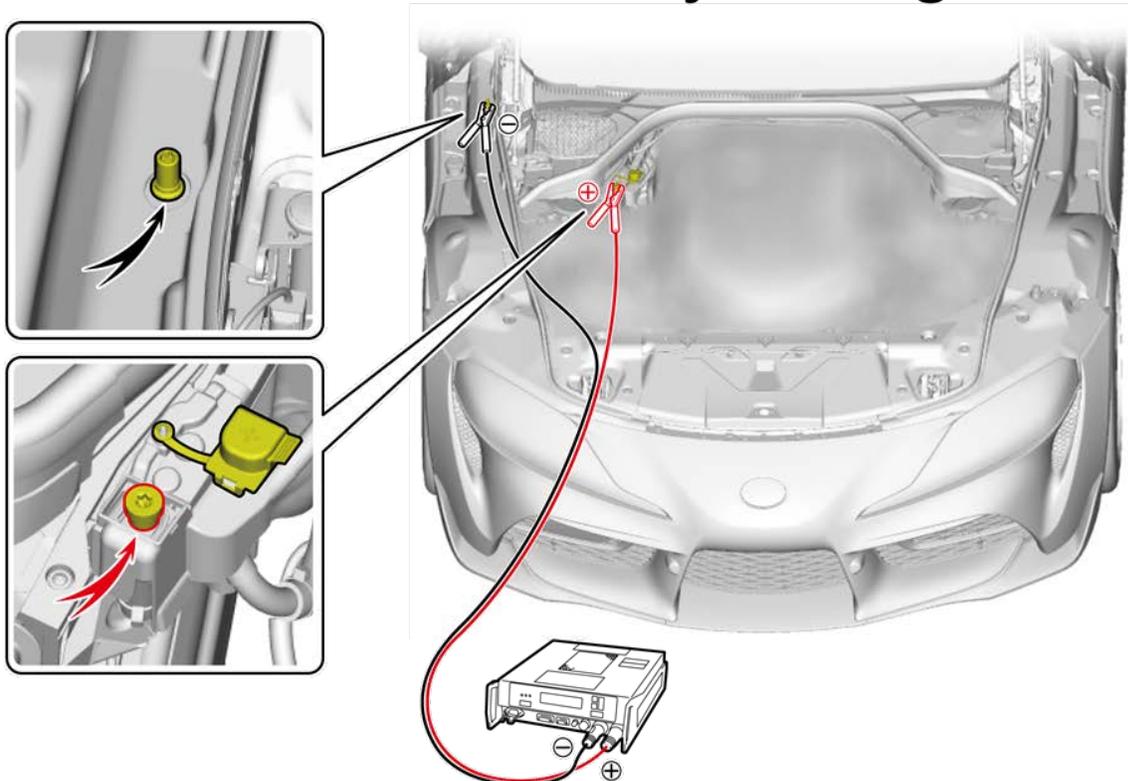
Connect Battery Charger

Before starting the reprogramming procedure, please make sure you have connected the DCA-8000 battery charger. The usage of a charger during the ECU Software update process is mandatory.

During this reprogramming the headlights will turn on, and the seats and other electrical components will function. To prevent damage to the ECU's, due to flat battery or voltage drop, ALWAYS connect the specified battery charger.

Unlike other Toyota vehicles, the new Toyota Supra is capable of drawing high amperage (a peak of 70 Amps flows at maximum) during diagnosis and repair. The Toyota Supra is equipped with an AGM type battery, discharges will affect the life span of the battery. AGM batteries must not have a charging voltage that exceeds 14.6 volts.

- Always connect the power supply of the battery charger to an outlet directly. If a power strip or other device is used, and multiple electrical components are connected, the battery charger may detect a power supply error due to insufficient current, and it may not be possible to charge the battery.
- Make sure that the battery charger is off before connecting it.
- Make sure you respect the correct polarity when connecting the battery charger cables like displayed in the illustration below.
- **DO NOT** disconnect the battery charger during reprogramming work.

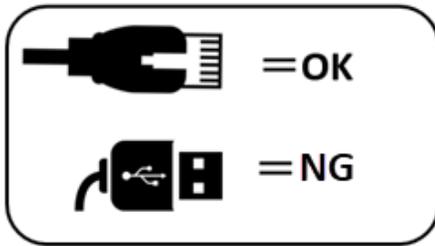
NOTICE: In the case of reprogramming, it is an absolute necessity that the vehicle is connected to the Techstream ADVi via the Toyota Supra Diagnostic Cable which has a LAN ethernet connection.

In order to maintain successful communication between the Techstream ADVi and the vehicle, the Toyota Supra Diagnostic cable must be used. Other interfaces that connect to the Techstream ADVi via USB are not allowed. Attempting to use such other devices may cause permanent ECU damage due to the slower communication speed.

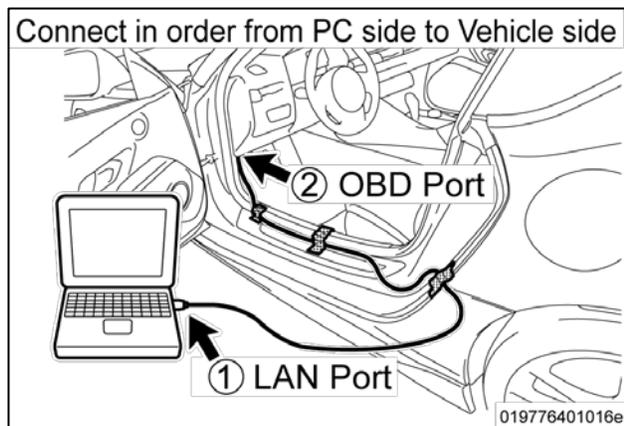
1. Connect the Cable (connection sequence):

Always connect the SUPRA diagnostic cable **first** to your **PC LAN port (1)** and only after that to the **OBD port of the vehicle (2)**.

If this order of operations is not respected, possible vehicle communication issues may occur when using Toyota ISTA software.

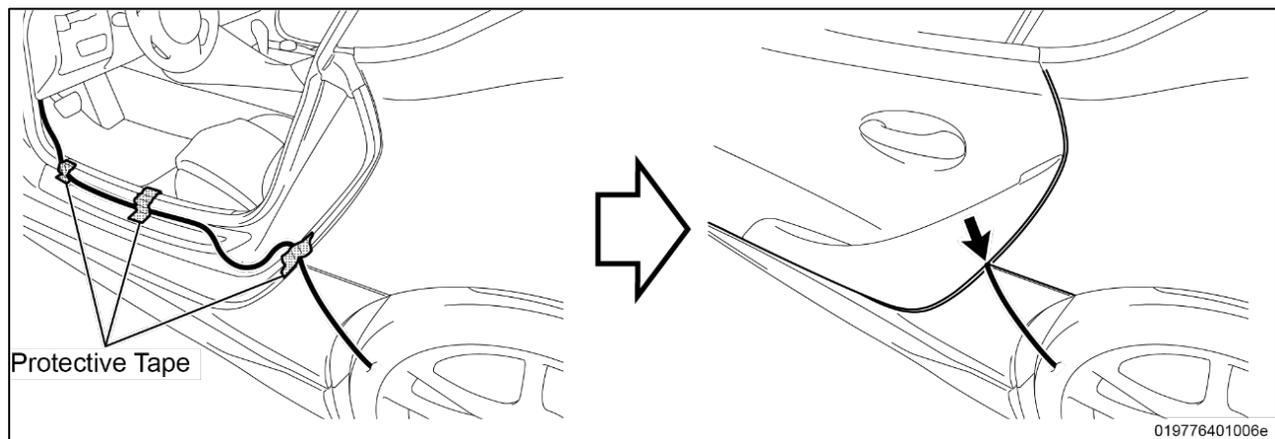
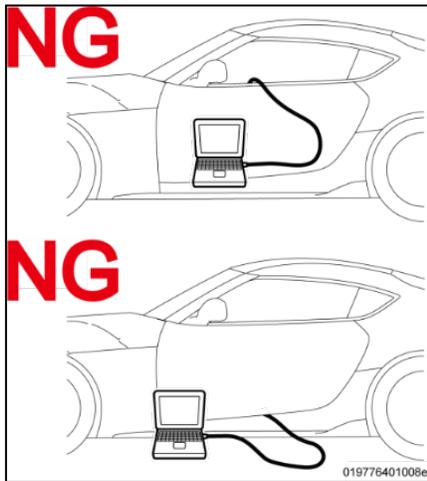
Position the SUPRA diagnostic cable out of the vehicle as shown in the illustration. Otherwise the **SUPRA diagnostic cable may be pinched, communication disconnected, and ECU's permanently damaged.**

The Toyota Supra Diagnostic cable should always be passed through the position shown in the figure below. If it passes through any other position it is possible that the cable will be damaged.

Using the gap between the rear fender and the side garnish, pull the Supra Diagnostic cable to the outside of the vehicle. Please use protective tape for fixation and protection of the cable.

Do not attempt to pass the Supra Diagnostic cable through the window opening. The window glass may move during reprogramming or initialization.

Ensure the cable is out of the path of the front Driver's seat. During initialization the driver's seat moves and could damage cable or disconnect the OBDII connector during movement.

Additionally, do not attempt to pass the Supra Diagnostic cable through any other position of the door opening as it may cause damage to the cable.

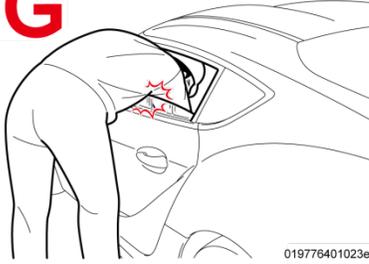
019776401023e

1. **DO NOT** put your head or hand in the window of the vehicle you are reprogramming. Since the window may close automatically at the time of initialization, there is the risk of being pinched and injured.

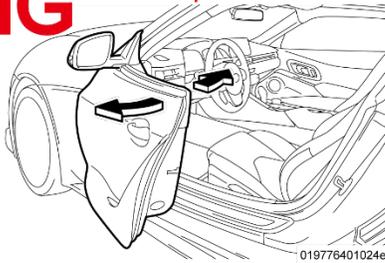
019776401024e

2. **DO NOT** open or close the driver's door and other door during the programming routine.

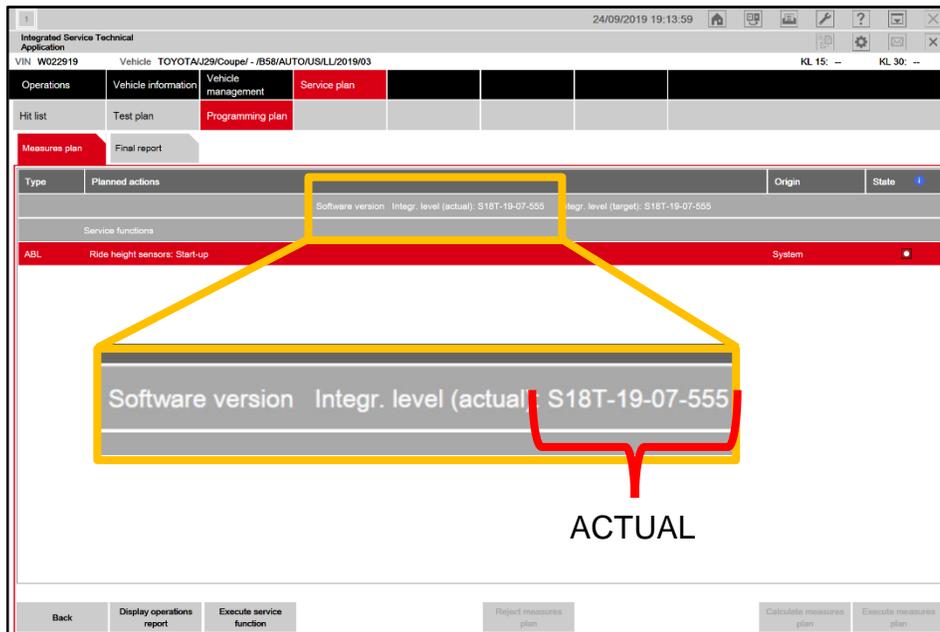
12. Confirm that the I-Level actual of the vehicle meets or exceeds S18T-19-07-538.

"I-Level" Actual of Vehicle	Required Action
Lower than S18T-19-07-538	REPROGRAMMING REQUIRED. Refer to page to page 5 to check that your version of ISTA is the minimum required version.
Equal to or Greater than S18T-19-07-538	WORK IS COMPLETE. Placing the vehicle in "Sleep mode" is required. Proceed with the procedure to place the vehicle in "Sleep mode".
