BR19-008c

VOLUNTARY SAFETY RECALL CAMPAIGN 2017-2019 QX60; ABS ACTUATOR

CAMPAIGN ID #: R1917 and R1921
APPLIED VEHICLES: 2017-2019 QX60 (L50)

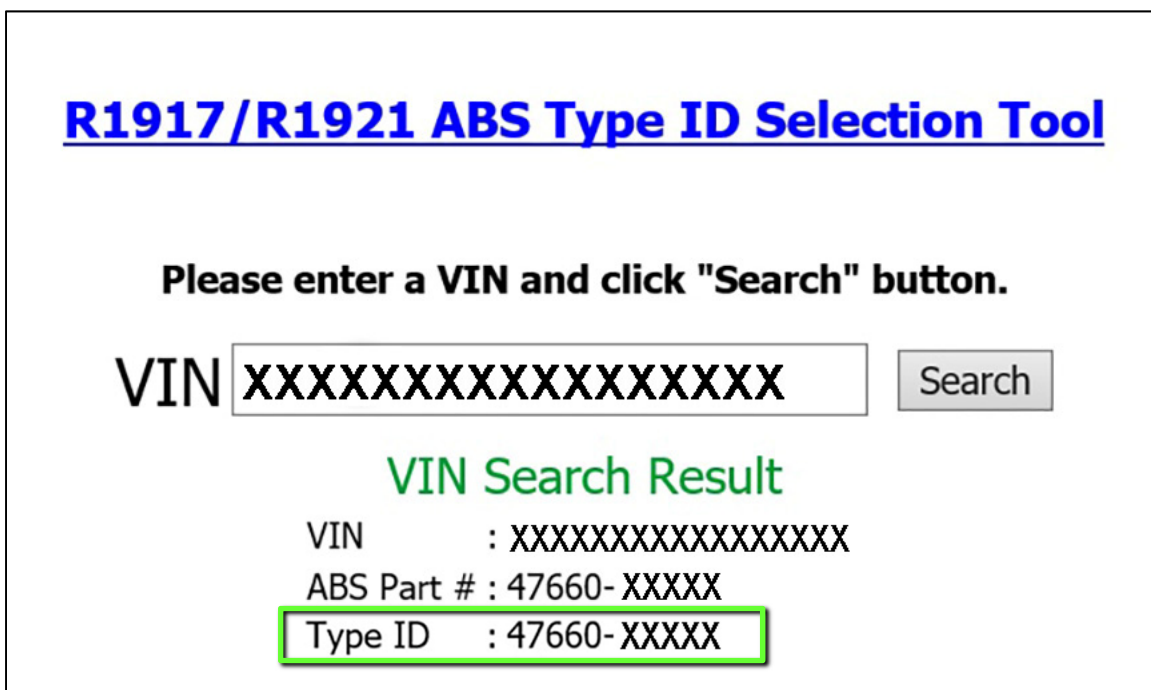
Figure 3

c. Enter the VIN of the vehicle, and then select Search.

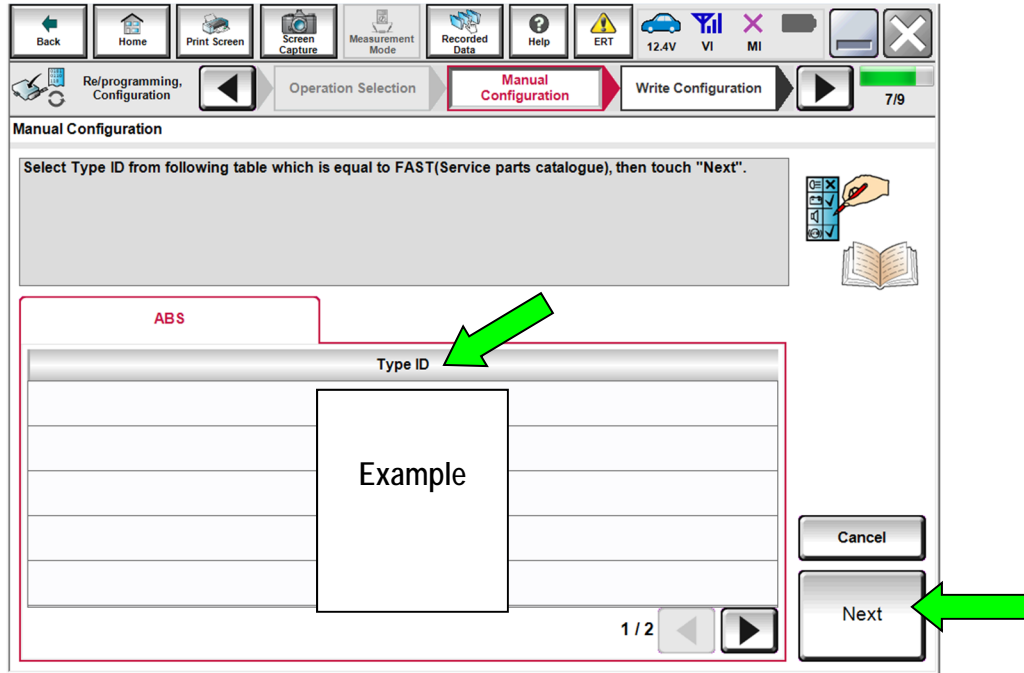
Figure 11

17. Select the Type ID (Figure 11) that was generated with the R1917/R1921 ABS Type ID Selection Tool in step 2.
 - If needed, use scroll arrows to find the correct number.

NOTE: When a vehicle has only one configuration available, a list will not be displayed. Select **Next** (step 18), and C-III plus will select the correct configuration.

18. Select **Next**.
