RECALL CAMPAIGN BULLETIN

VOLUNTARY SAFETY RECALL CAMPAIGN FLEET AND NEW INVENTORY 2016-2018 MAXIMA, 2015-2018 MURANO AND 2017-2019 PATHFINDER; ABS ACTUATOR

CAMPAIGN ID #: R1920
APPLIED VEHICLES: 2016-2018 Maxima (A36)
2015-2018 Murano (Z52)
2017-2019 Pathfinder (R52)

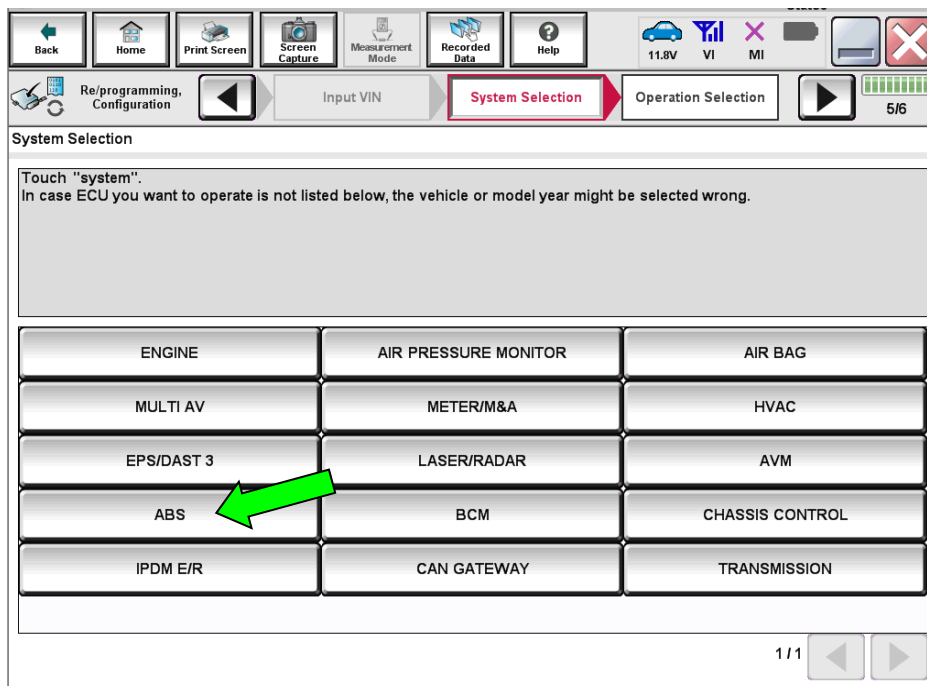
Figure 6

14. Select **ABS**.

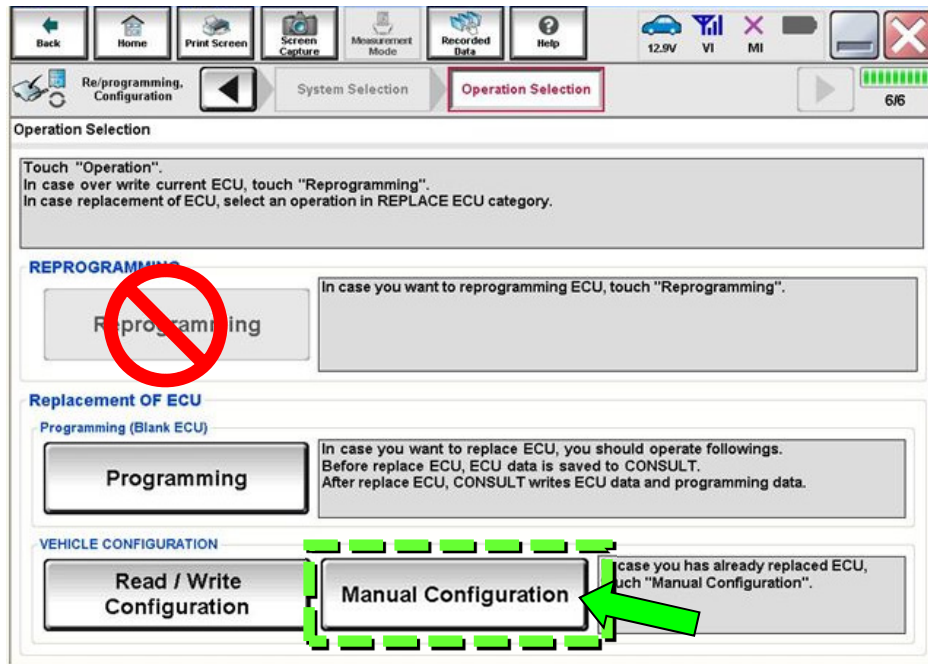
Figure 7

15. Select **Manual Configuration**.
 - **DO NOT** select Reprogramming.

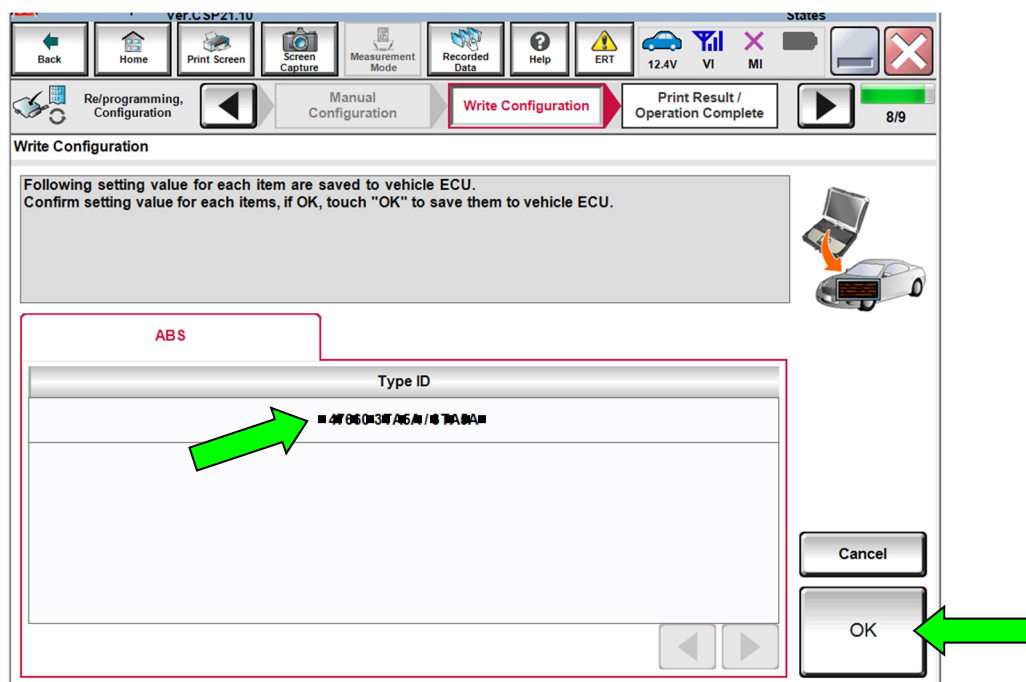
Figure 9

18. Confirm the correct Type ID number is selected.

19. Select **OK**.
