**AKC1 - Re-programming Operator Control Unit in Front Center Console and Updating Software for Various Control Units (Stop Delivery/Recall Campaign)**

Model Year: **2020**

Vehicle type: **911 (992)**

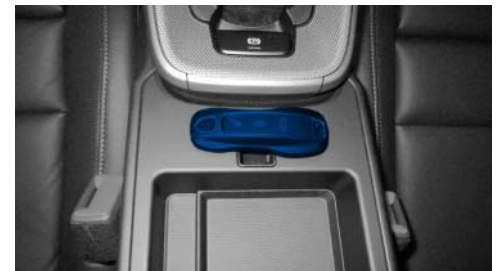
*Emergency start tray*

2 Place the **driver's key** with the back facing down in the area in front of the storage compartment under the armrest (**emergency start tray**) in order to guarantee a permanent radio link between the vehicle and driver's key ⇒ *Emergency start tray*.

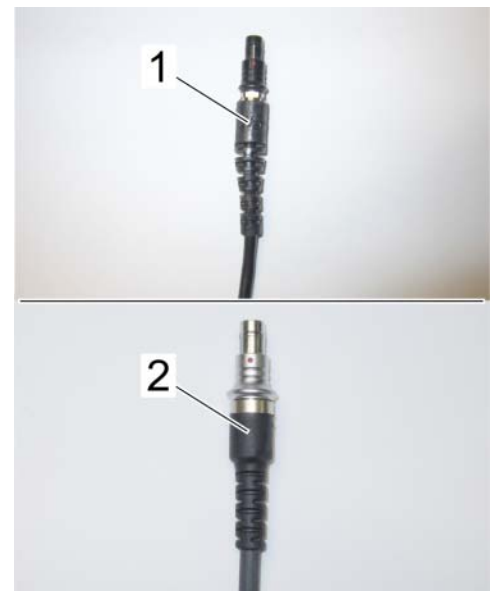
*PIWIS Tester data cable*

Use the **new** PIWIS Tester data cable for carrying out the campaign. The difference between the old ⇒ *PIWIS Tester data cable -1-* and new ⇒ *PIWIS Tester data cable -2-* data cable is shown in the illustration.

If the connection between the vehicle and PIWIS Tester is interrupted, check the data cable for the PIWIS Tester for signs of damage. If the data cable is damaged, it **must be replaced**. To do this, follow the instructions in the PPN for "Returning faulty USB cable caps" (PPN portal > Dr Ing. h.c. F. Porsche AG > Aftersales > Workshop > PIWIS > Documents).
