**2. VEHICLE INSPECTION PROCEDURE**

2019-2020 Mazda3 vehicles, equipped with smart brake support (SBS)

**REPAIR PROCEDURE  
Recall Campaign 4219L**

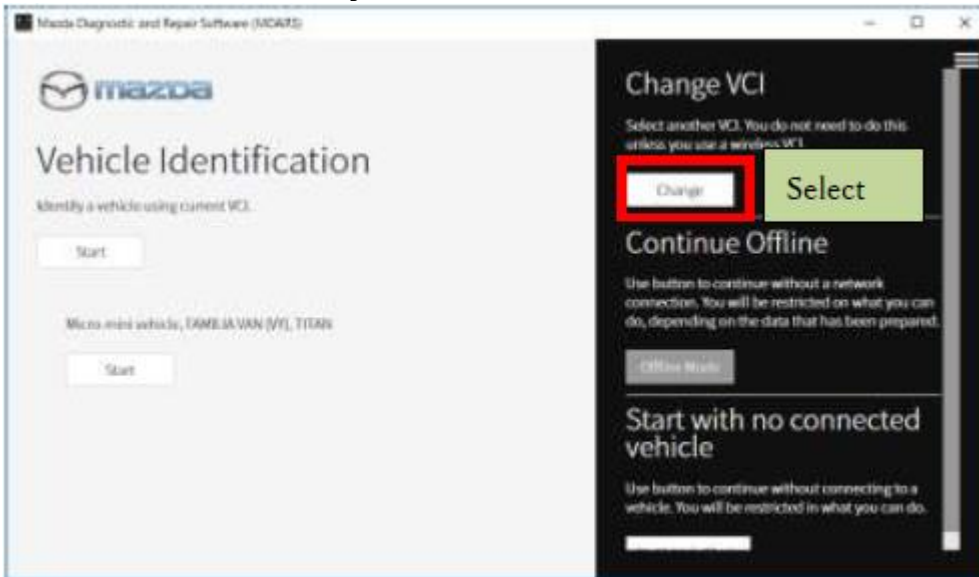
1. Confirm VCI Settings before vehicle identification. Select 'Change VCI'

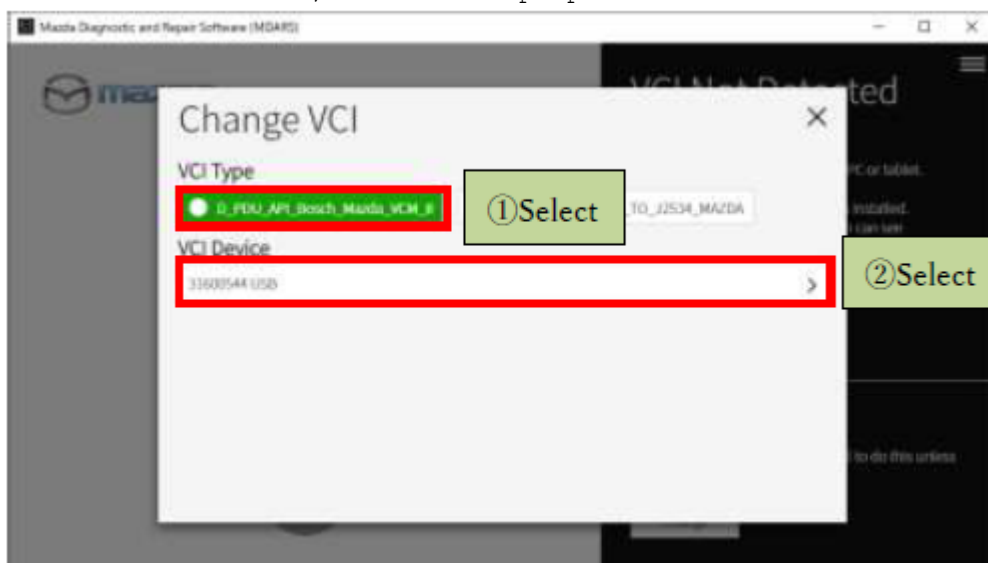
3. Ensure "D\_PDU\_API\_Bosch\_Mazda\_VCM\_II" is selected (highlighted green)

4. Under VCI Device, ensure the proper VCM serial number is shown

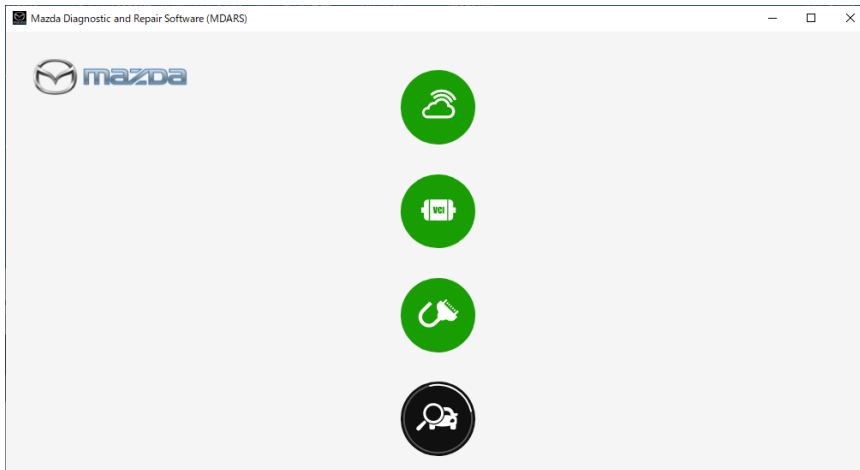
5. Vehicle identification begins automatically.

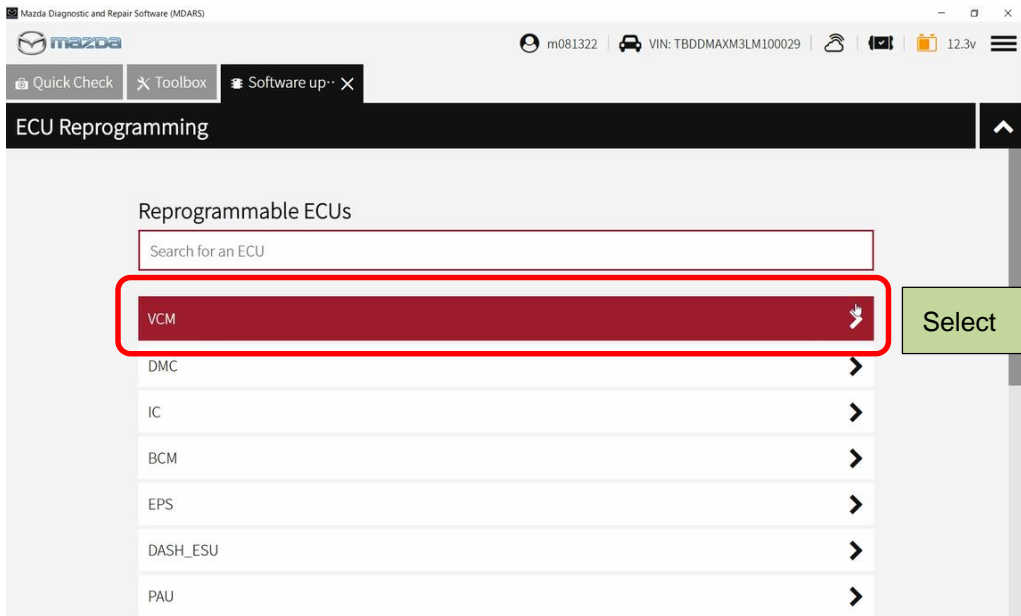
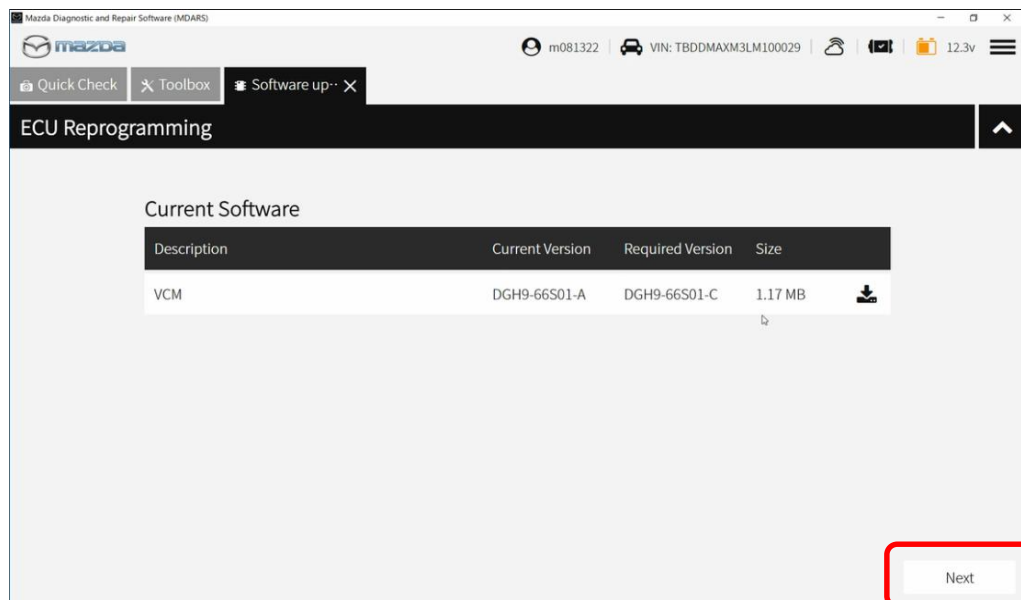
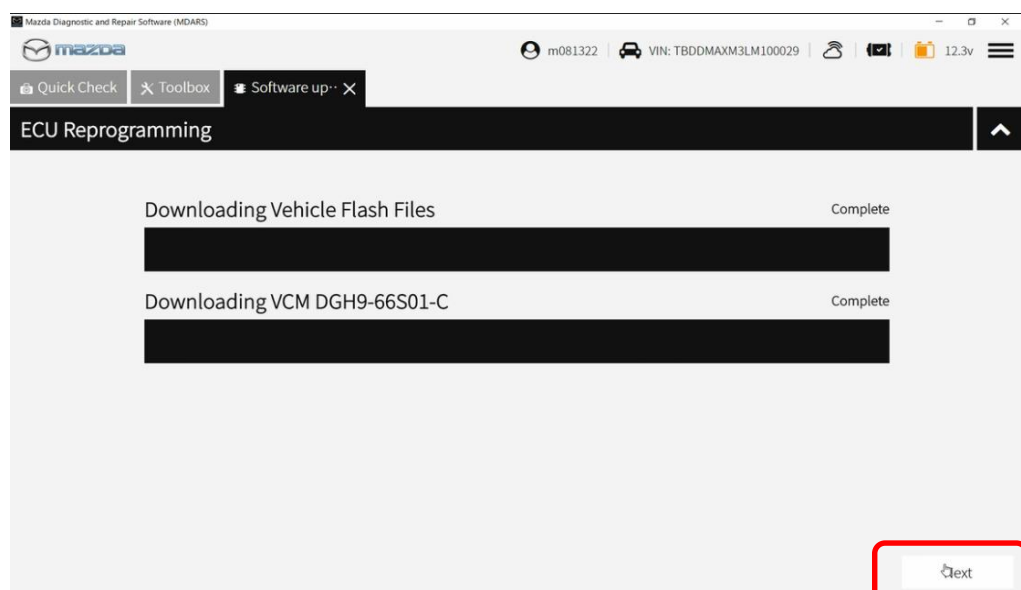
### Software Update

Ensure the following action has been taken.

- Connect the battery charger to vehicle battery.
- Connect the power supply cable to PC.
- Make sure all electrical loads are off.
- Make sure the connections between the diagnostic tester and the vehicle are secure.
- Do not touch and move the cables connecting the diagnostic tester and the vehicle during reprogramming.

### Turn the ignition switch to the OFF position.

✓ Ignition Condition : OFF Current value : OFF

### Turn the ignition switch to the ON position. (The engine should not start.)

✓ Ignition Condition : ON Current value : ON  
✓ Engine RPM Condition : 0 rpm Current value : 0.0 rpm

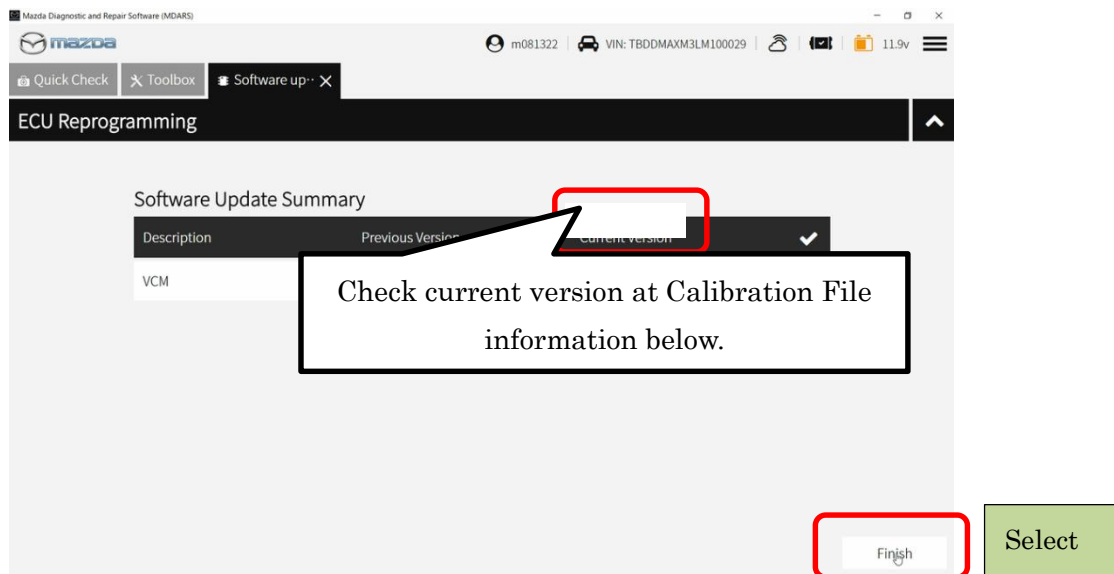
After VCM reprogramming, verify the calibration file name with the chart below in the screen of the (VCM) FILENAME.

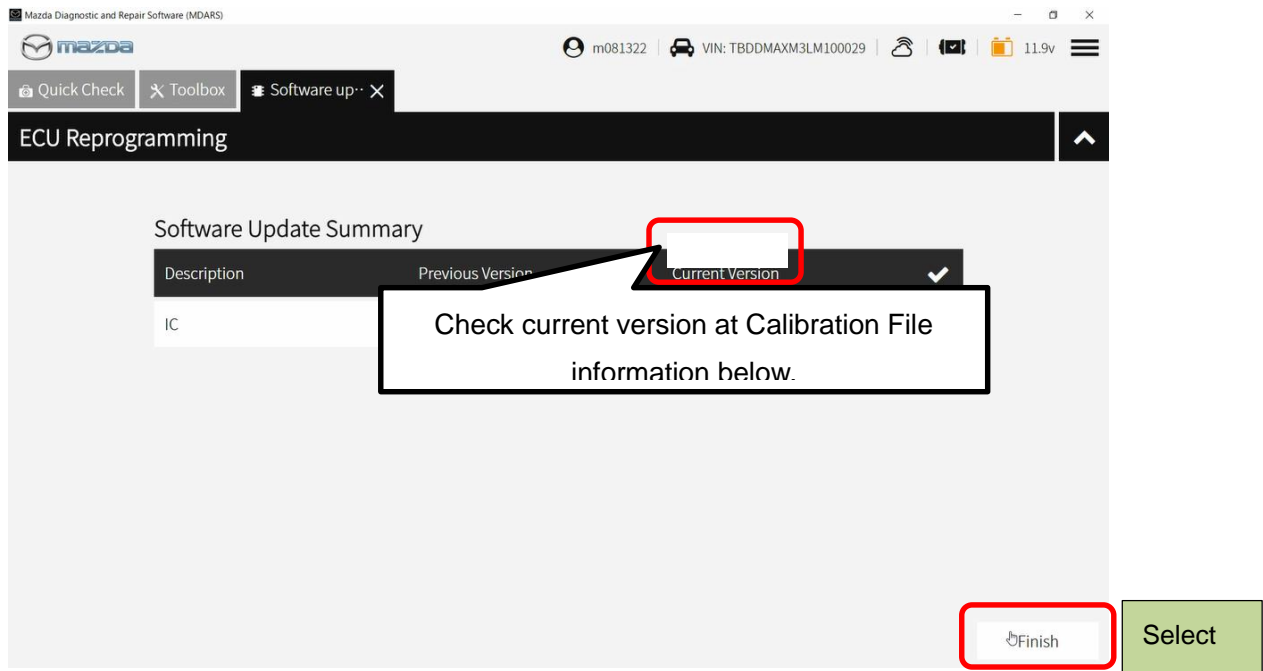
After IC reprogramming, verify the calibration file name at current version with the chart below in the screen of the (IC) FILENAME.
