Subject: **3 New Takata Recalls (Effective Today, January 16, 2020)**

BMW AG is conducting 3 Voluntary Safety Recalls (effective today, January 16, 2020).

SIB 65 04 20

RE: Recall 20V-017: Replace Driver's Front Air Bag Module – B65 04 20

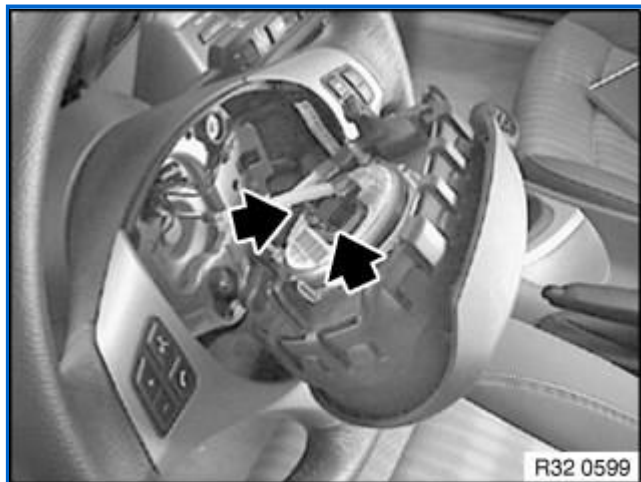
Airbag unit may only be set down with the airbag itself facing upwards.

Tilt airbag unit forwards.

Disconnect plug connections and remove
airbag

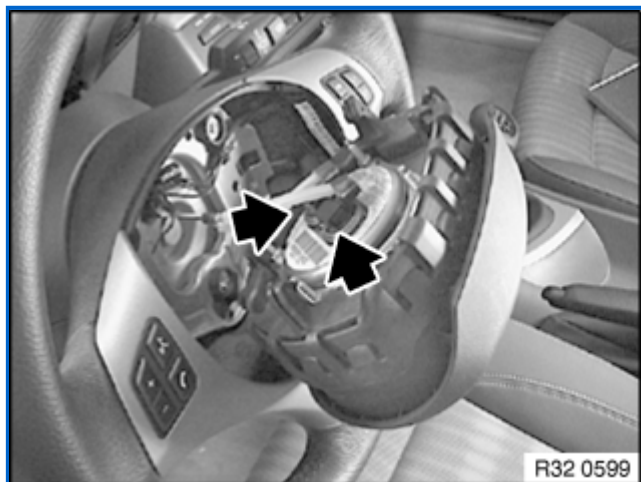
Airbag unit may only be set down with the airbag itself facing upwards.

Tilt airbag unit forwards.

Disconnect plug connections and remove airbag unit.

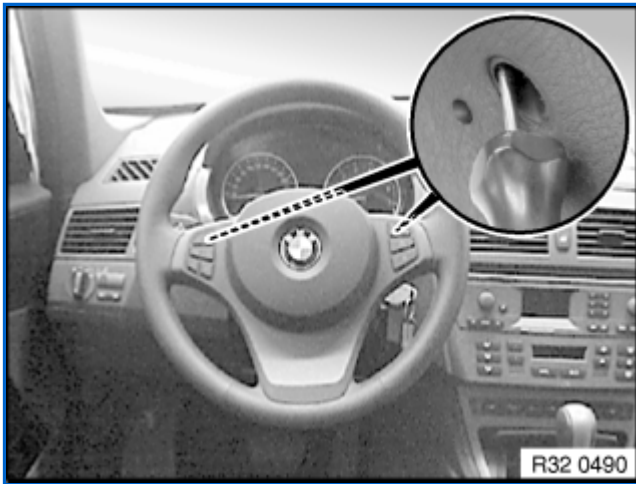
Insert Torx screwdriver (T30) horizontally into opening on reverse side of steering wheel up to stop (approx. 4.5 cm).

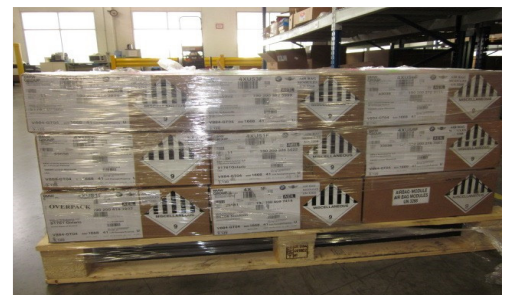
Place the recall airbag components neatly on a pallet, and securely shrink-wrap them to the pallet.

Note: The total height of the pallet and boxes cannot exceed 60 inches.

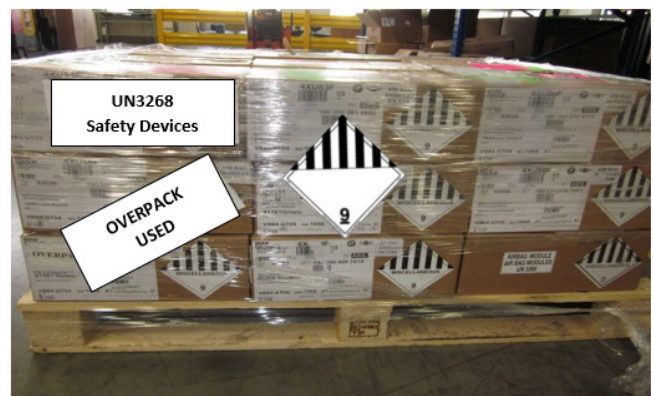
Securely attach the following labels on each side of the shrink-wrapped pallet.

- o Class 9 Label
- o UN3268 Safety Device *
- o OVERPACK USED *
