TECHNICAL INSTRUCTIONS

SAFETY RECALL 20TA10

HYBRID SYSTEM SOFTWARE UPDATE

CERTAIN 2014 - 2017 PRIUS V

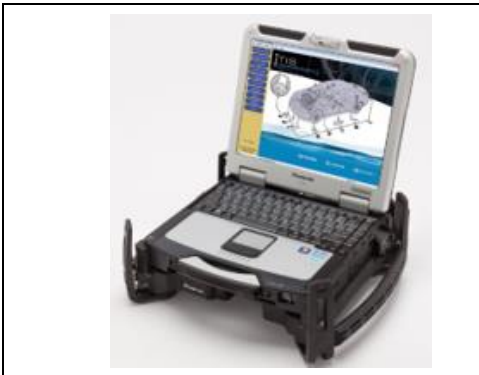
1. Verify Techstream Configuration

- From the menu at the top of the screen, select: Setup / Techstream Configuration.
- Continue to the third setup screen: Required Information.
- Verify that "US Dealer 1" is selected as the User Type.

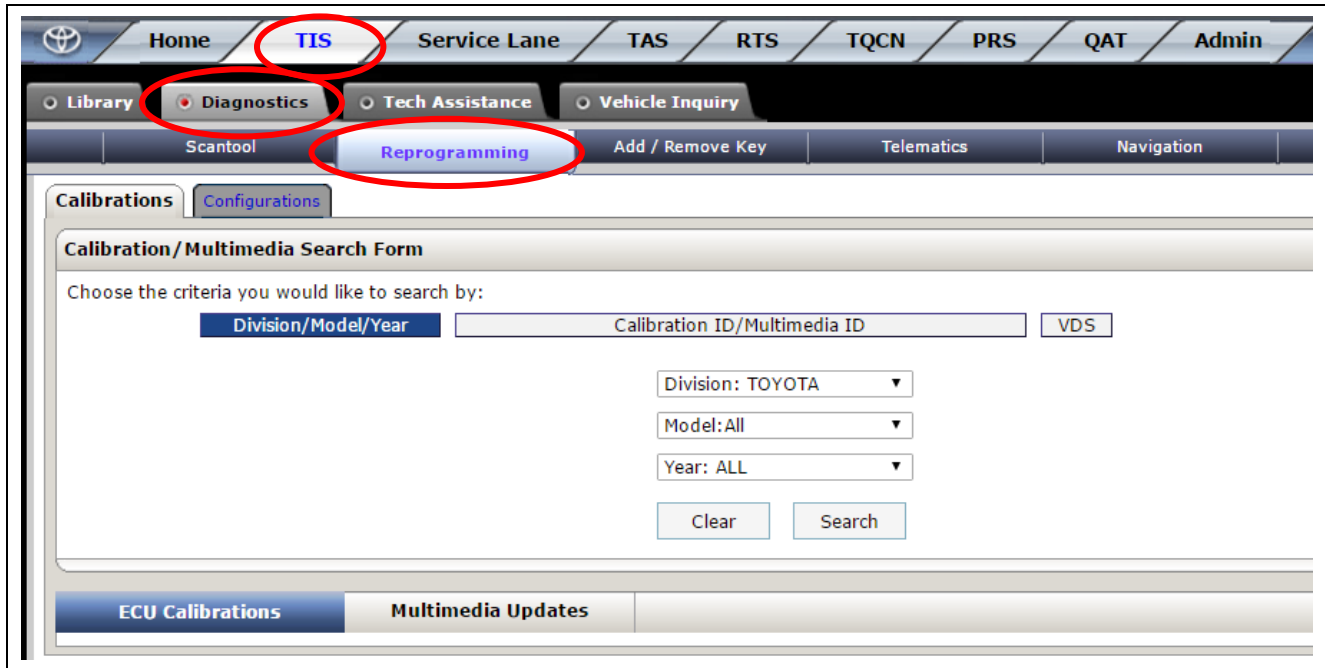
a. In TIS, select the following:

- TIS / Diagnostics / Reprogramming

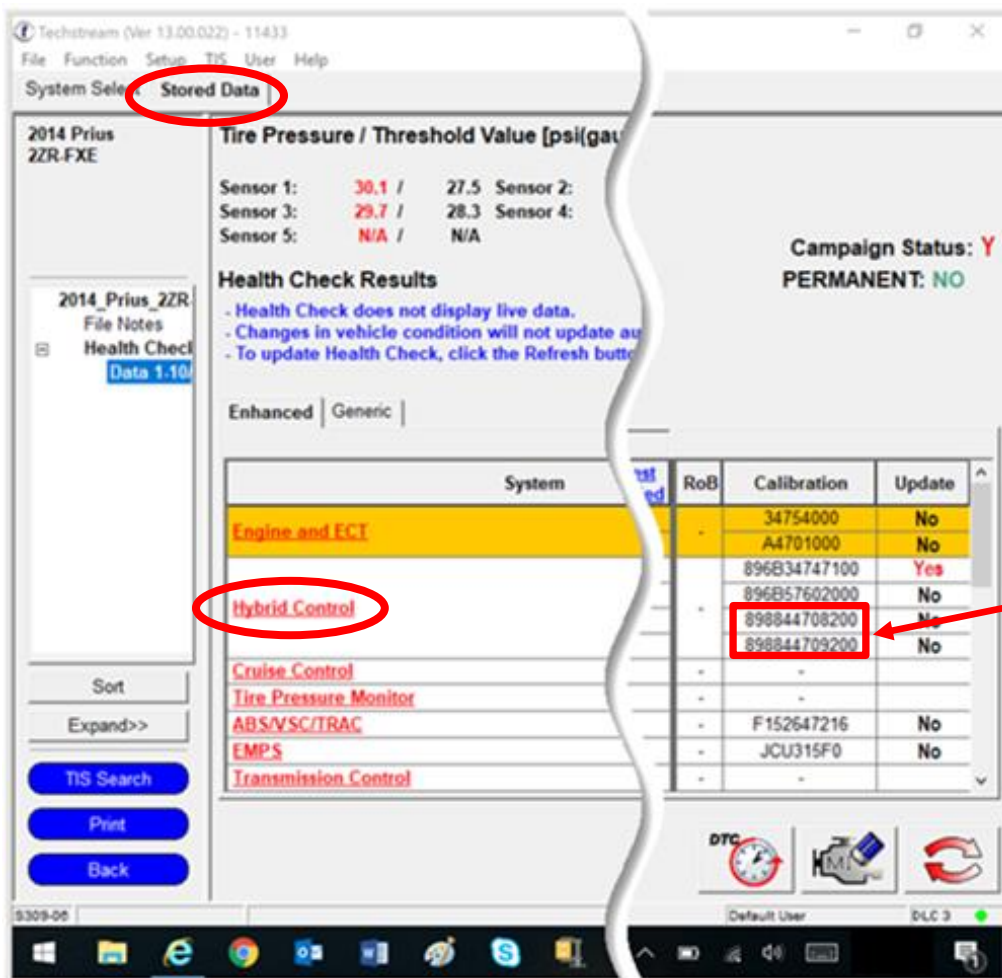
- Identify the Hybrid Control CID's #3 & #4 from the Stored Data tab.
- Referencing the chart on the next page, identify the matching CID #3 & #4.
- Select the Group # link (blue text) to begin the update process.
- Follow the instruction on the screen to complete the installation.
- When CID installation is completed, skip to Section XII. COMPLETE REPAIR on p. 15.

2014 MY ONLY

Diagram shown if from a Prius. Prius V will be similar.

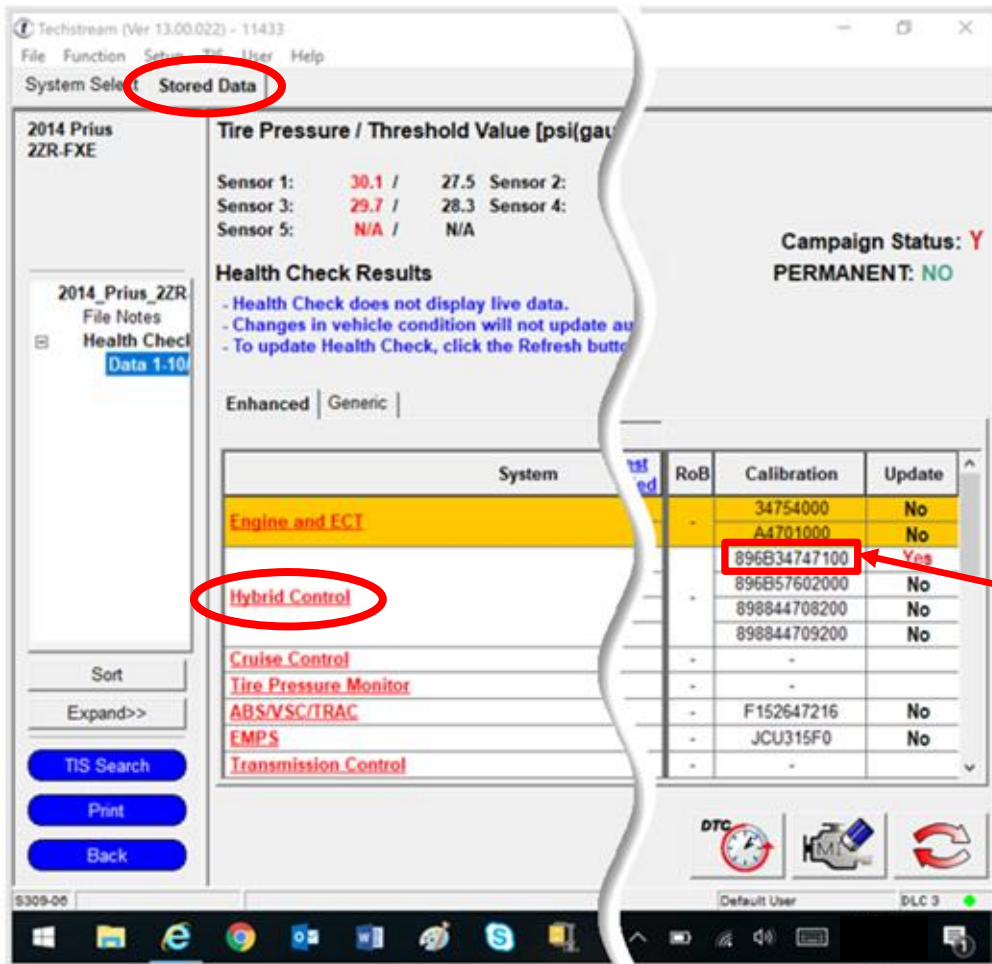
- a. Identify the Hybrid Control CID #1 from the Stored Data tab.
- b. Referencing the correct chart below, identify the chart that has the matching CID #1.
- c. Select the link (blue text) on that row to begin the update process.
- d. Follow the instruction on the screen to complete the installation.

**2015 – 2017
MY ONLY**

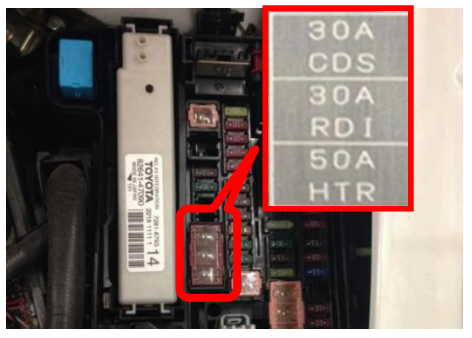
1. REINSTALL JOINT FUSE INTO ENGINE ROOM FUSE BOX
 - a. Confirm the joint fuse orientation before reinstalling because the joint fuse can be installed in either direction.
 - b. Reinstall the joint fuse that encases the CDS (30A), RDI (30A) and HTR (50A).

BE SURE TO ORIENT THE FUSE AS SHOWN ON THE FUSE BLOCK COVER.

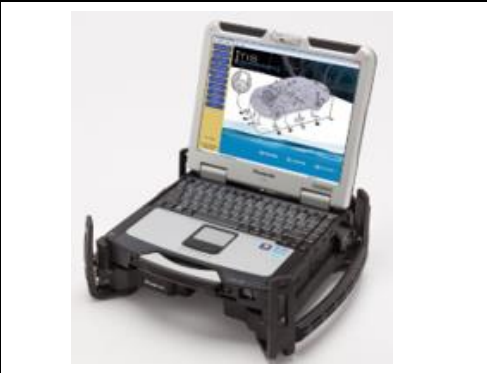
2. PERFORM VERIFICATION HEALTH CHECK
 - a. Using a Techstream, perform a Health Check.
 - c. Clear DTCs that may have set during the re-flash procedure.
 - d. Re-run the Health Check to confirm that no DTCs reappear.

The screenshot shows the Techstream interface for a 2014 Prius. The 'Stored Data' tab is active. Under 'Health Check Results', it states: '- Health Check does not display live data.', '- Changes in vehicle condition will not update au...', and '- To update Health Check, click the Refresh butto...'. Below this is a table with columns: System, RoB, Calibration, and Update. The 'Hybrid Control' system is highlighted, and its CID #1 (896B34747100) is circled in red. The 'Update' column for this CID is also circled in red and labeled 'CID #1' and 'MUST say "NO"'. Other systems listed include Engine and ECT, Cruise Control, Tire Pressure Monitor, ABS/VSC/TRAC, EMPS, and Transmission Control.

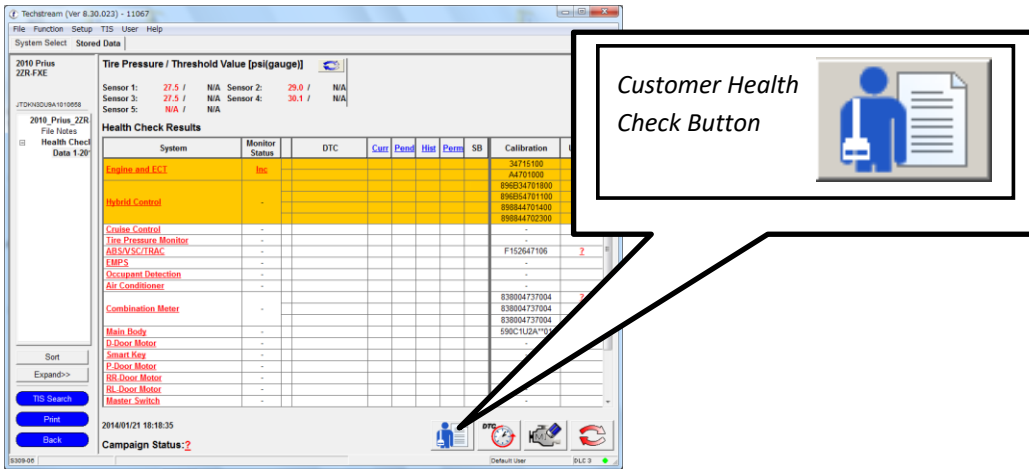
- a. From the Stored Data tab, select the Customer Health Check Report button (TIS will launch when button is pressed).

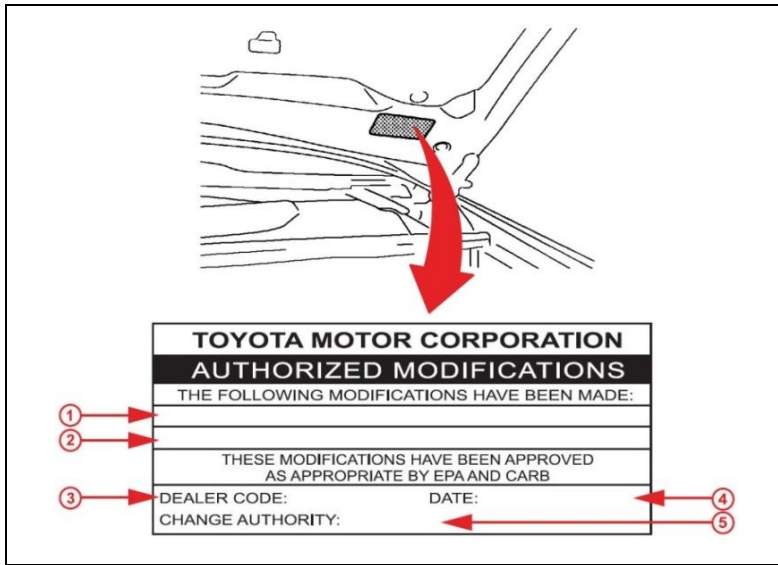
- a. Fill out the label.
- b. Affix the label to the under-side of the hood.

1	Hybrid Control System
2	(Calibration IDs)
3	(Dealer Code)
4	(Date Completed)
5	Safety Recall 20TA10

Calibration IDs listed for the Hybrid Control System after completing the final Health Check. The CIDs will vary from car to car.
