SAFETY RECALL

HINO L6 - ABS SOFTWARE REPROGRAMMING

CAMPAIGN NO: AAJS0

SUBJECT VEHICLES: Certain 2021MY Hino L6 trucks equipped with a J08 engine

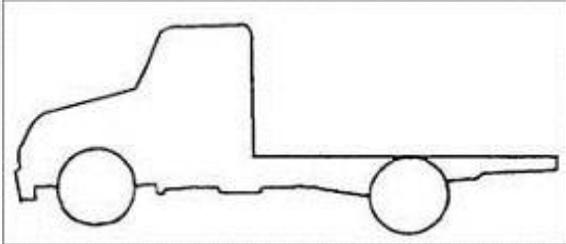
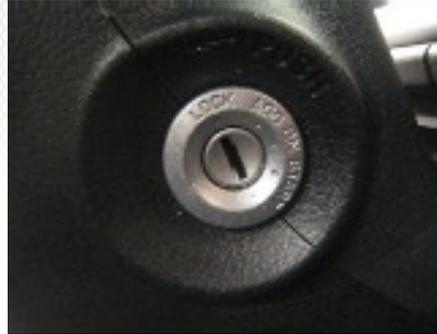
1. Park the vehicle on a flat, level and solid surface. Confirm the engine is stopped, the ignition switch is in the off (LOCK) position, and the key is removed.

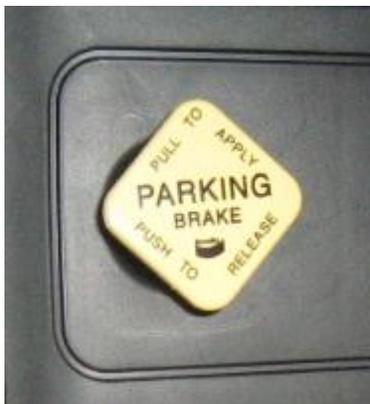
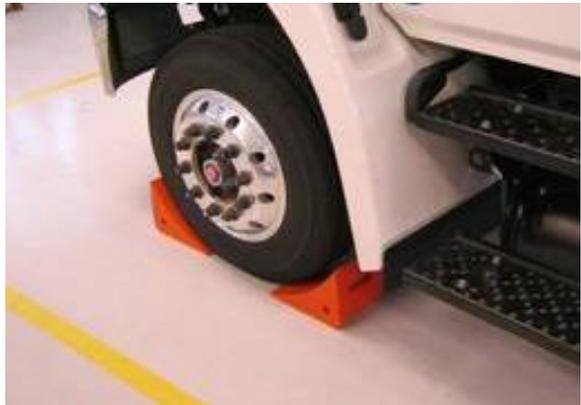
2. Apply the parking brake. Chock all of the wheels.

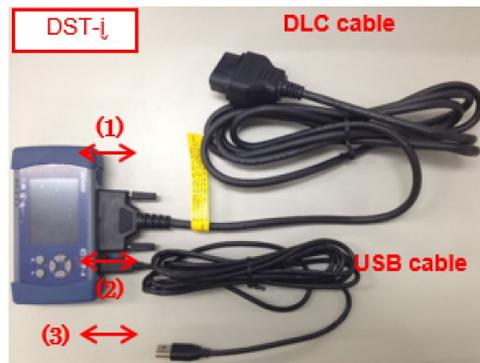
1. Prepare a DXII compatible interface, such as the Denso DST-i or the Nexiq USB Link 2 to perform this reprogramming procedure.

To assemble the interface cable, perform the following steps.

- (1) Connect the DLC (Diagnostic Link Connector) cable to the interface.
- (2) Connect the USB Cable to the interface.
- (3) Connect the USB connector to the USB port on your computer.

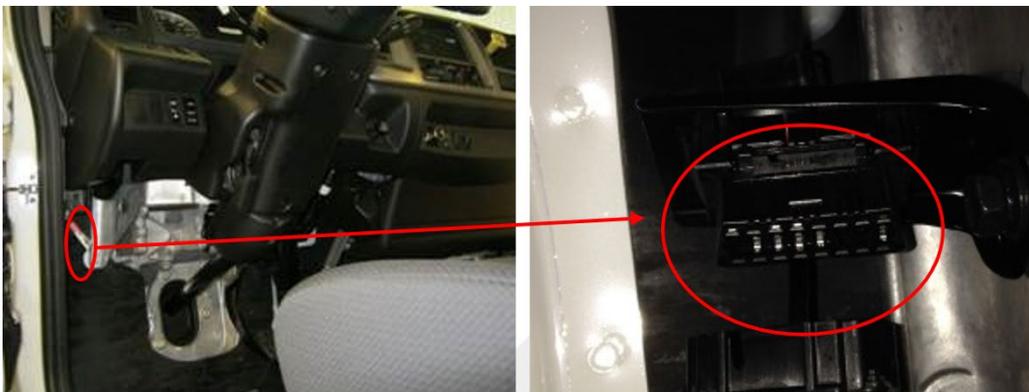
2. Connect the DLC cable to the vehicle's DLC connector. The DLC connector is found under the dash on the left side of the steering column.

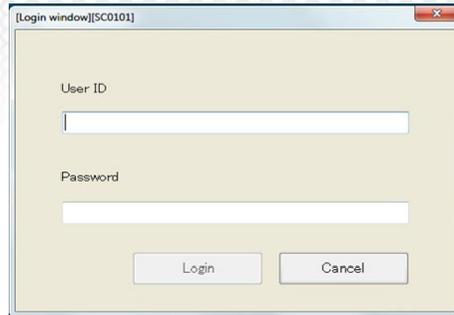
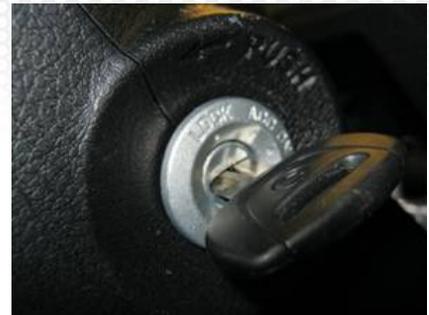
3. On your computer, locate the “Hino DX2” icon and open it. Clicking on Hino DX2 will open a login menu window which will prompt you for a “User ID” and “Password”. Enter your User ID, and password and then select the “Login” icon. Verify that the DX2 has software version 1.1.20.7 or later. Update the DX2 software if required. Insert the ignition key into the starter switch and turn the key to the “ON” position.

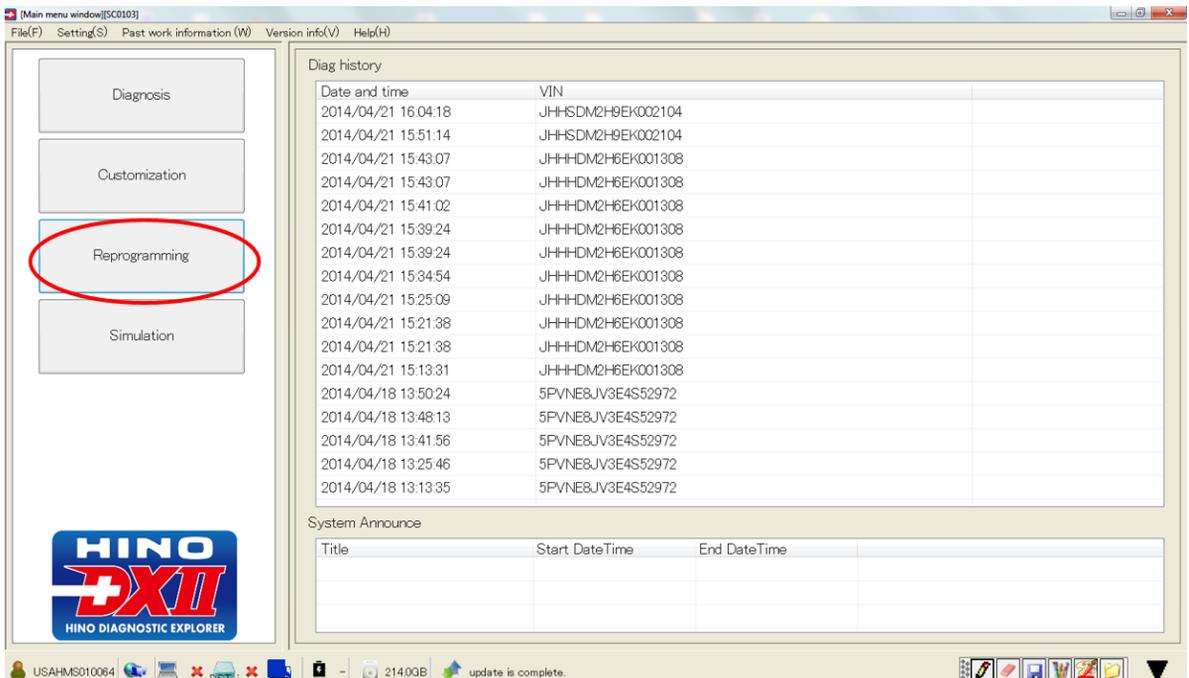
4. Select the “Reprogramming” icon.

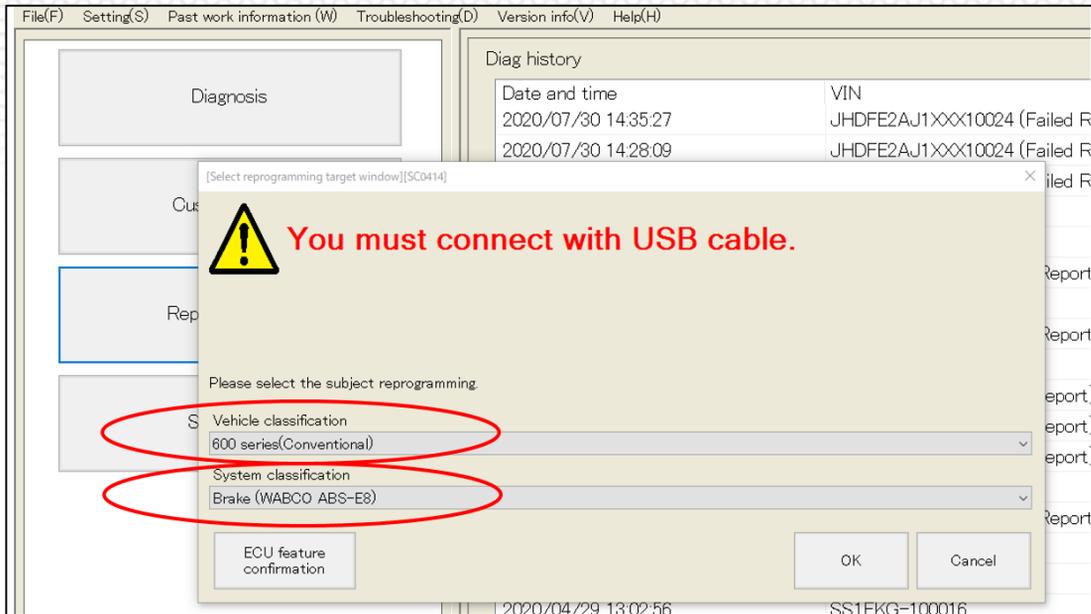
5. Select both “600 Series” under the “Vehicle Classification” drop down menu, and “Brake (WABCO ABS-E8)” under the “System Classification” drop down menu. Then select the “OK” icon.

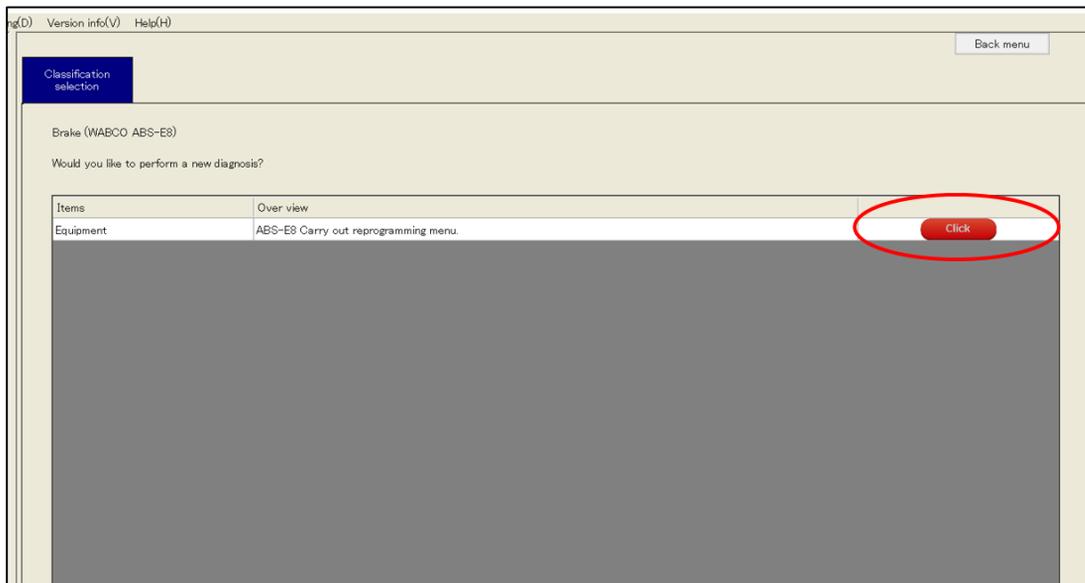
6. Select the red “Click” icon to proceed to the “ABS-E8 Carry out reprogramming menu.”

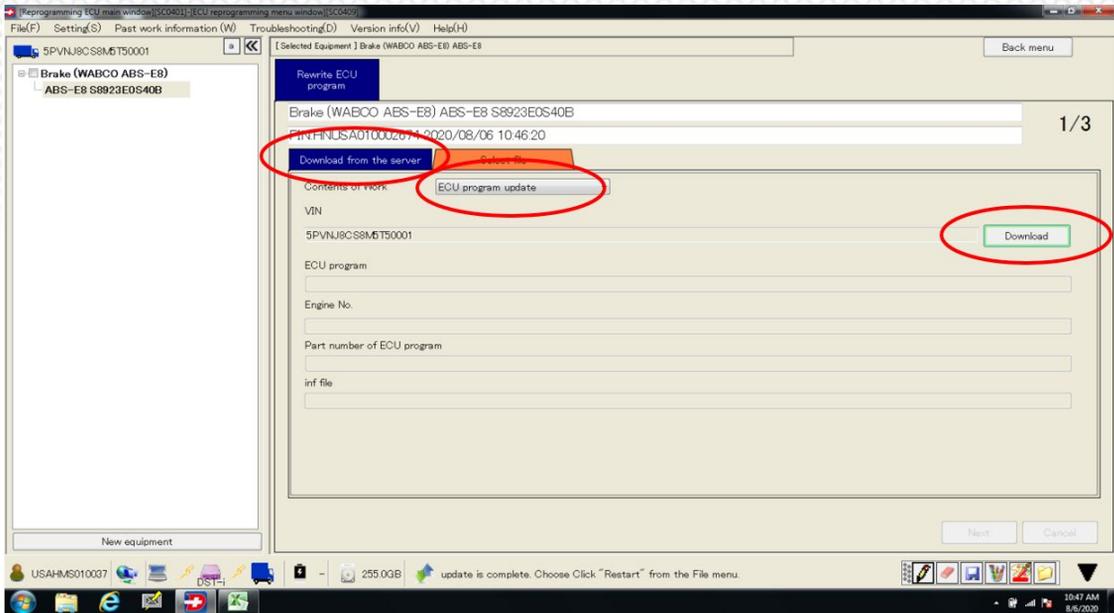
7. Under the “Download from the server” tab, choose “ECU program update” from the drop-down menu. Click “Download” to retrieve the software update file from the reprogramming server.

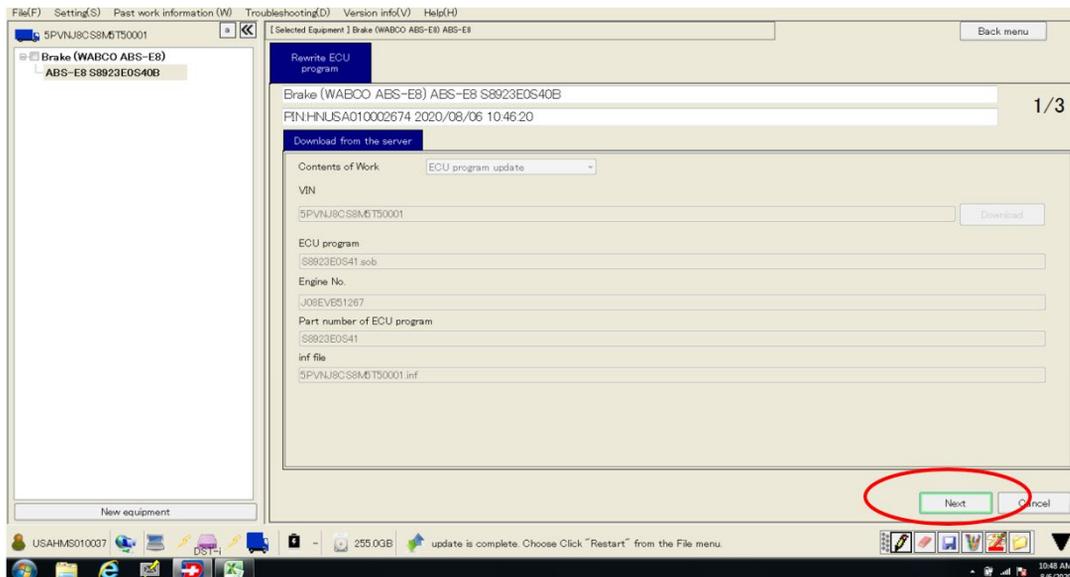
8. After the file is downloaded, select “Next” at the lower right.

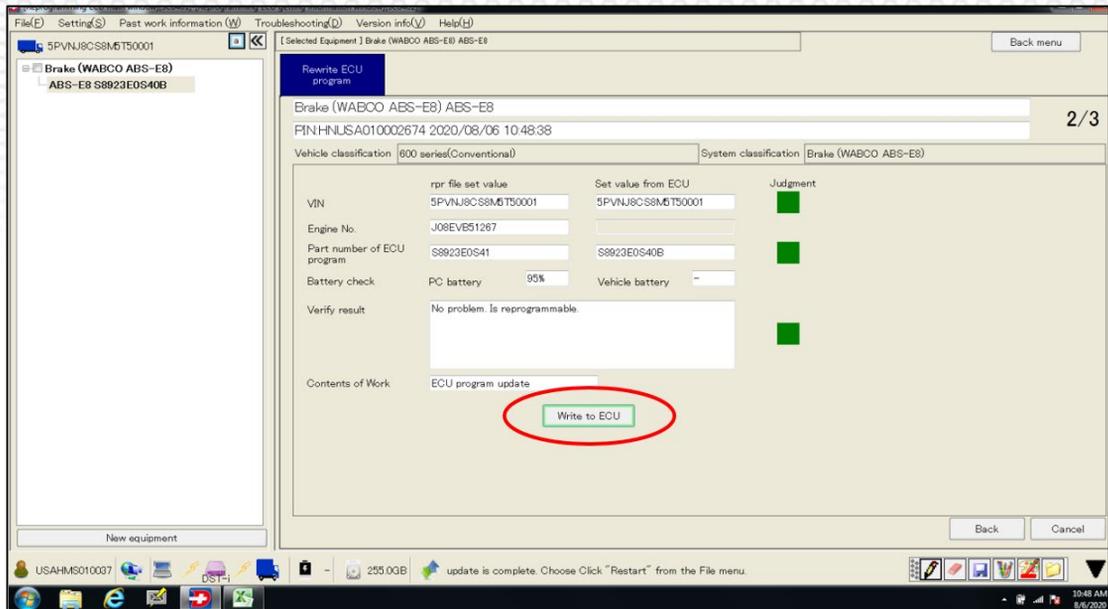
9. The DX2 will verify the downloaded file is compatible with the vehicle. Ensure that all three Judgments are marked as green. Click the “Write to ECU” icon.

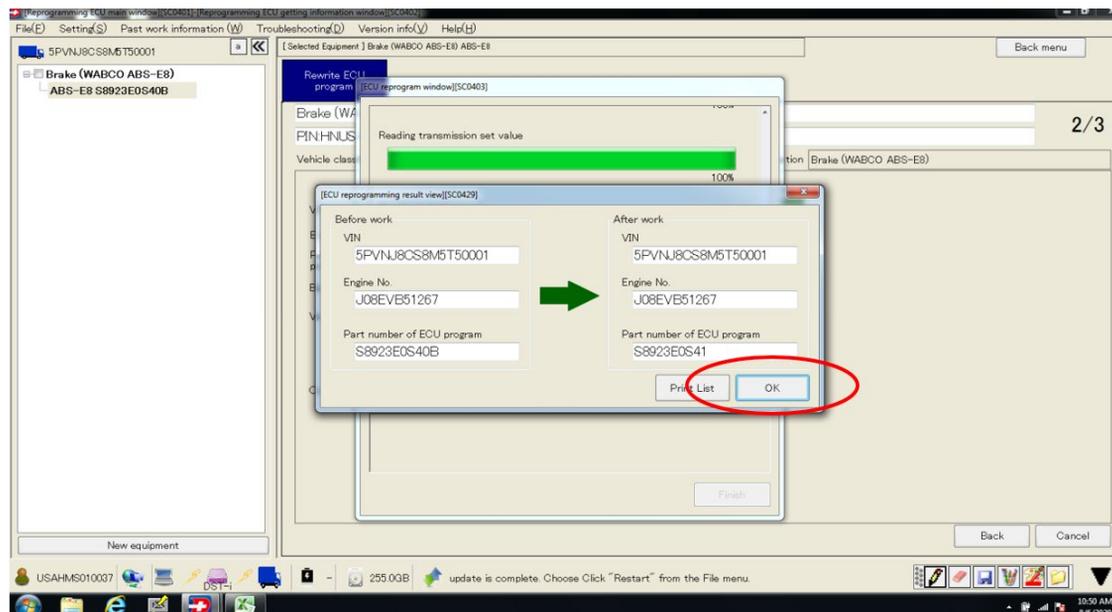
10. After completion of programming, the DX2 will report both the “before work” and “after work” software part numbers. Click “OK”.

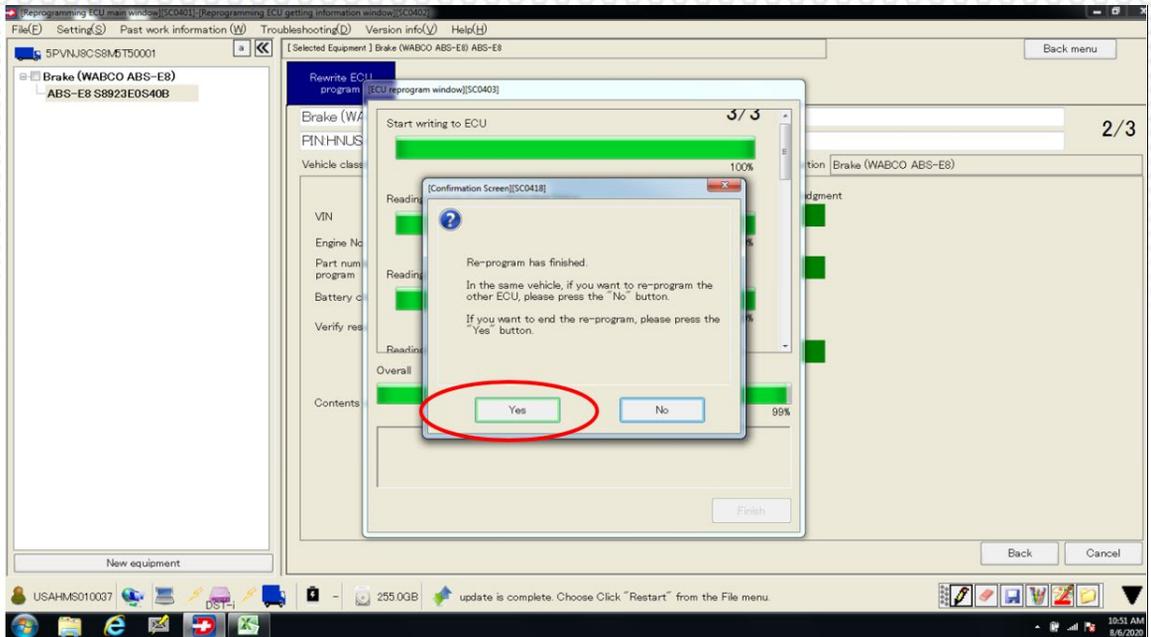
11. Click “Yes” to end the reprogramming session.

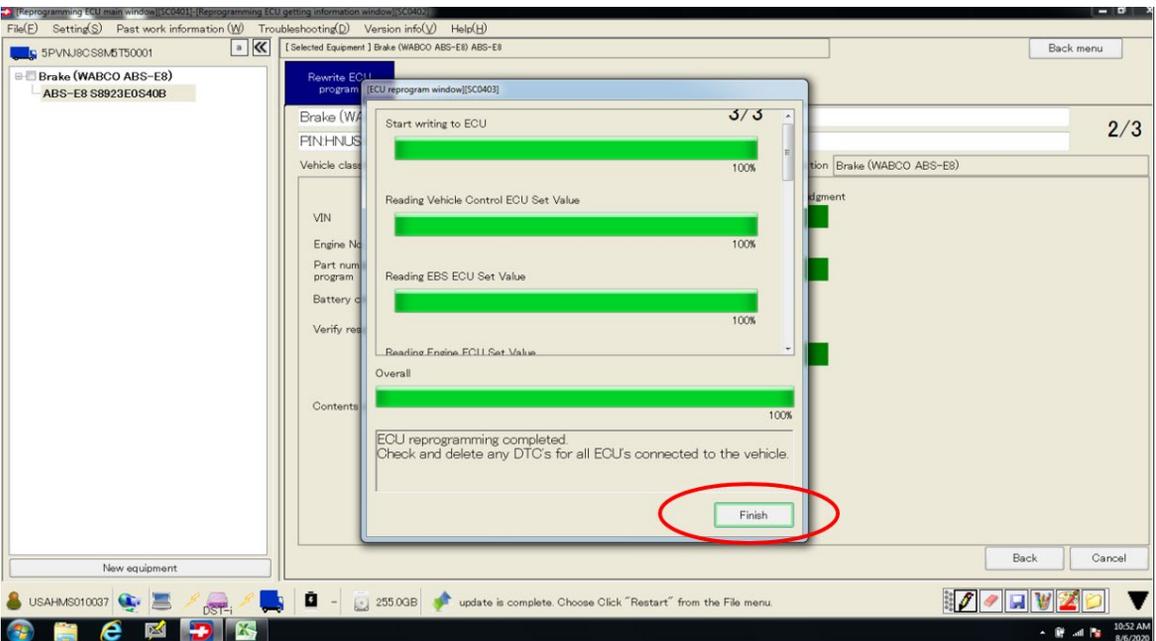
12. Click “Finish” to return to main DX2 menu.

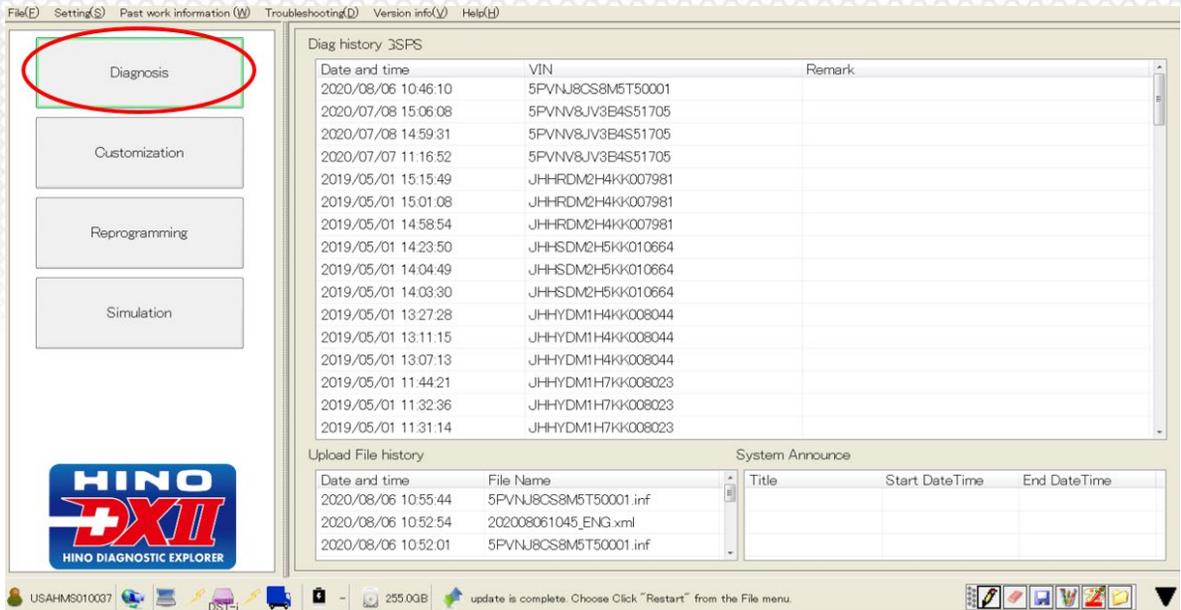
13. Select the “Diagnosis” icon.

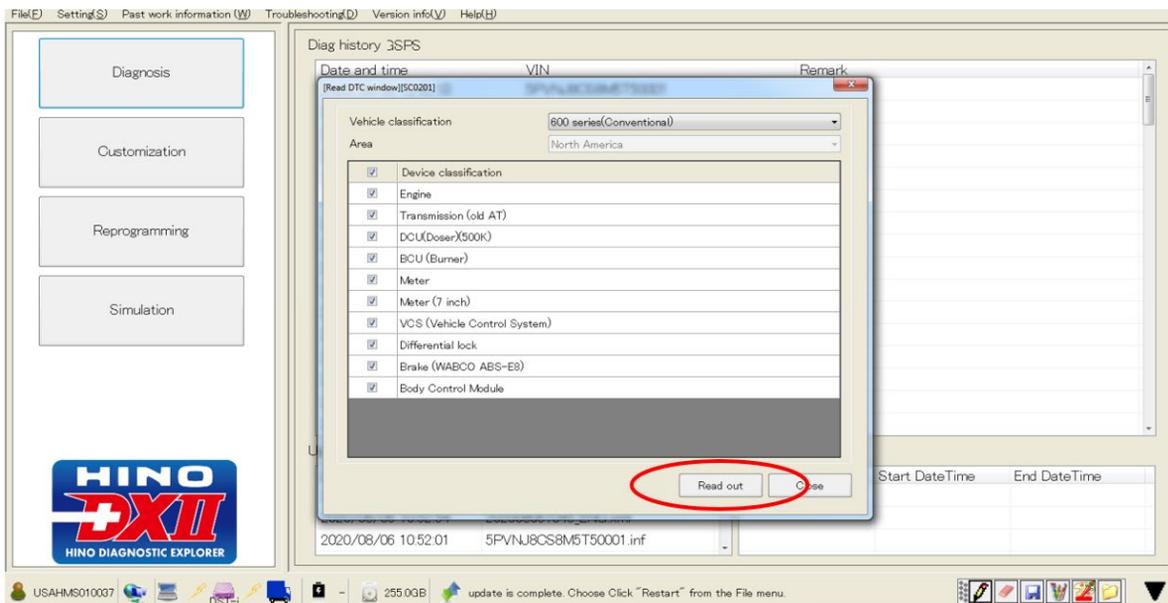
14. Select “600 series(Conventional)” and check mark all eleven (11) devices. Then click “Read Out”.

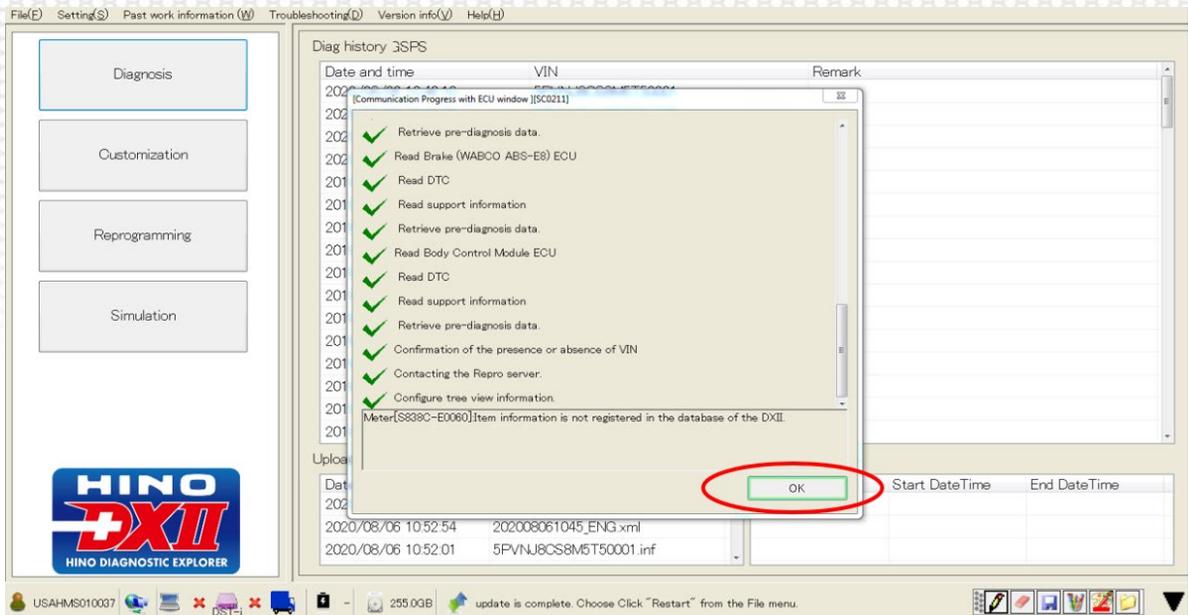
15. Select "OK".

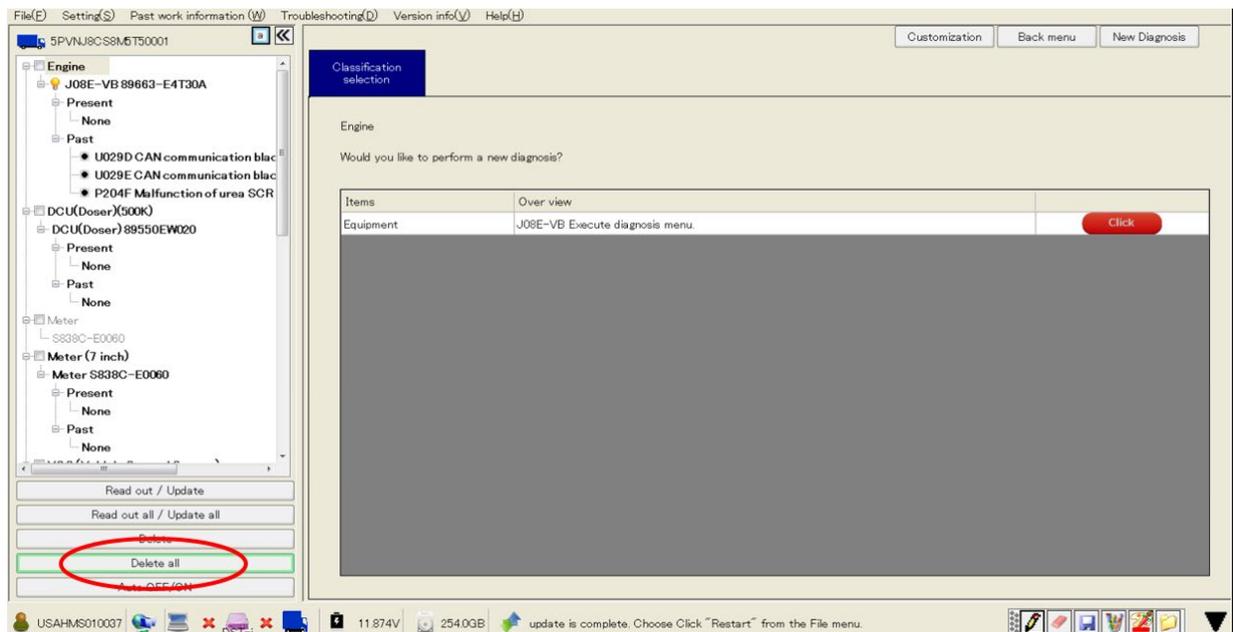
16. Click "Delete all" to delete DTC's from all vehicle modules.

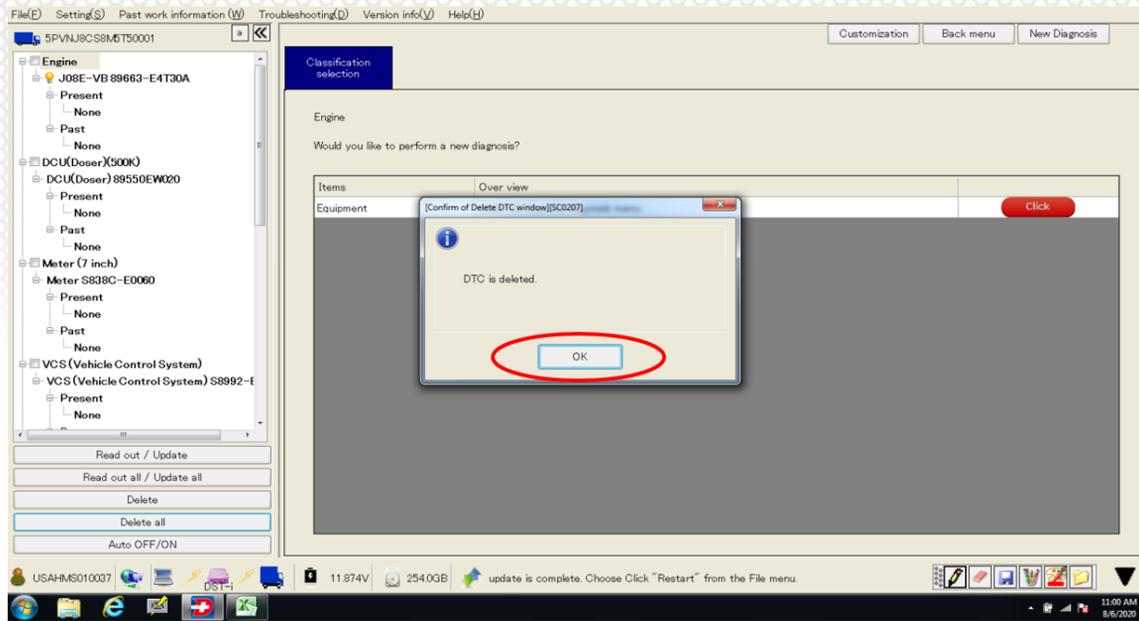
17. On the “DTC is Deleted” menu click “OK”.

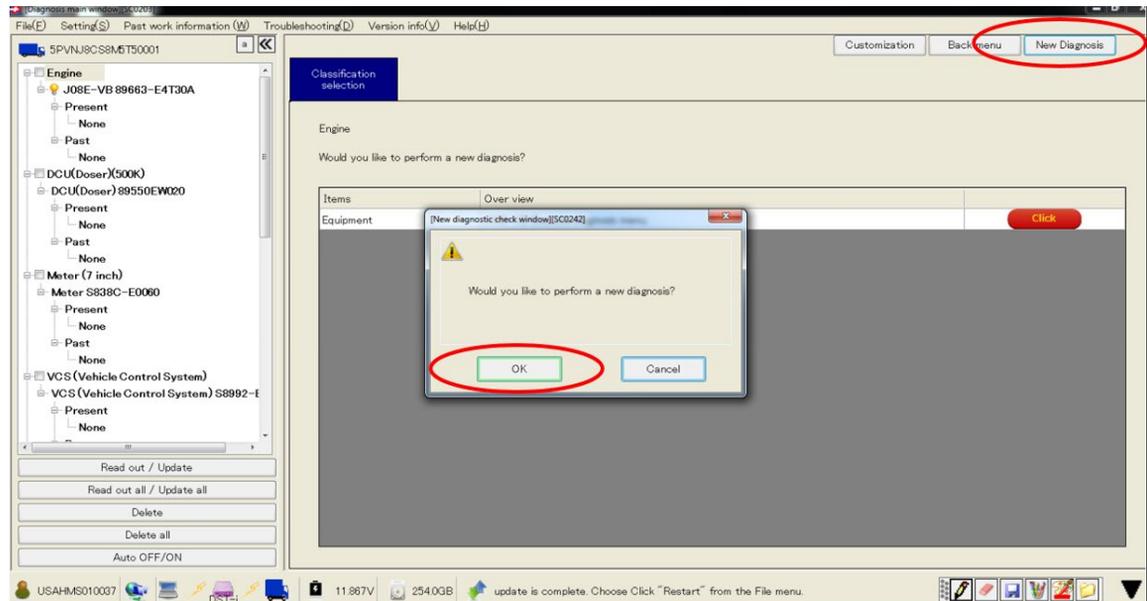
18. Select “New Diagnosis” to end the diagnostic session, and confirm by clicking “OK”.

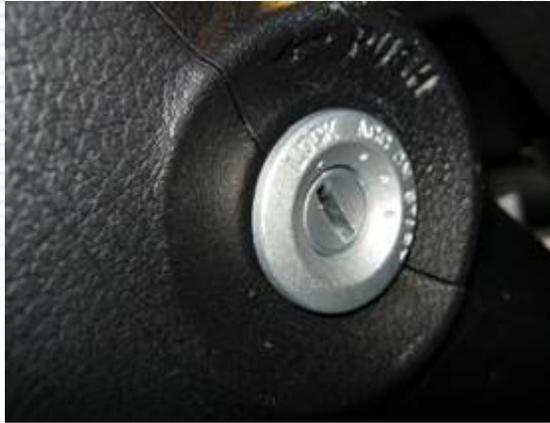
19. Turn the starter switch to the “LOCK” position and remove the key.

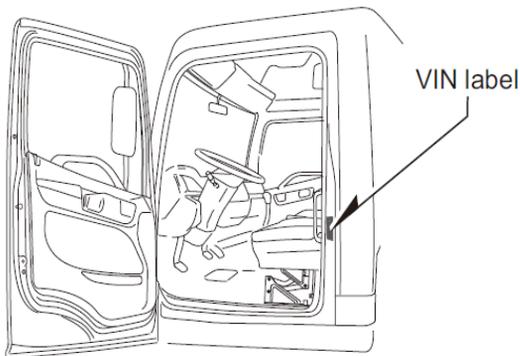
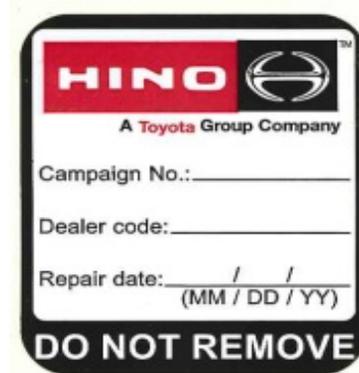
Once all above steps in this recall procedure have been completed, apply a recall label to the left door jamb above the VIN label. Fill in the Campaign No, Dealer code, and Repair date. Proceed to the Final Inspection Procedure, on Page 14.
